**Subject: Environmental Impact Statement for Estabrook Dam  
Milwaukee County, Wisconsin**

# Environmental Impact Statement for Estabrook Dam

Milwaukee County, Wisconsin

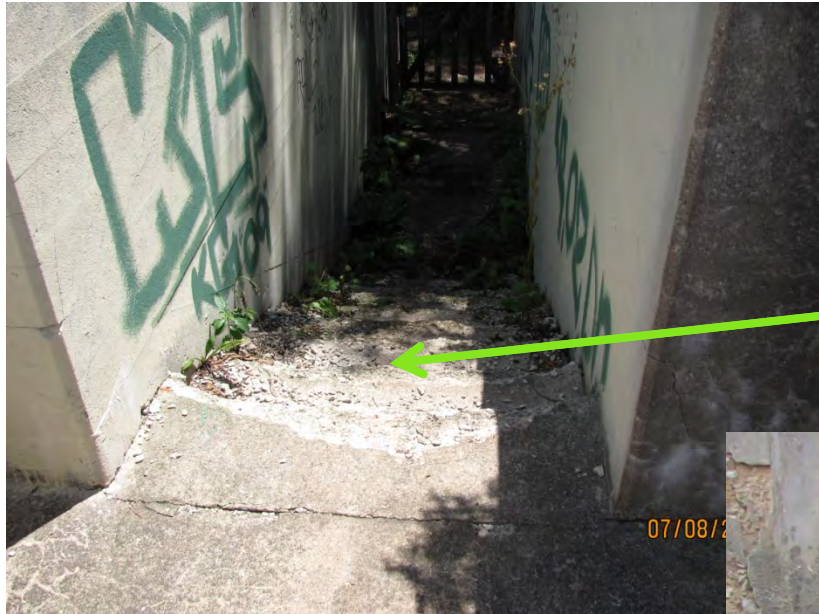
Photo 7/8/10

Repair stairs at both ends of gated spillway

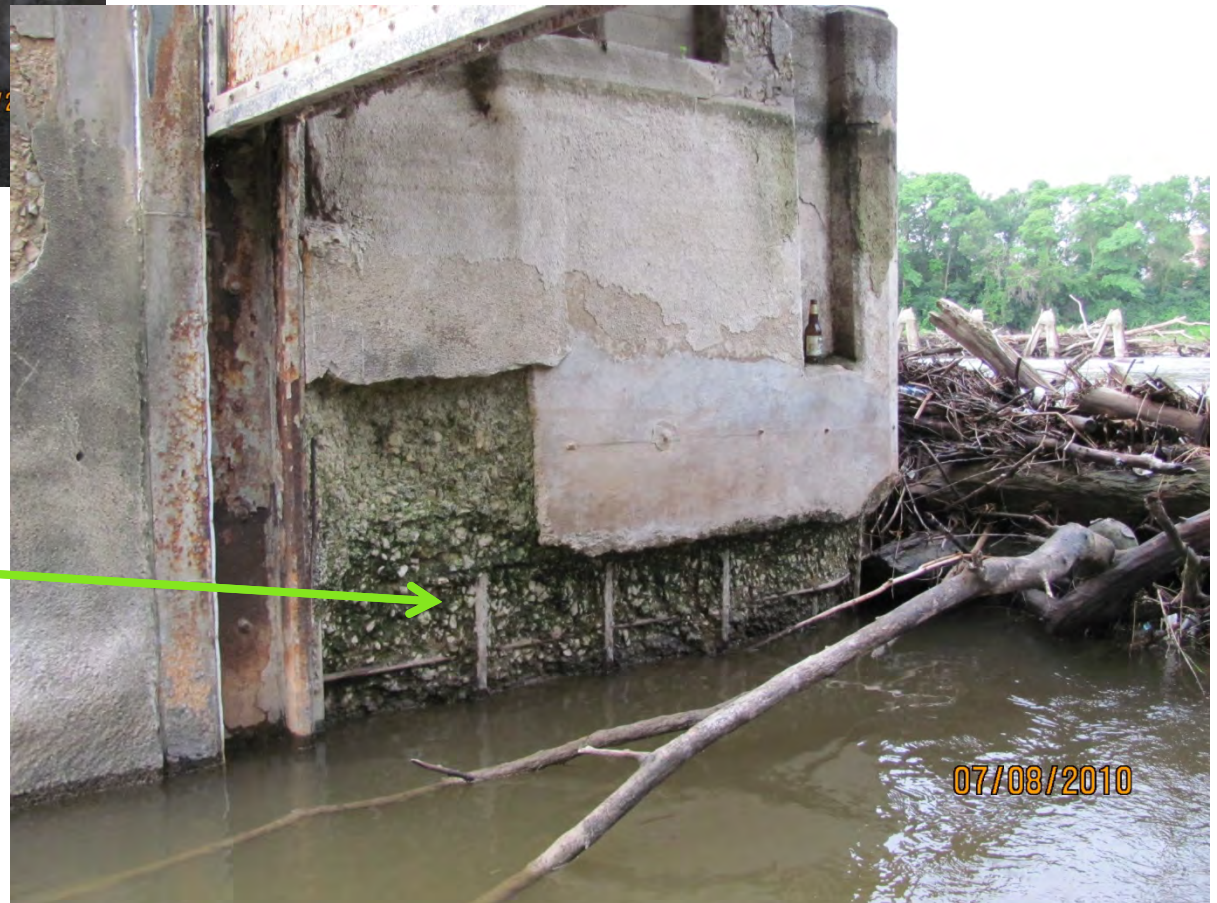
Photo 8/8/10

Repair deterioration below water line at gate piers

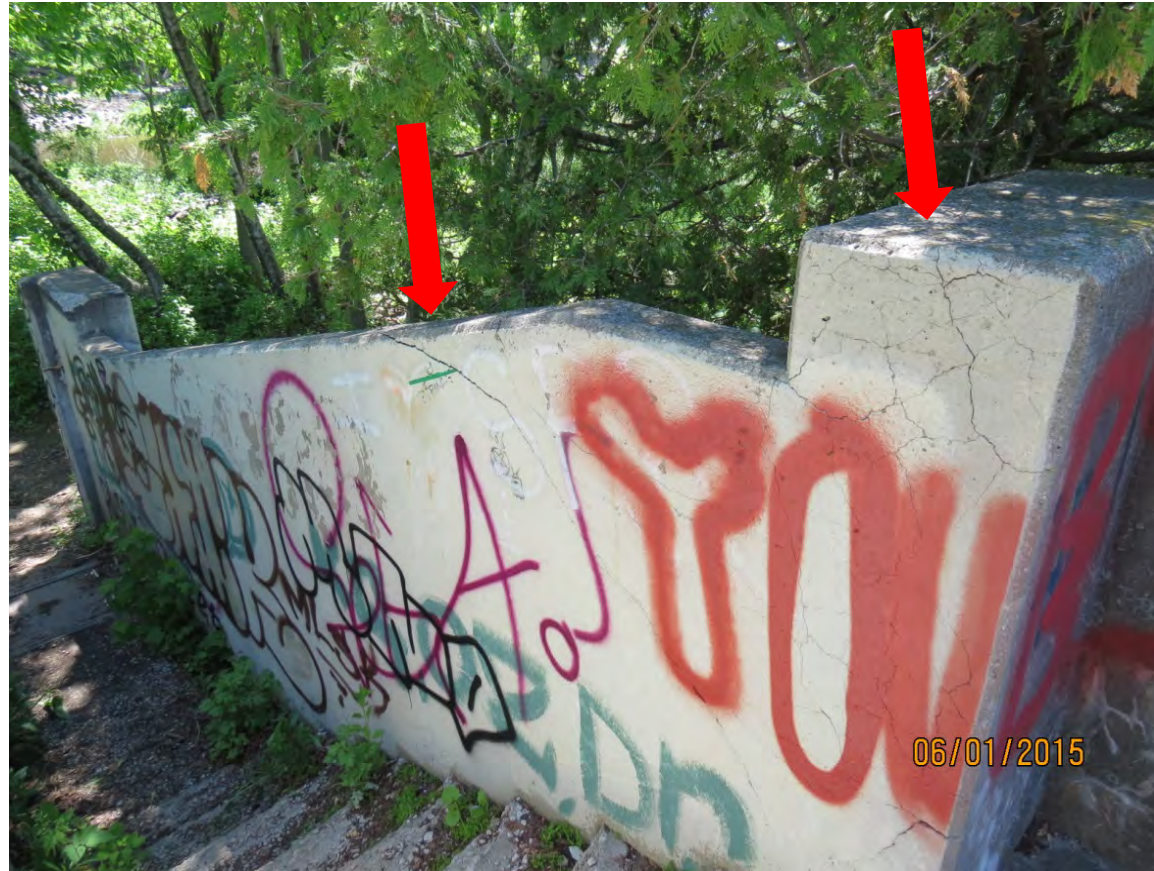
Wall of the south abutment stairs with severe cracking

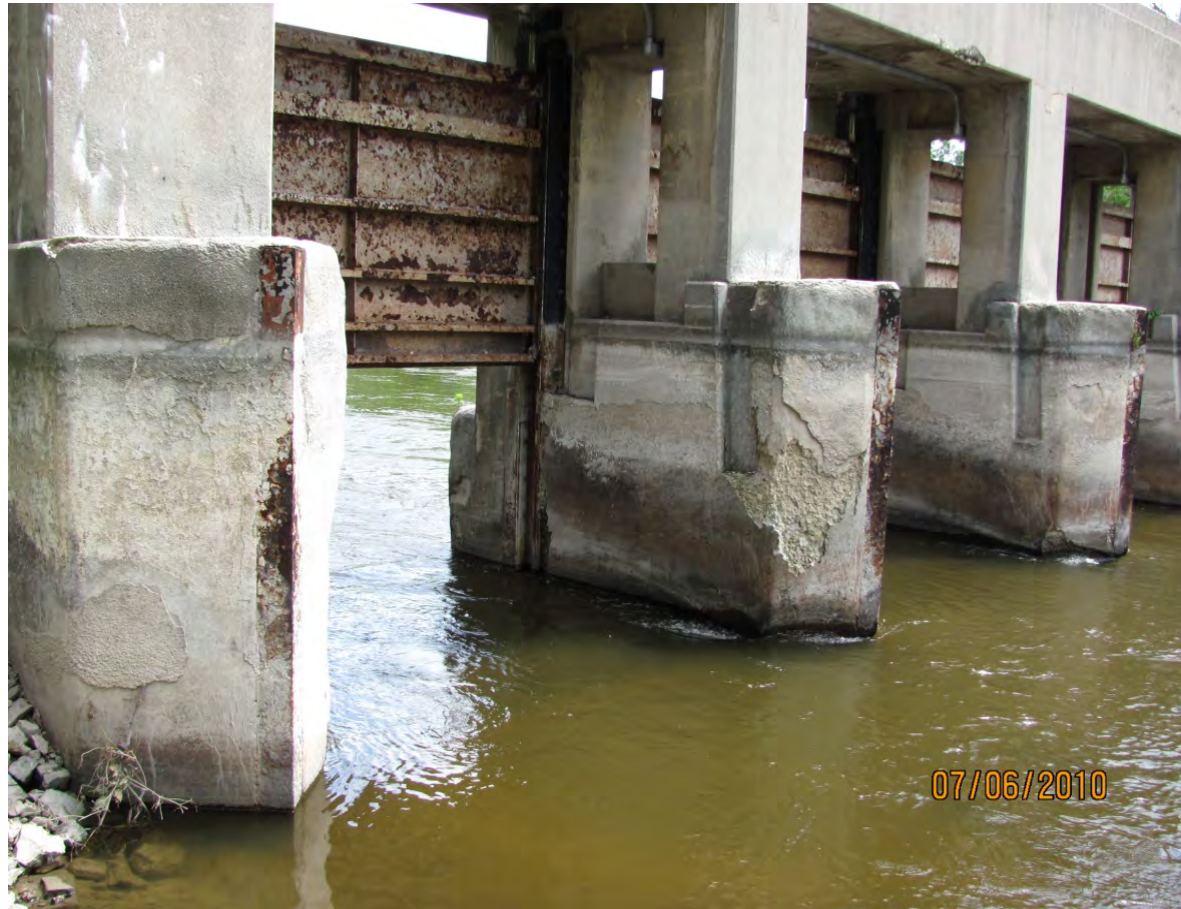
Upstream side of  
Pier 1 (left), Pier 2  
(center), and Pier 3  
(right) in 2010

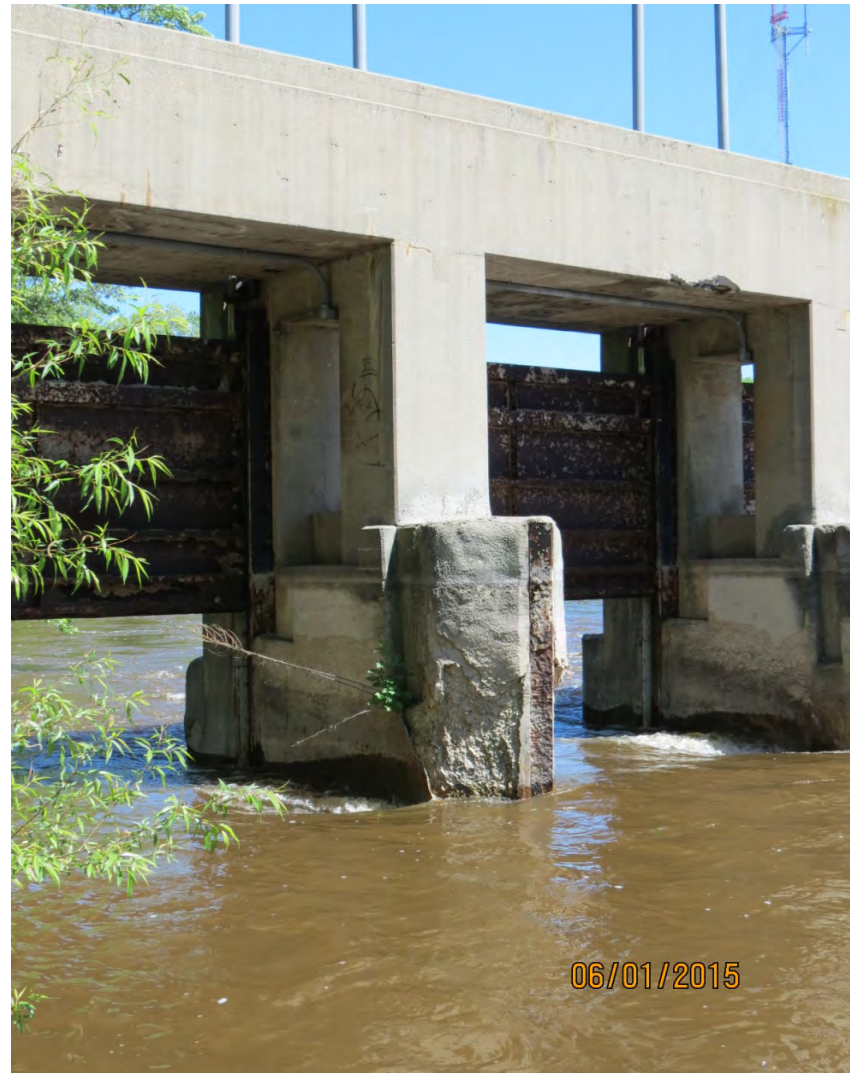
View of the upstream face of Pier 2 in 2015 with spalling of the concrete at the tip of the pier. Refer to photo on page 8 for comparison to 2010 observed condition.

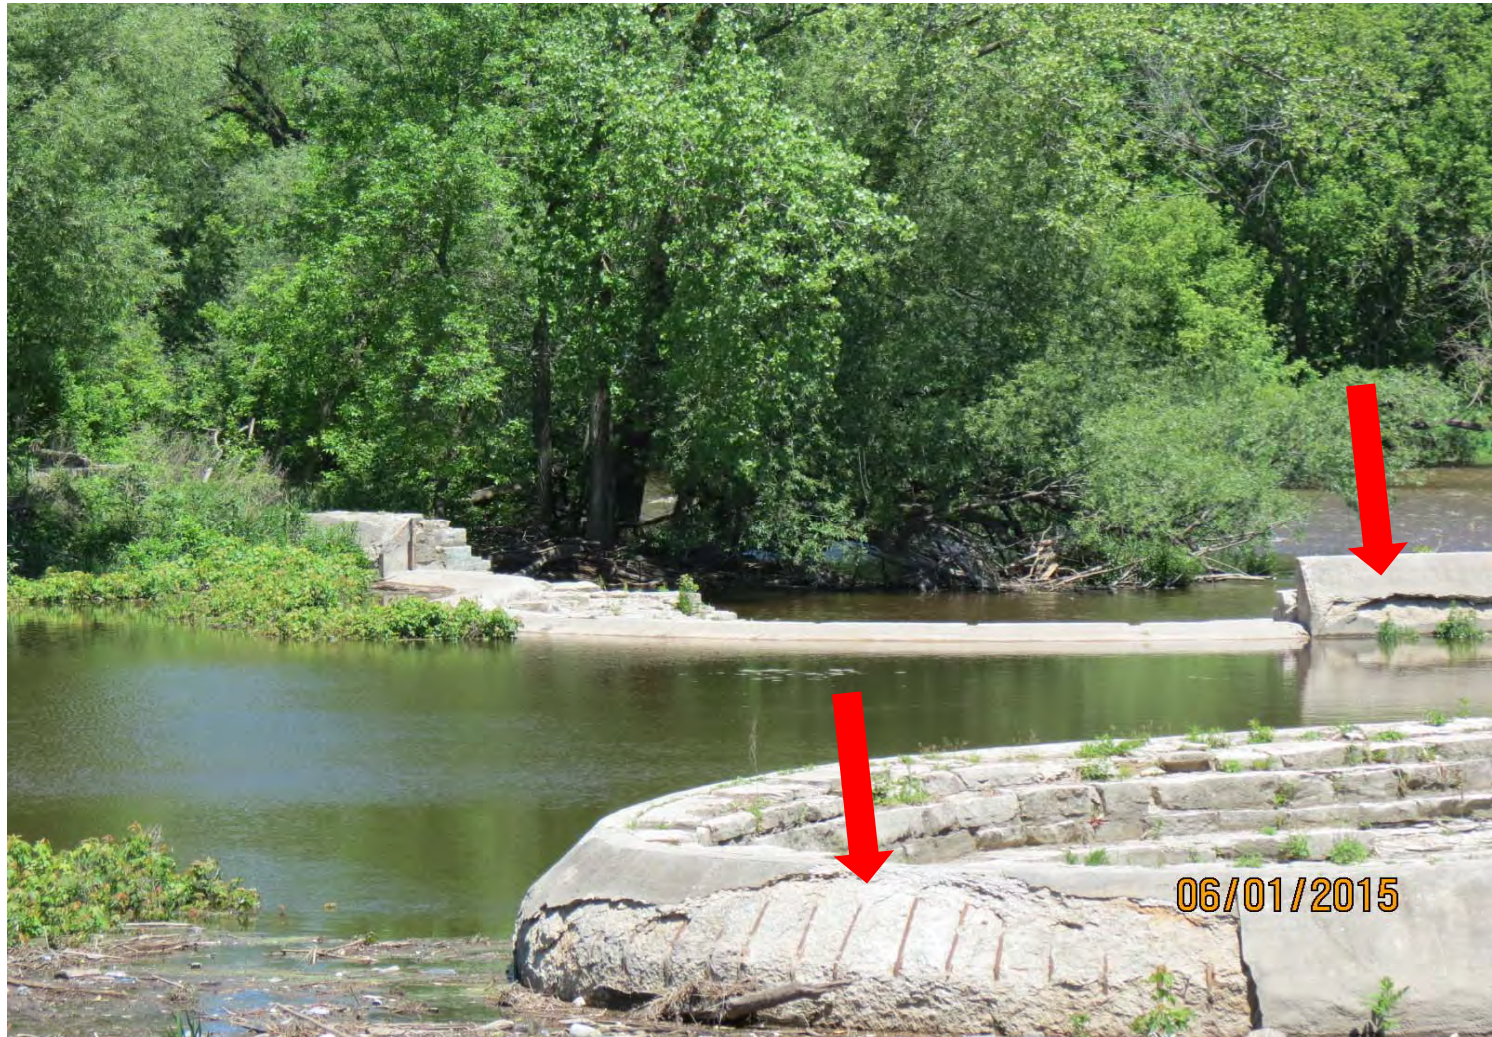
- Fixed crest spillway, spalling concrete and shotcrete.

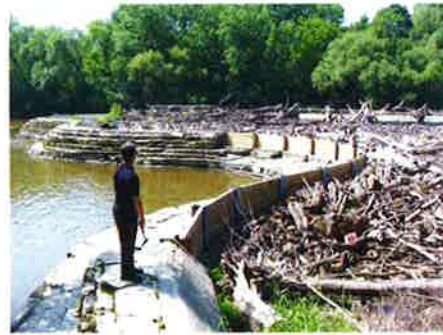
A picture of the serpentine spillway from 2010, undergoing some emergency repairs.

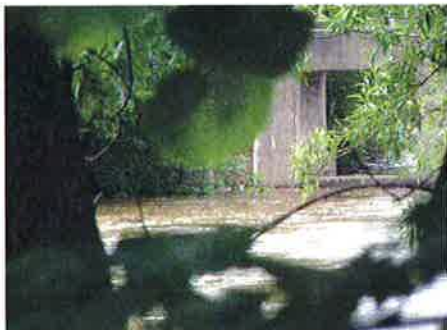
June 2008 storm event: water level is almost above top of gate and the same level upstream and downstream of the dam structure.

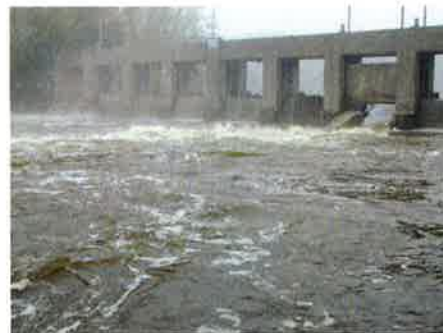
Estabrook Dam on May 11, 2004. Note only two gates were opened.
