**Deposit POG1-B Remediation Phase 2 –
Post Construction Monthly Reports**

Deposit POG1 B, Phase 2 Post-Construction Status Report – January 2007

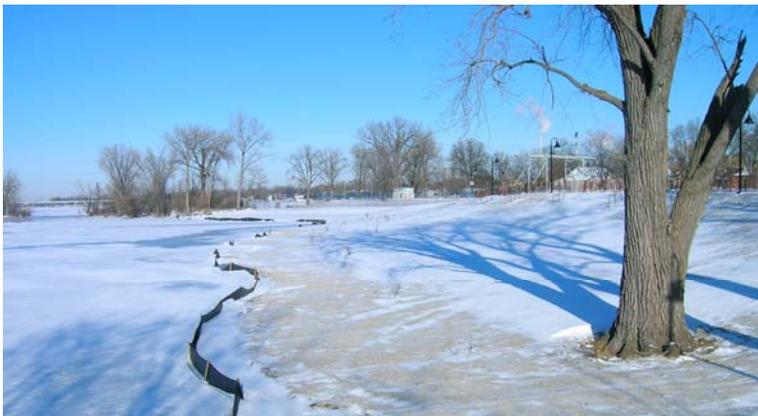
A thin sheet of ice had formed on approximately the western two or three hundred feet of Little Lake Butte des Morts, including the cove adjacent to Deposit POG1 B, on January 9, 2007. The lake surface was almost completely frozen over on January 17, 2007. The surface of the ice intersected the lower portion of the silt fence along the shoreline. Portions of the silt fence that were down in December were now frozen into the ice and could not be recovered for repair. Site conditions on January 17, 2007 are shown in Photograph 1.

Photograph 1 – Shoreline looking north from pedestrian bridge.

Recommendations: With the ice cover and stable slope conditions no activities are proposed. When the ice thaws and the silt fence is again accessible, it should be repaired to help reduce erosive forces of wind and wave action. Fallen sections of the silt fence should be repaired by stapling or wiring existing or new geotextile to the support stakes.

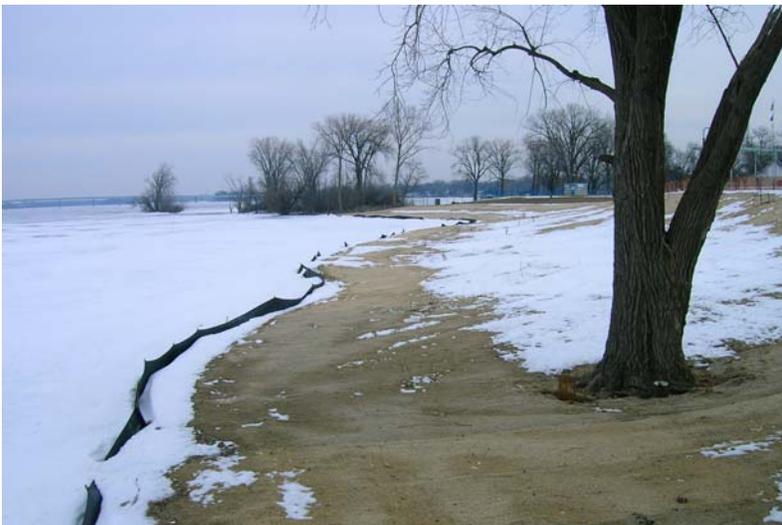
Ice covered approximately the eastern portion of Little Lake Butte des Morts, including the cove adjacent to Deposit POG1 B. The surface of the ice intersected the lower portion of the silt fence along the shoreline. Site conditions on February 21, 2007 are shown in Photographs 1 and 2.

Photograph 1 – Shoreline looking north from pedestrian bridge.

Recommendations: With the ice cover and stable slope conditions no activities are proposed. When the ice thaws and the silt fence is again accessible, it should be repaired to help reduce erosive forces of wind and wave action. Fallen sections of the silt fence should be repaired by stapling or wiring existing or new geotextile to the support stakes.

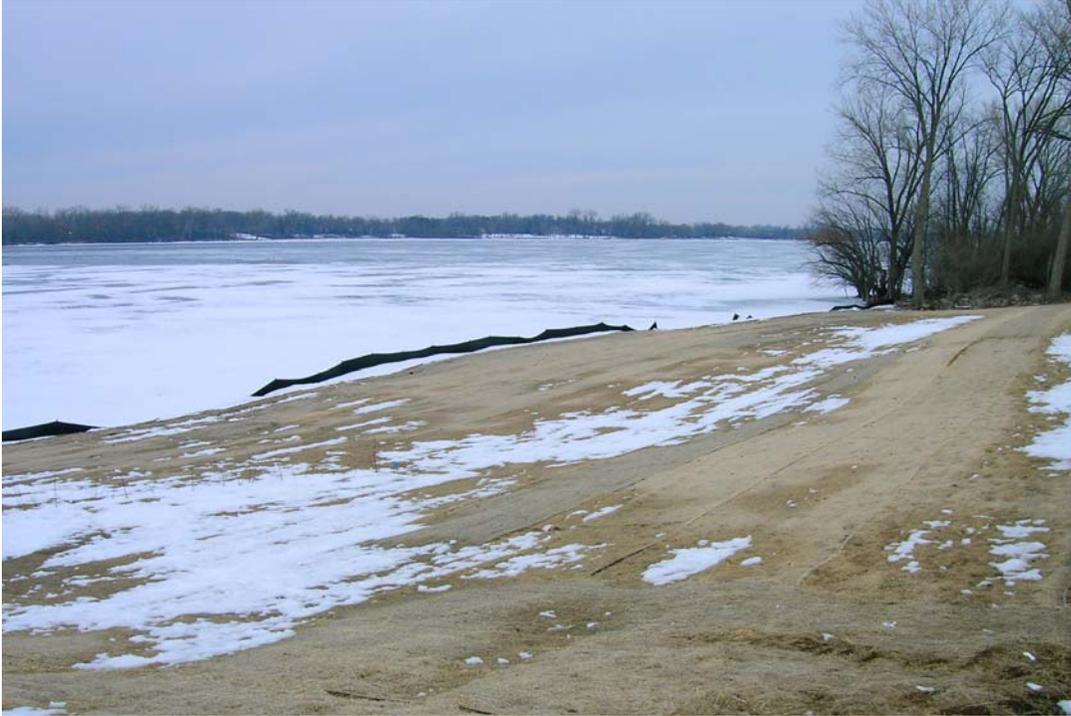
Photograph 2 – Looking northwest from southern lock location.

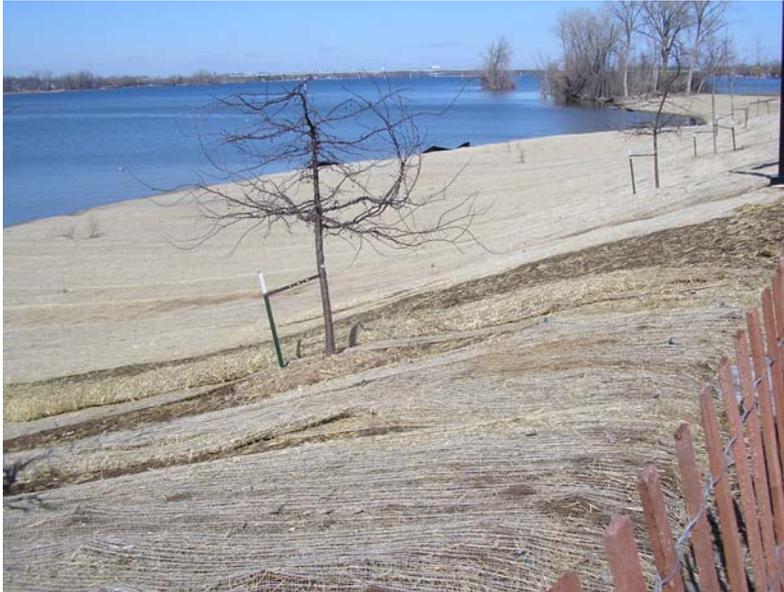
Observations: The area of Deposit POG1 B was observed by STS Consultants, Ltd (STS) on March 20, 2007. Observations indicated the site was in generally good condition, as shown in Photograph 1. There were several sections of the erosion control mats that were rolled back by the wind, as shown in Photograph 2. No soil erosion was evident where the mats were rolled back.

Photograph 2 – Erosion control mat rolled back by wind.

Synagro was informed of the condition of the erosion mats. Repair and replacement of the erosion control mats were completed on March 30, 2007. Photograph 3 shows the site after the repairs were completed. Synagro also viewed the silt fence. Although portions of the silt fence were submerged it appeared it was providing some degree of protection. Synagro did not reset the silt fence because the substrate was loose. It was their opinion that re-stacking into the loose substrate would not provide additional support. With the water level rising onto the erosion control mats and the silt fence being partially intact, it was decided to continue monitoring the shore area and take corrective action, if and when, required.

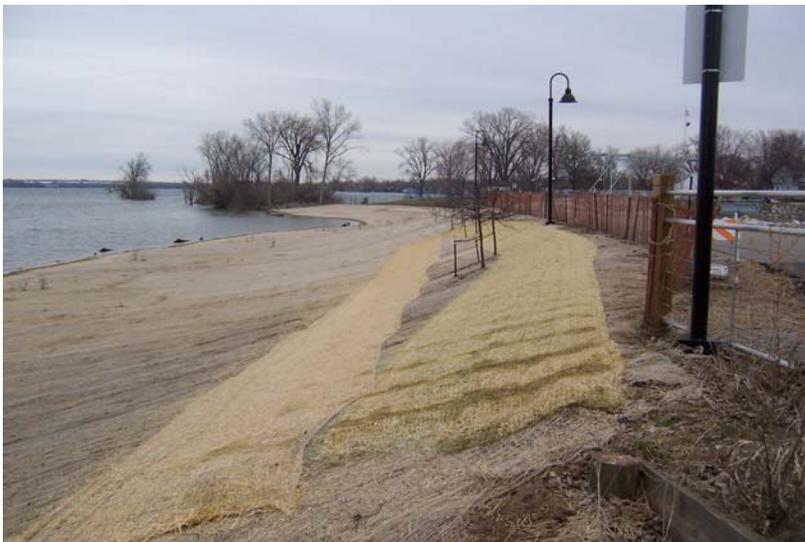
Photograph 3 – Erosion control mat repair.

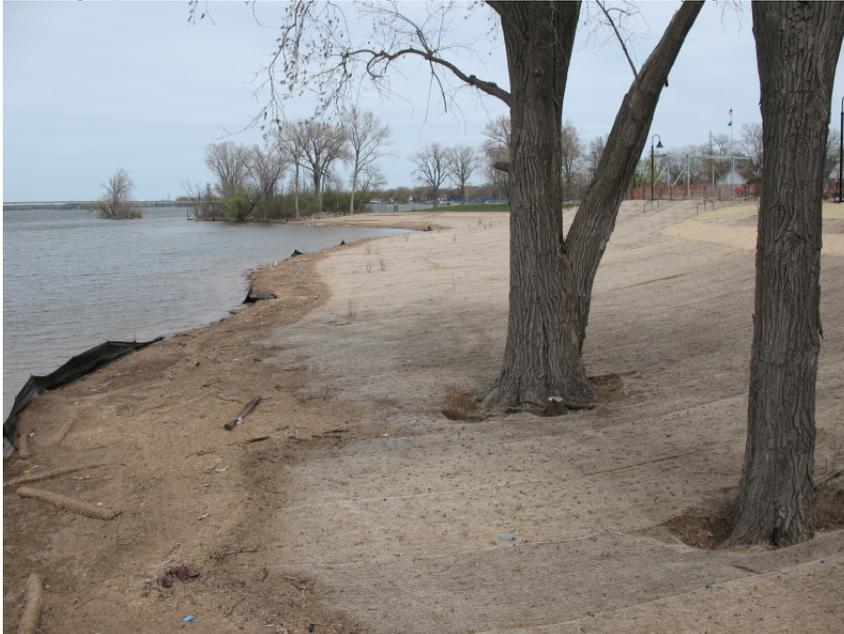
Observations: The area of Deposit POG1 B was observed by STS Consultants, Ltd (STS) on April 25, 2007. Observations indicated the site was generally in good condition. Grass was starting to grow through the erosion control mats and buds were swelling on the shrubs and trees. Wind caused several sections of the erosion control mats to roll back on the north end of the site. Changes in lake levels and wave action removed portions of the erosion control mats along the shoreline. Site conditions on April 25, 2007 are shown in Photographs 1 and 2.

Photograph 1 – Shoreline looking north from pedestrian bridge.

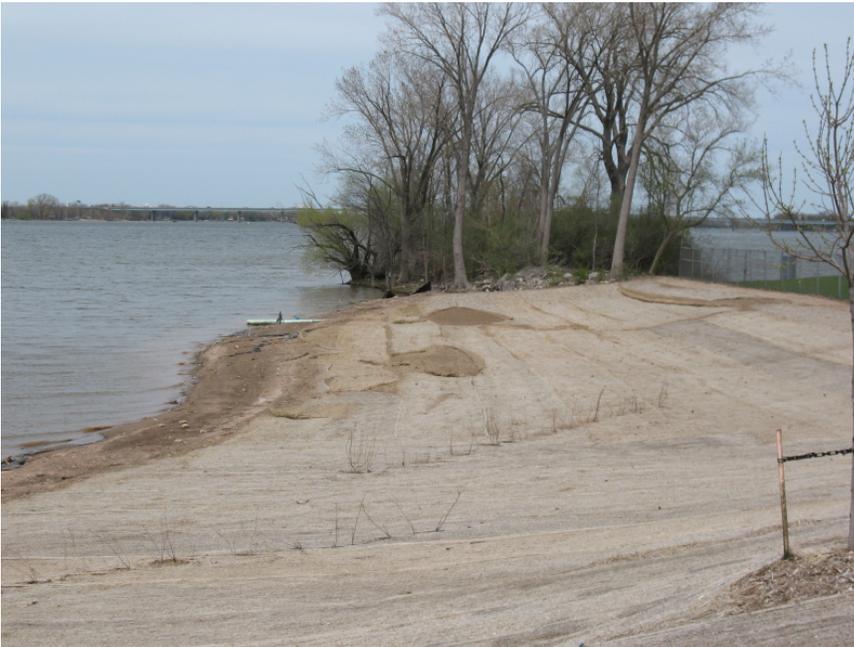
Photograph 2 – Erosion control mat rolled back by wind.

Synagro completed repair and replacement of the erosion control mats at the north end of the site on May 4, 2007. Photograph 3 shows the site after the repairs were completed.

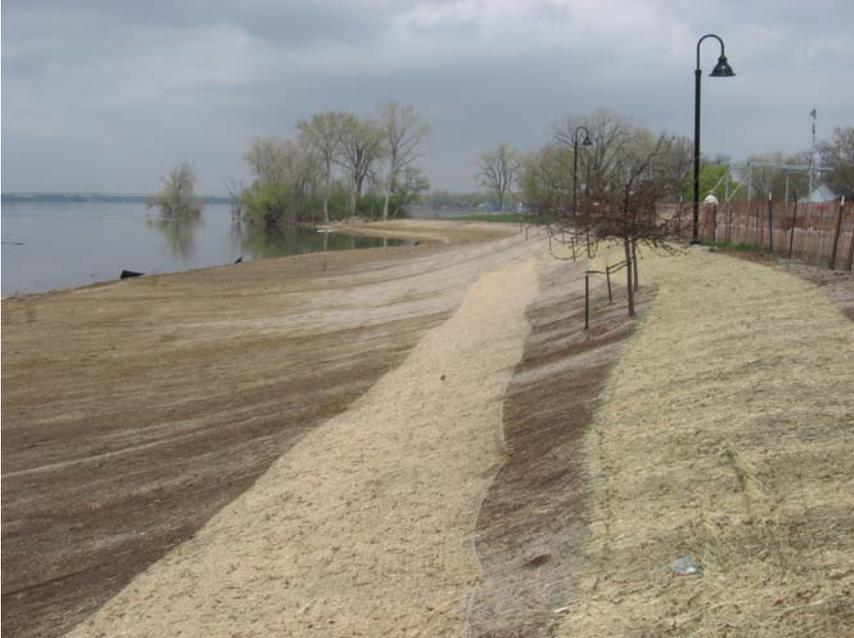
Photograph 3 – Erosion control mat repair.

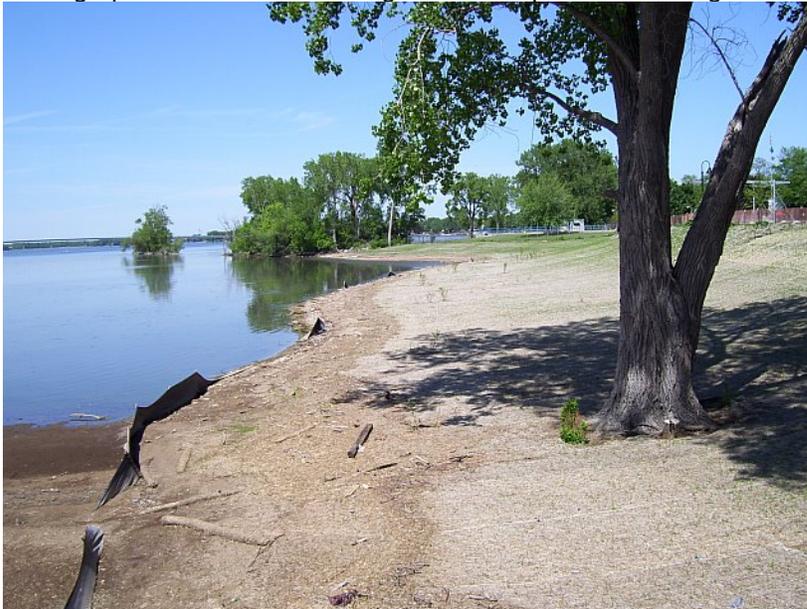
Observations: The area of Deposit POG1 B was observed by STS on May 25, 2007. The lake level had receded to the point that the lake bed was exposed in front of the silt screen, near the pedestrian bridge, as shown in Photograph 1. As noted in April 2007, changes in lake levels and wave action removed portions of the erosion control mats along the shoreline. The erosion control mats on the slopes were generally in good condition.

Photograph 1 – Shoreline looking north from pedestrian bridge.

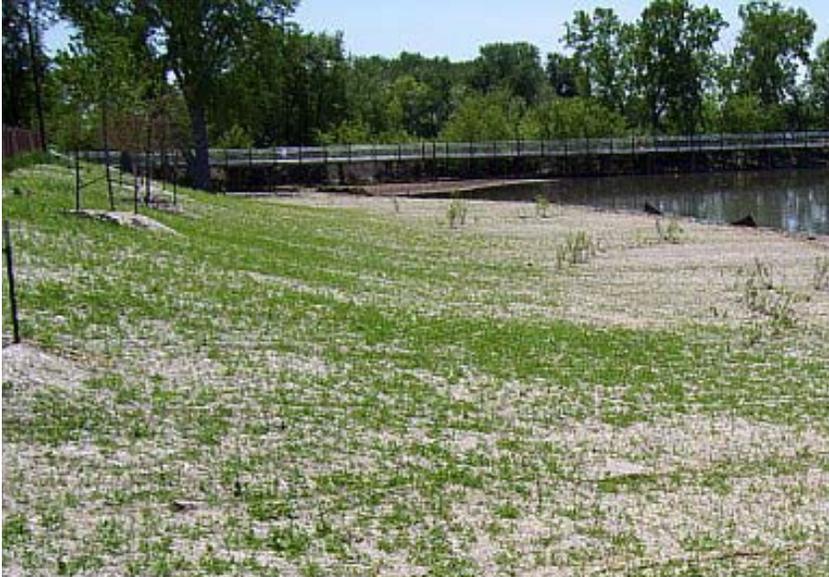
The shrubs and trees were leafing out as noted in Photograph 2. The temporary cover seeding from 2006 did not appear to be emerging and it is suspected that it was lost (rotted) over winter. Invasive plants, including thistle and burdock, were noted along the pedestrian path. The invasive plants appear to have been pre-existing perennials that were pushing through the thin mantle of new soil fill along the path. Most of the emerging plants on the slope were herbaceous, versus grasses.

Photograph 2 – Shrubs and trees leafing out.

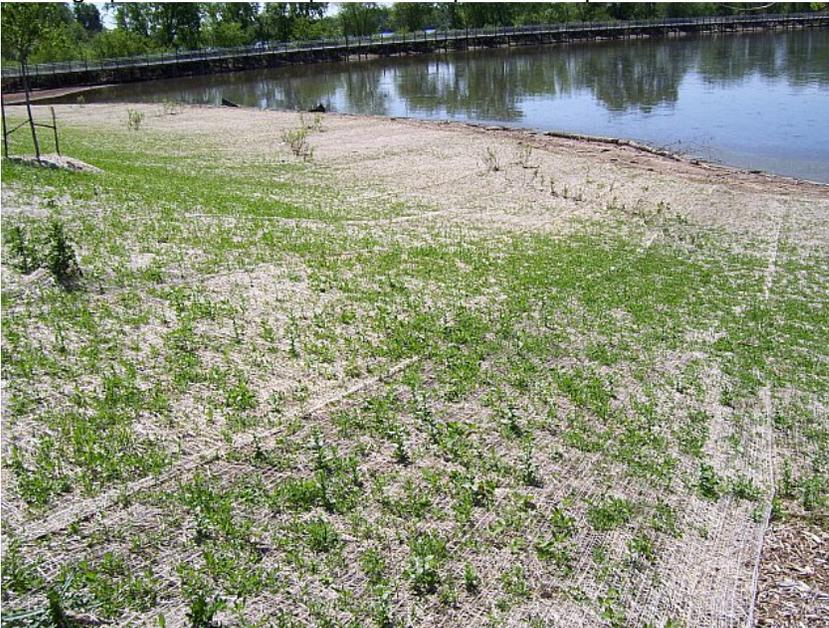
Photograph 3 – Invasive species near pedestrian path and herbaceous vegetation on slope.

- Remove invasive species along the pedestrian path with herbicide (select spraying).

- Apply native grass seed with water from a hydromulcher. This should float seed under the erosion control mats and negate removal and reinstallation of the mats. It will also reduce site disturbance and allow germination and emergence of seed that may have successfully over-wintered.
- Apply mulch to the entire site with a hydromulcher. This will provide additional protection of the slope and newly placed seed.
- If sufficiently dry, the silt fence will be removed (previous attempts found the ground to be too soft to traverse without significant disturbance).

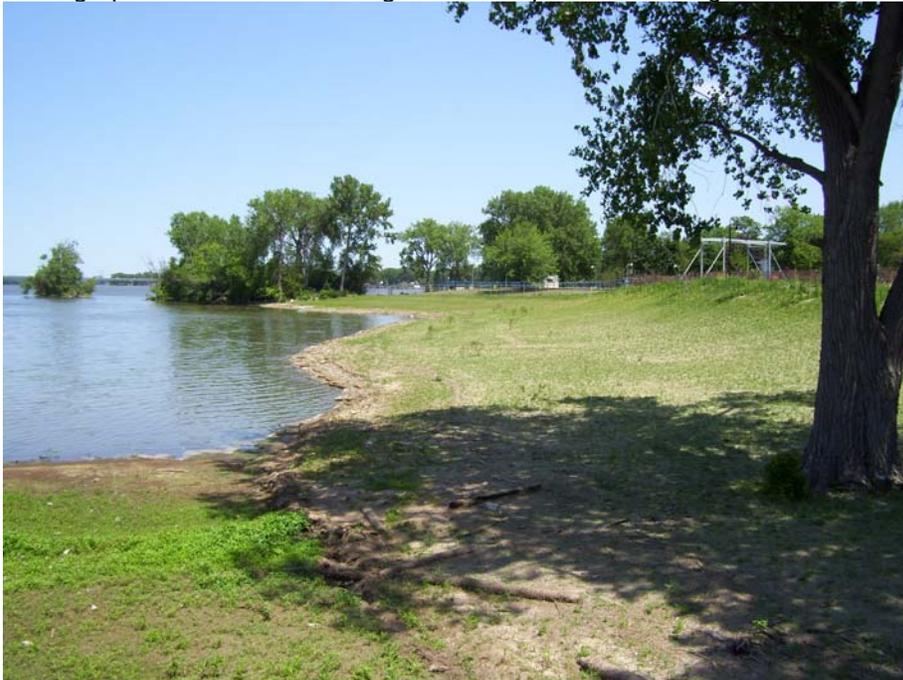
Observations: The area of Deposit POG1 B was observed by STS on June 27, 2007. The lake level continued to be relatively low and the shoreline was below the seeded area. The slopes continued to be stable and did not show signs of erosion. The erosion control mats were starting to show signs of deterioration, as expected.

Photograph 1 – Shoreline looking north from pedestrian bridge.

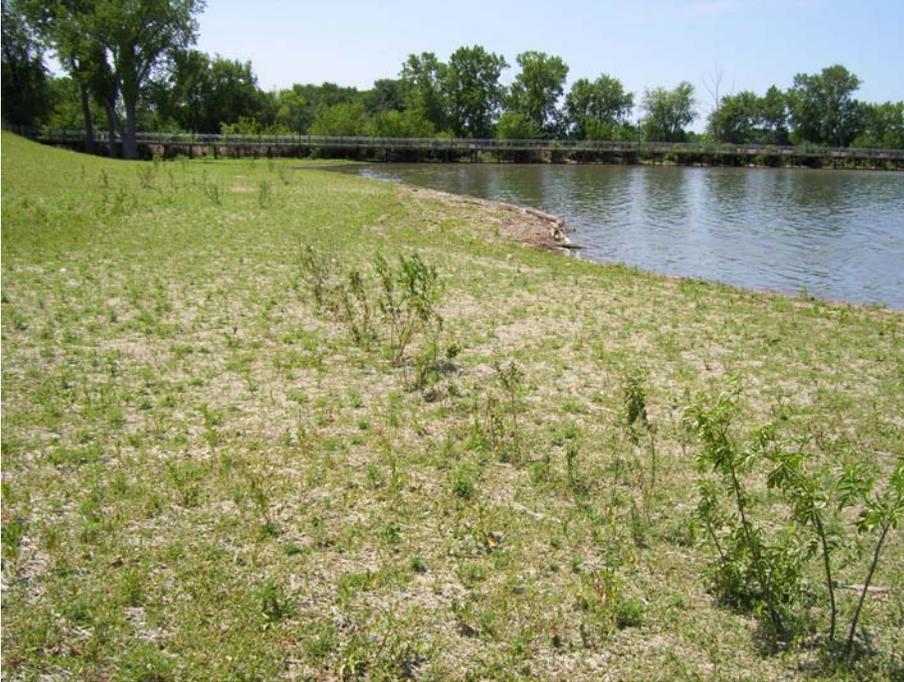
Photograph 2 – Slope conditions in the mid-section of the site, looking south.

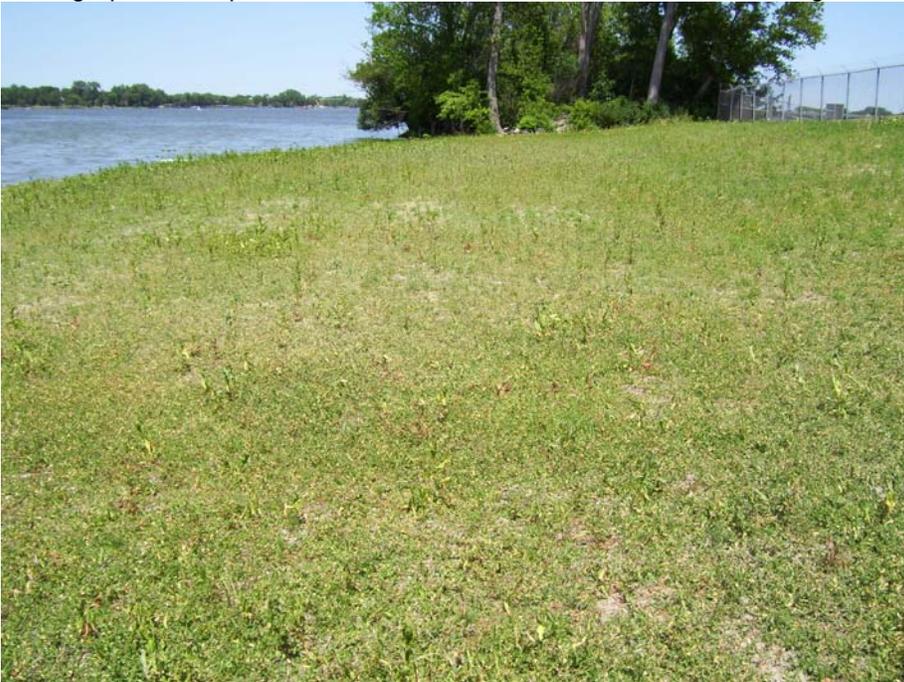
Photograph 3 – Slope condition at the northern end of the site, looking north.

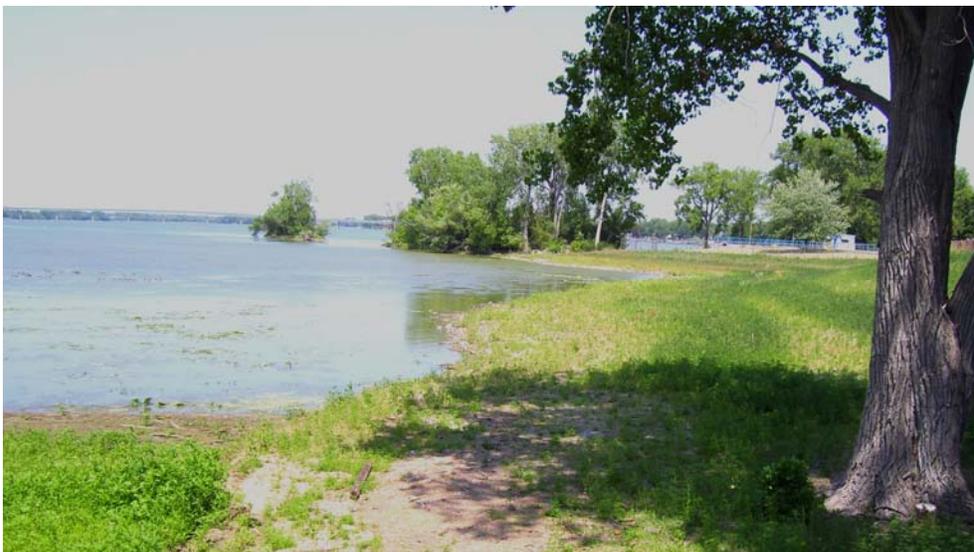
Observations: The area of Deposit POG1 B was observed by Synagro on July 18, 2007 and by STS on July 23, 2007. On these dates the lake level was at about +736.4, almost two feet below normal pool level. The shore zone, which was bare in June 2007, had started filling in with vegetation. The slope was stable. Photographs 1 through 4 show site conditions on July 23, 2007.

Photograph 1 – Shoreline looking north from pedestrian bridge.

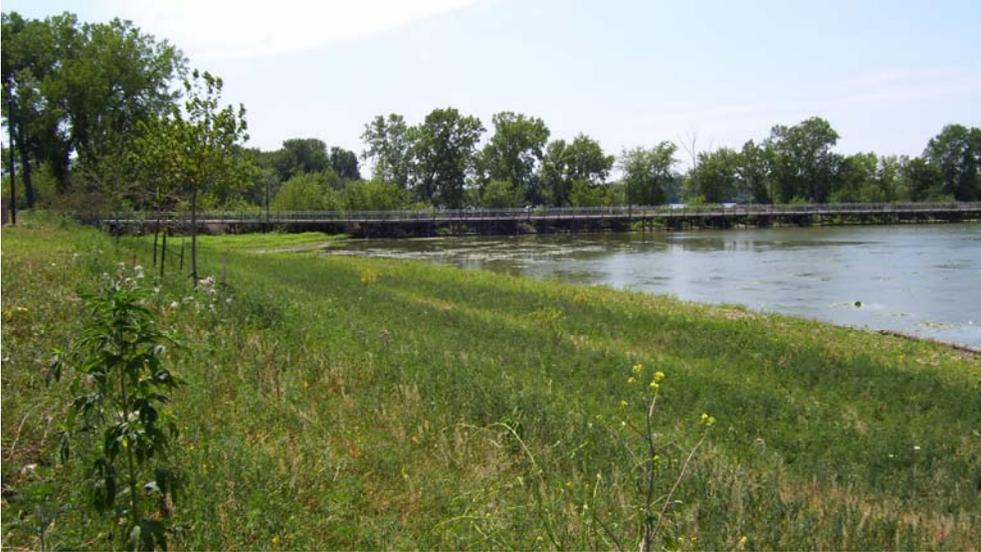
Photograph 2 – Slope conditions in the mid-section of the site, looking south.

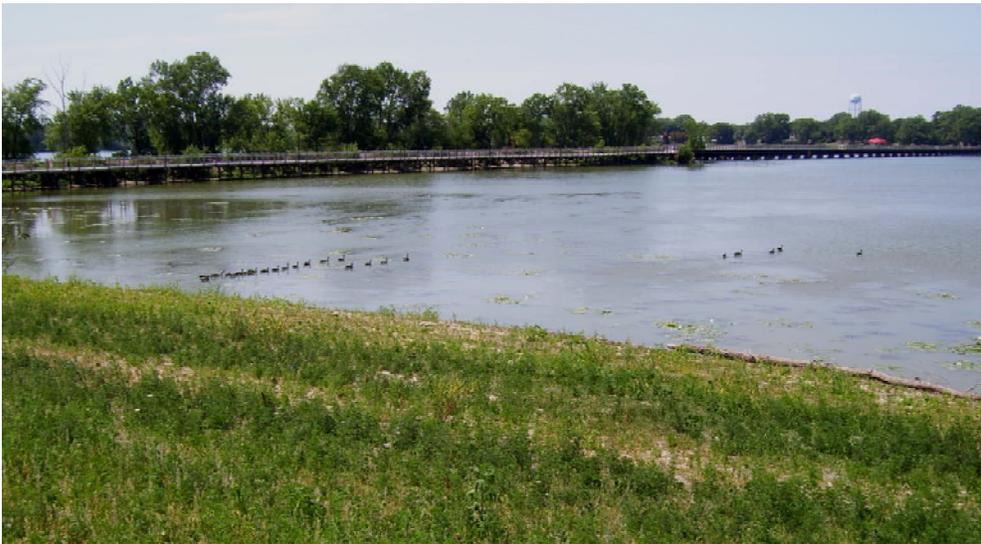
Photograph 2 – Slope conditions in the mid-section of the site, looking west. Note use by Canada geese.

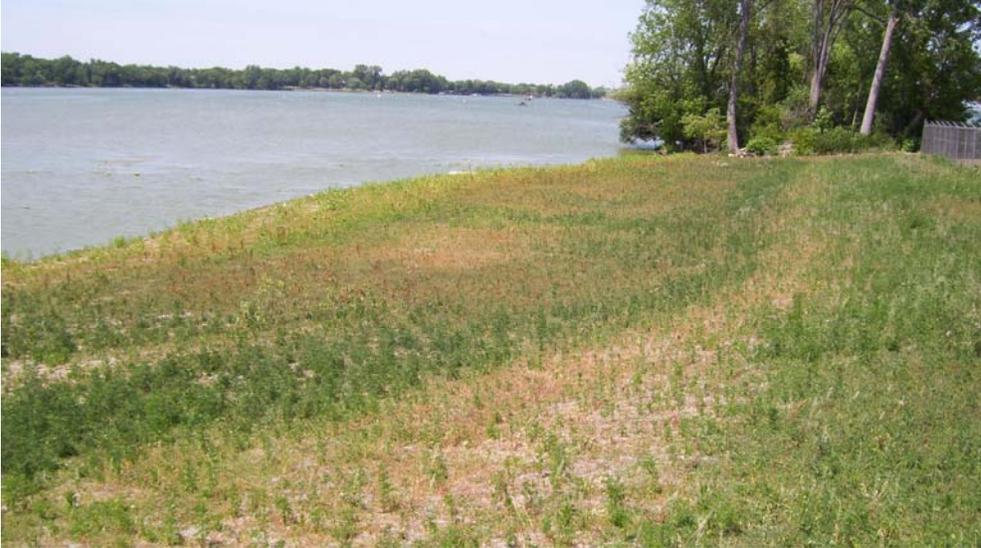
Photograph 4 – Slope condition at the northern end of the site, looking north.

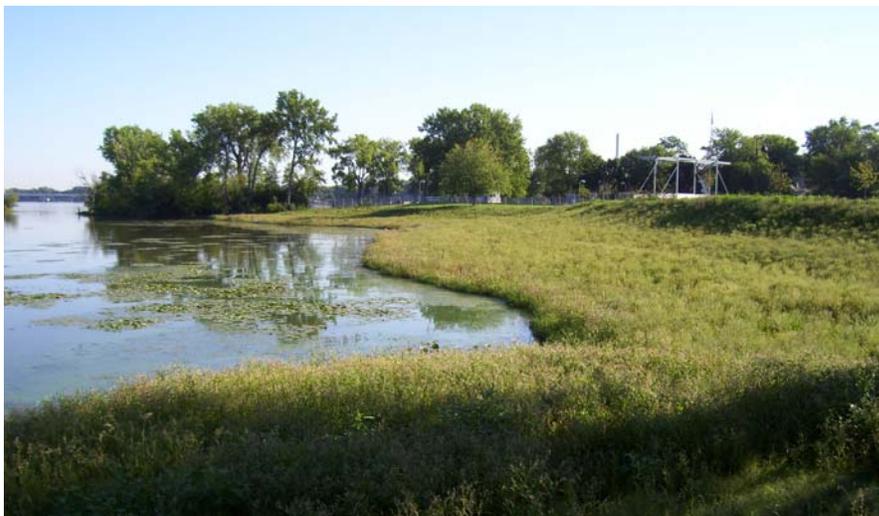
Observations: The area of Deposit POG1 B was observed by STS on August 31, 2007. On this date the lake level was at about +736.6, about 1.5 feet below normal pool level. The shore zone and slope were stable. Site conditions on August 31, 2007 are shown in Photographs 1 and 2. Recent precipitation promoted vegetative growth. The slope was dominated by common ragweed; however, there was an under-story of new growth, which included desired species such as black-eyed Susan, goldenrod, vervain, lobelia, cinquefoil and coneflowers. The shore area had a significant smartweed cover. The shallow water area was filling in naturally, as shown in Photograph 1.

Photograph 1 – Shoreline looking north from pedestrian bridge.

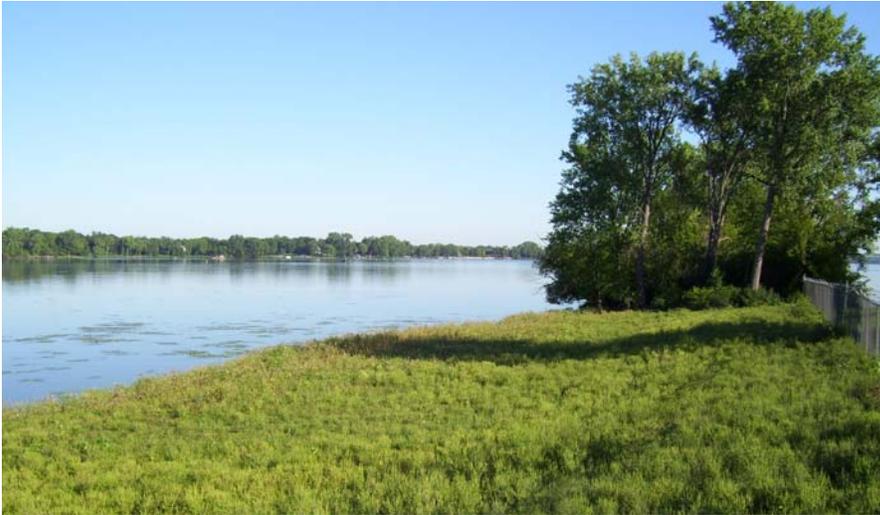
Photograph 2 – Slope condition at the northern end of the site, looking north.
