Deposit POG1 B, Phase 2 Post-Construction Status Report – March 2007

Purpose: Comply with Wisconsin Department of Natural Resources (WDNR) conditional work plan approval for remediation of Deposit POG1 B, dated September 11, 2006. The conditional work plan approval required monthly reports following construction activities to remediate Deposit POG1 B. The monthly reports must document the condition of the erosion control measures and any required maintenance activities. The monthly reports must be submitted the first week of each month until the area is re-vegetated and stable.

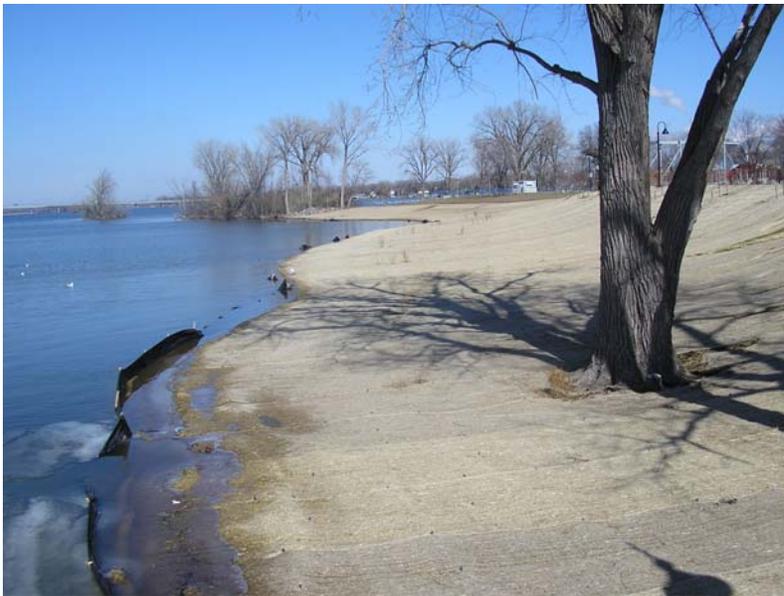
Observations: The area of Deposit POG1 B was observed by STS Consultants, Ltd (STS) on March 20, 2007. Observations indicated the site was in generally good condition, as shown in Photograph 1. There were several sections of the erosion control mats that were rolled back by the wind, as shown in Photograph 2. No soil erosion was evident where the mats were rolled back.

Photograph 1 – Shoreline looking north from pedestrian bridge.

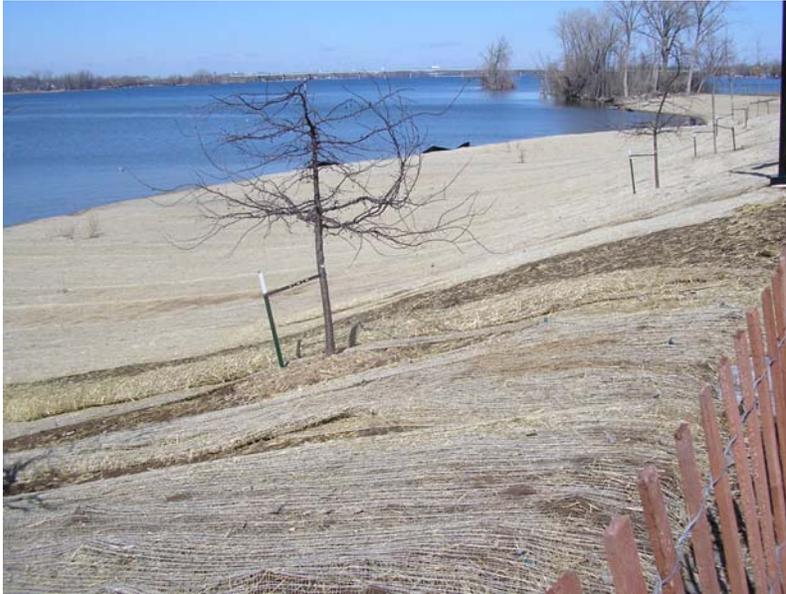
Photograph 2 – Erosion control mat rolled back by wind.

Synagro was informed of the condition of the erosion mats. Repair and replacement of the erosion control mats were completed on March 30, 2007. Photograph 3 shows the site after the repairs were completed. Synagro also viewed the silt fence. Although portions of the silt fence were submerged it appeared it was providing some degree of protection. Synagro did not reset the silt fence because the substrate was loose. It was their opinion that re-stacking into the loose substrate would not provide additional support. With the water level rising onto the erosion control mats and the silt fence being partially intact, it was decided to continue monitoring the shore area and take corrective action, if and when, required.

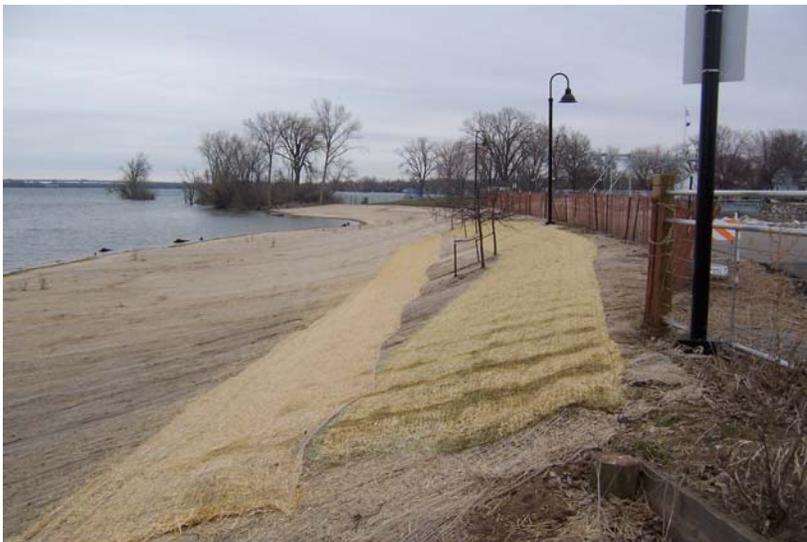
Photograph 3 – Erosion control mat repair.
