RESTORING THE RECREATIONAL POTENTIAL OF SMALL IMPOUNDMENTS

The Marion Millpond Experience

*An Inland Lake Renewal
and Management Demonstration
Project Report*

Technical Bulletin No. 71
DEPARTMENT OF NATURAL RESOURCES
Madison, Wisconsin

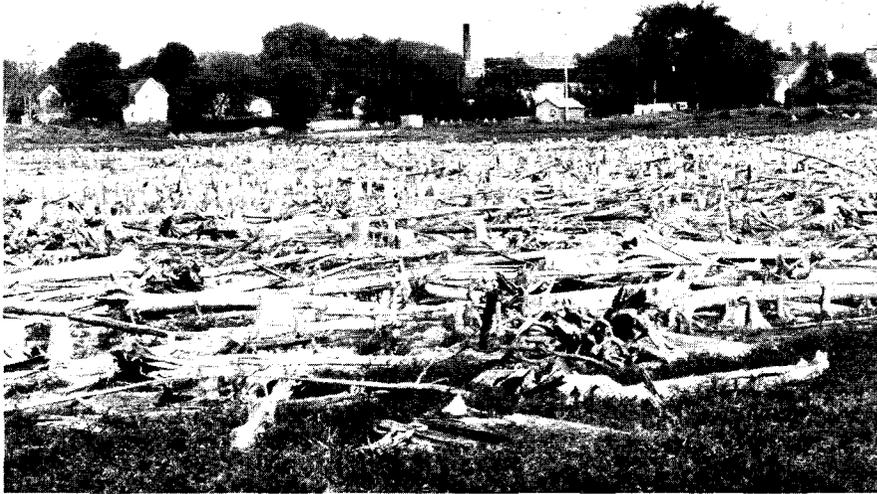
FIGURE 6

Stump field on millpond bottom.

Stump and Log Removal. With the pond filled, thousands of submerged and partially submerged stumps and toppled trees (left behind when the pond was originally flooded) hindered recreation and boating. With the pond drained, they were present almost everywhere and hampered work on the pond bottom (Fig. 6). Prior to draw-down, stump removal activities had been entirely directed at cutting off exposed stumps at the water line. After drawdown, cutting of stumps as close to the ground as possible was continued, but failed to permit adequate preparation of the pond bottom for subsequent treatments. Therefore, intensive work "bees" were organized by the community to mechanically and manually remove debris, logs and stumps embedded in the pond sediments. Although the work was facilitated by construction and farm machinery in part donated by local people and businesses, the work was tedious, back-breaking and slow.

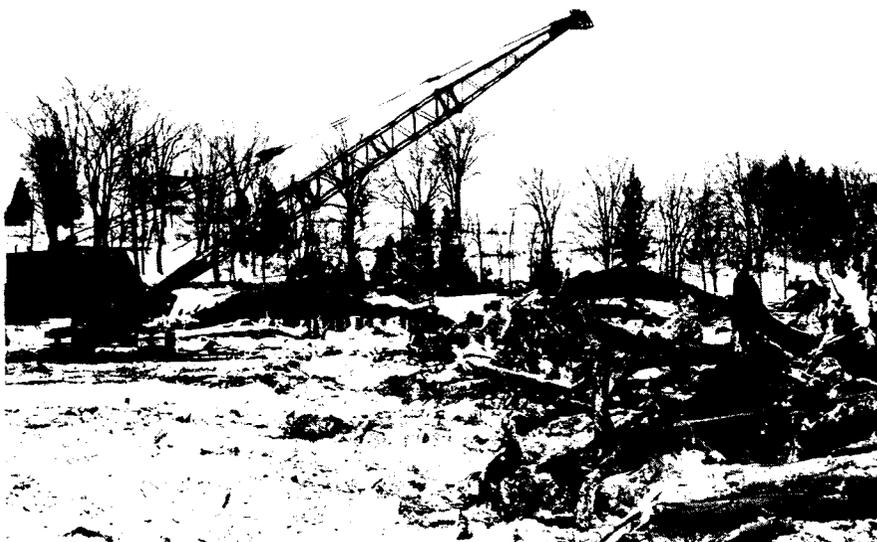
FIGURE 7

Winter stump removal.

During the 1969-1970 winter, roads were frozen-in on the pond bottom. This enabled contracted heavy equipment to work on the pond bottom proper. Deeply embedded logs and stumps were removed by a drag line, wind-rowed by a front-end loader, and moved off the pond bottom by truck. (Fig. 7). The large volumes of stumps and debris were trucked to a disposal area. (In spite of a great deal of thought, no salvage value was found for this wood - largely cedar and

elm). This approach was more effective than working directly on the unfrozen pond bottom. The heavy equipment expedited the job, and about forty acres were cleared in this way. However, this work proved very expensive.

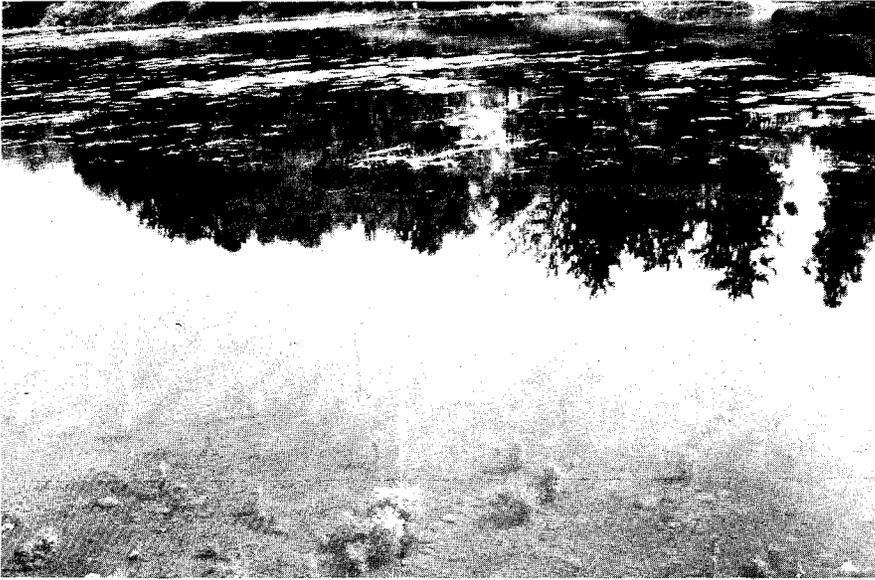
FIGURE 15
Plant growth in treated areas (foreground) vs. untreated areas during the second year after treatment.

Based upon this two-year comparison, treated areas generally exhibited less plant growth than untreated areas (Fig. 15). Data for 1972 indicate that the areas that were blanketed with sheeting and sand or gravel had substantially less growth than those areas which were only dredged or dredged and sandblanketed; an exception to this occurred where dredging was done to a depth exceeding the photic zone (Treatment 9, see Appendix C). Treated areas have a different vegetation than the control areas. Macrophytic algae of the genus *Chara* form the majority of the plant growth in the treated areas. In contrast, rooted angiosperm macrophytes constitute most of the plant growth in control areas. The shallow-water treated areas had a high biomass of filamentous algae in 1971. Production of this algae dropped off markedly from 1971 to 1972, although small amounts were present clinging to plant tops and shoreline areas. The decrease in filamentous algae was expected, in view of competition from the higher biomasses of other plants in 1972.

To maintain the recreational usability of the pond, fairly intensive management procedures (periodic drawdown to freeze out littoral zone vegetation and provide access to the pond bottom, repair of bottom treatment areas, etc.) will be necessary. During especially troublesome summers, chemical treatments may be needed as a last resort to control aquatic vegetation. In this way, the pond can be maintained as a valuable community asset.
