# Wisconsin Water Quality Handout

## Ashwaubenon Creek 2015 (EGAD 3200-2018-62)

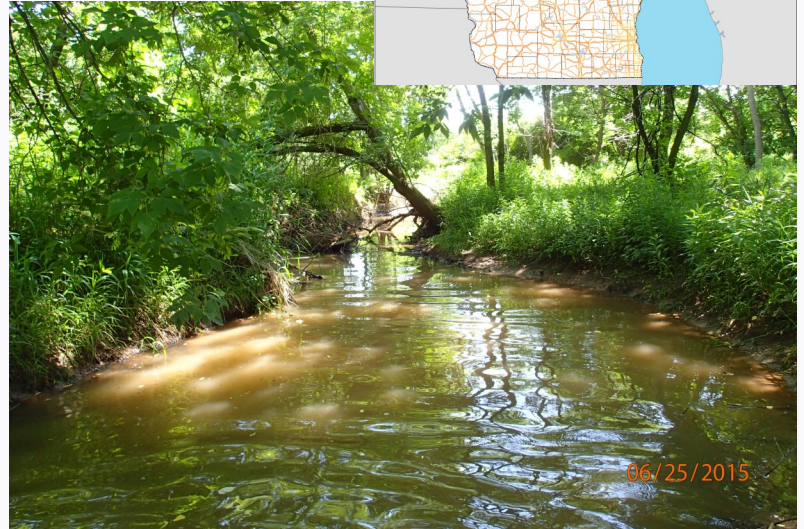
Hemlock Creek downstream Sand Acres Drive.

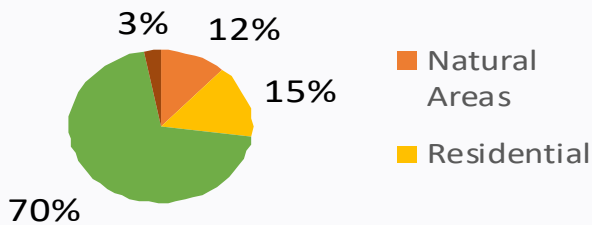
### Ashwaubenon Creek Watershed Land Use

The Ashwaubenon Creek watershed in Brown County is predominantly agricultural in the upper reaches converting to residential and urban in the lower reaches prior to draining into the Fox River. In 1996, a priority watershed plan was developed for the Duck, Apple, and Ashwaubenon Creek watersheds to address potential non-point sources of phosphorus and sediment.

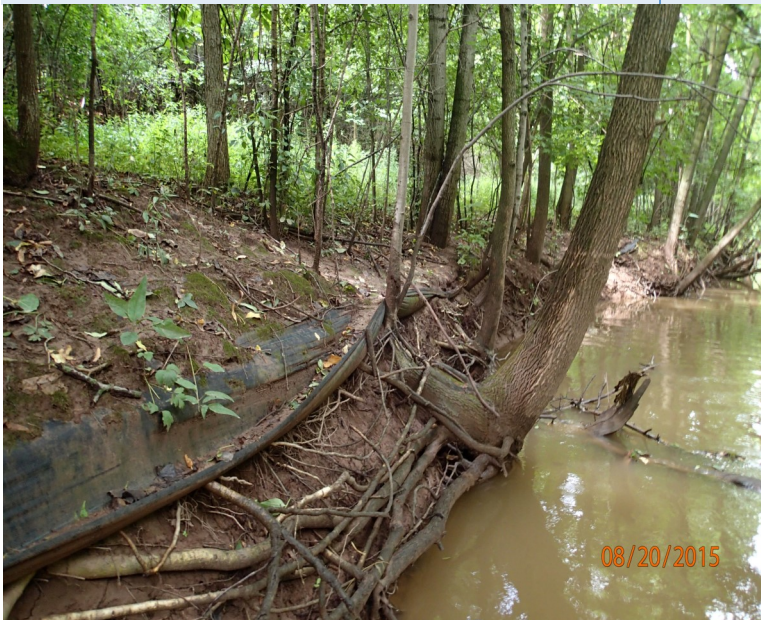
Streams in the three survey areas of Ashwaubenon Creek run through a residential/urban landscape. Habitat ratings ranged from fair to good. The stream segments lacked adequate pools, banks were significantly eroded, all habitats were dominated by fine sediments, and cover for fish was relatively absent.

Old silt fence on the banks of Ashwaubenon Creek upstream Grant Road.

Soil Health principles should be adopted to improve infiltration along with sediment and nutrient retention on agricultural lands in the watershed. Construction site erosion control needs to be properly planned and maintained to adequately prevent erosion and soil loss during events. Urban storm water best management practices should continue to properly site treatment ponds and consider additional infiltration practices to reduce the rate of storm water delivery to streams. Re-establishment of adequate vegetative buffers along stream corridors could include the removal of undesirable species such as box elder and buckthorn allowing for the management of more desirable tree species. Additionally, vegetative buffer widths should be expanded to prevent soils losses and increase distance of nutrient application in proximity to waterways. Conservation practices to address dissolved phosphorous should be a high priority in this watershed. Where possible, reconstruction of meandering stream with natural features should be a priority to increase habitat diversity within the stream.

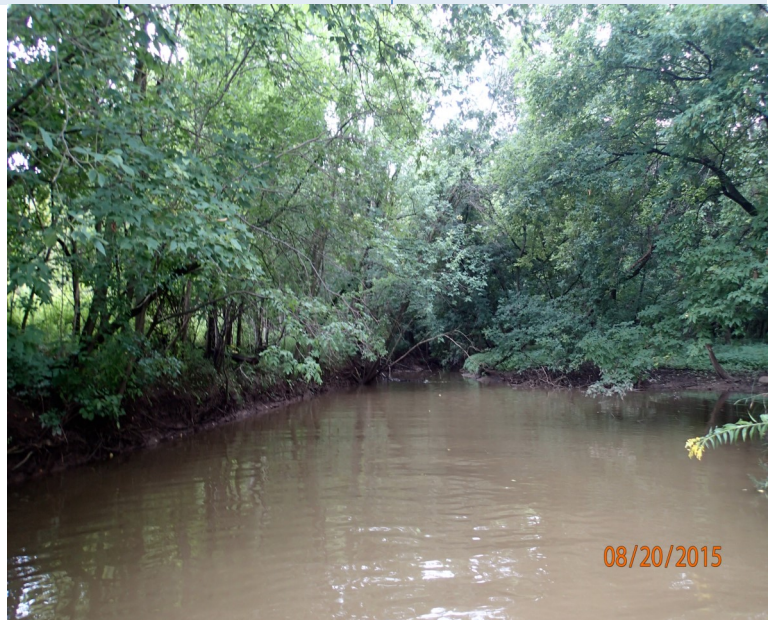
Ashwaubenon Creek above Grant Road.
