Permit Fact Sheet

Permit Number:	WI-0063908-03-0
Permittee Name:	UW Arlington Agricultural Research Station
Address:	N695 Hopkins Rd
City/State/Zip:	Arlington WI 53911
Discharge Location:	<p>Blaine Dairy, W6723 Badger Lane, Arlington WI 53911, Town of Leeds, Columbia County, NE-SW, Sect. 29, T10N, R10E.</p> <p>Beef Grazing, W7431 County Road K, Arlington WI 53911, Town of Arlington, Columbia County, NW-NE, Sect. 36, T10N, R09E.</p> <p>Beef Nutrition, N551 Ramsey Road, Arlington WI 53911, Town of Leeds, Columbia County, SW-SW, Sect. 30, T10N, R10E.</p> <p>Sheep South, 4857 Meek Road, Arlington WI 53911, Town of Vienna, Dane County, NW-NE, Sect. 01, T09N, R09E.</p> <p>Sheep North, 4857 Meek Road, Arlington WI 53911, Town of Arlington, Columbia County, SW-SE, Sect. 36, T10N, R09E.</p> <p>Swine Facility, N636 County Road I, Arlington WI 53911, Town of Leeds, Columbia County, NW-SW, Sect. 31, T10N, R09E.</p> <p>Bookhout Farm, W7114 Ramsey Road, Arlington WI 53911, Town of Leeds, Columbia County, SE-SW, Sect. 30, T10N, R10E</p>

Receiving Water:	Unnamed tributaries of the Headwaters Yahara River Watershed and groundwaters of the state
Stream Classification:	Yahara River 303d
Discharge T

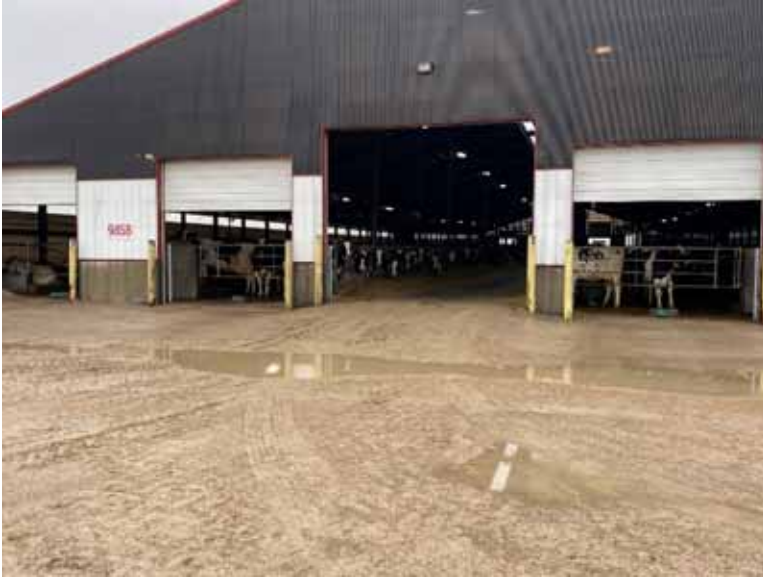
Photo #	1
Date/Time:	April 5, 2023
Location	UW- Arlington- Blain Dairy
Photo taken by:	J. Hanrahan

Description: South end of freestall barn 985 facing north. All dairy milking cows at Blaine Dairy are housed under roof.

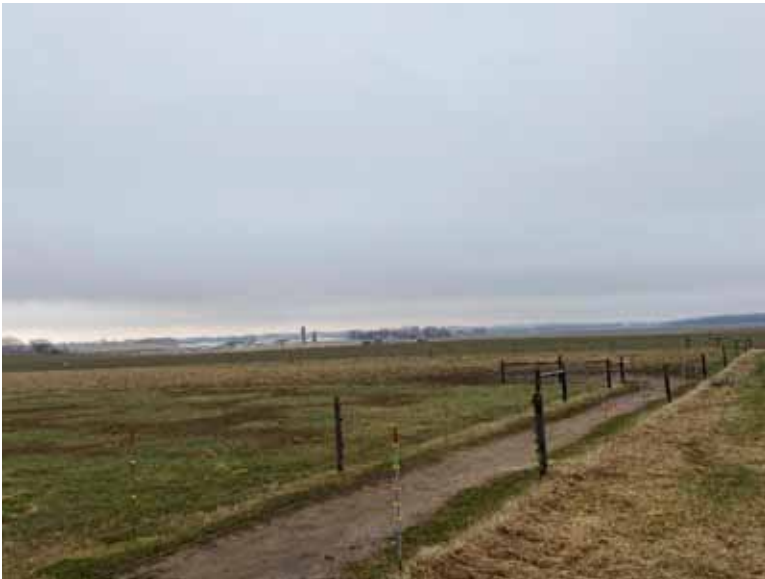
Photo #	3
Date/Time:	April 5, 2023
Location	UW- Arlington- Blain Dairy
Photo taken by:	J. Hanrahan

Description: Pasture walkway from Dry Cow Barn. Used for certain projects. Pastures were well maintained. Facing southeast from west side

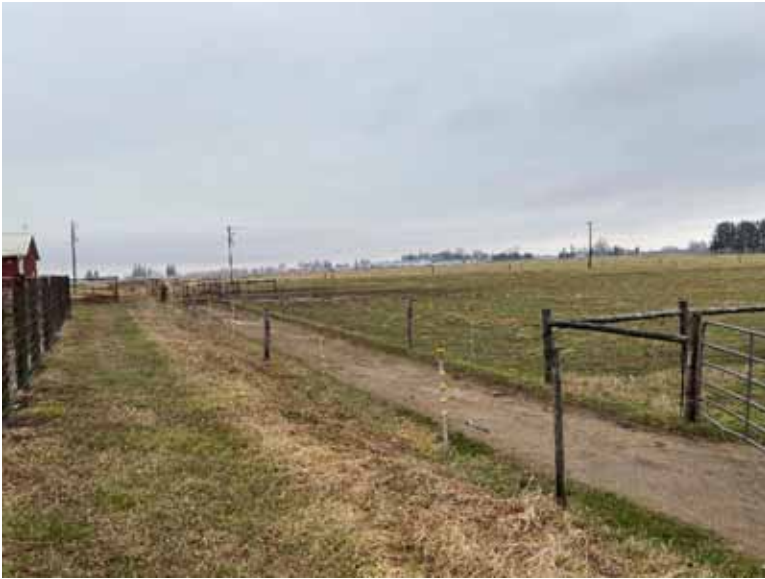
Photo #	4
Date/Time:	April 5, 2023
Location	UW- Arlington- Blain Dairy
Photo taken by:	J. Hanrahan

Description: Pasture walkway from Dry Cow Barn, facing northeast.

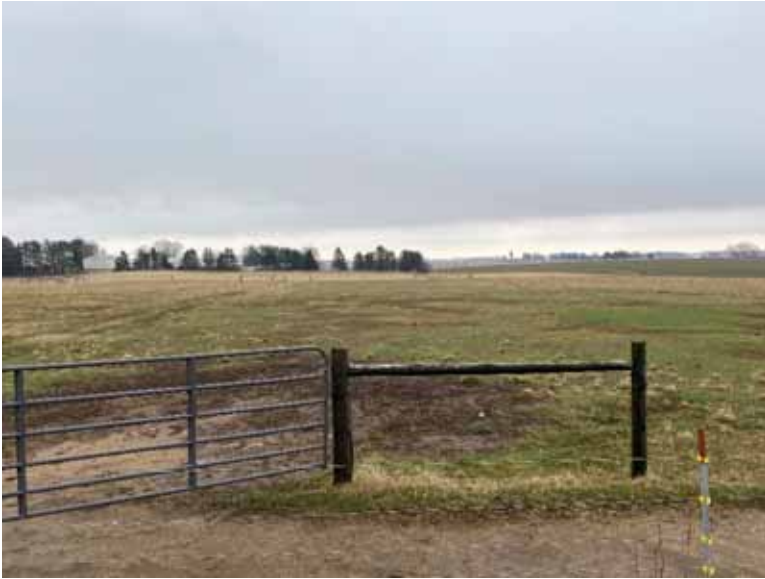
Photo #	5
Date/Time:	April 5, 2023
Location	UW- Arlington- Blain Dairy
Photo taken by:	J. Hanrahan

Description: Pasture walkway facing east at one of the entrances to the paddock. Only area needing some maintenance or gravel/limestone to stabilize the walkway.

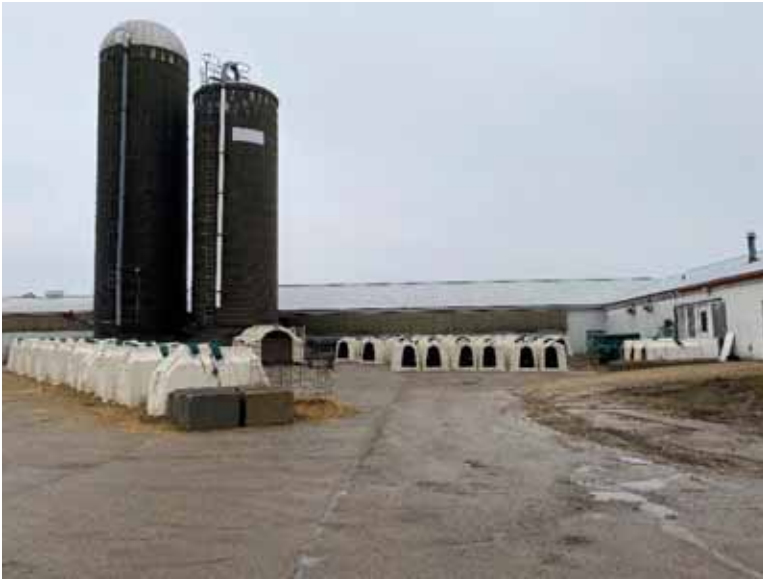
Photo #	6
Date/Time:	April 5, 2023
Location	UW- Arlington- Blain Dairy
Photo taken by:	J. Hanrahan

Description: Calf Hutches outside the old dairy barn at Blaine Dairy. Facing south from the driveway area.

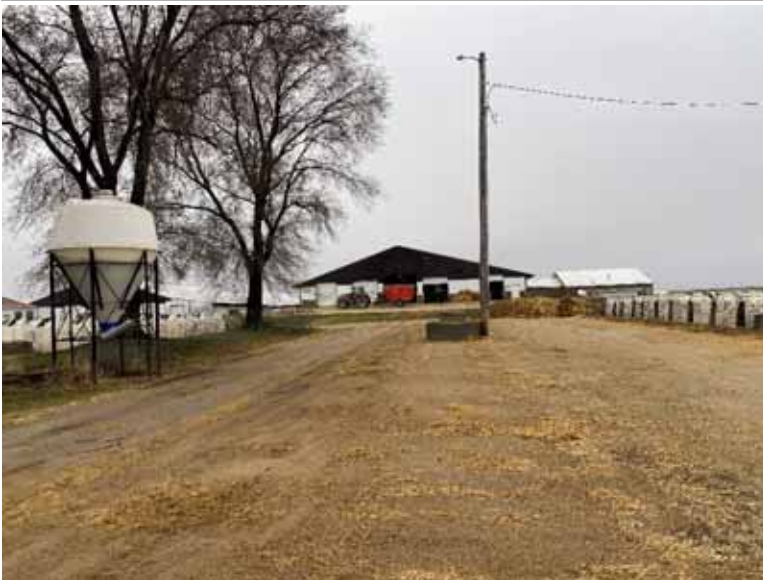
Photo #	7
Date/Time:	April 5, 2023
Location	UW- Arlington- Blain Dairy
Photo taken by:	J. Hanrahan

Description: Facing west from the east side of the calf hutch area, on west end is a staging area for manure and bedding that is land applied or taken to approved storage structure.

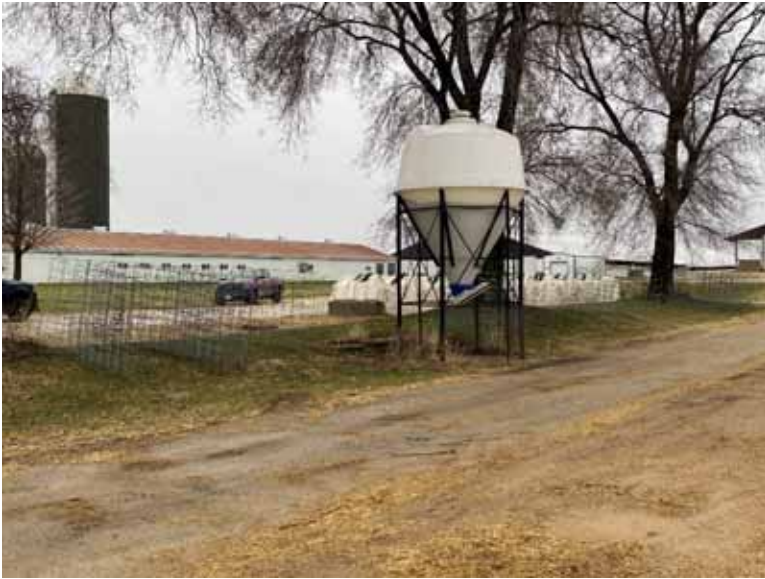
Photo #	8
Date/Time:	April 5, 2023
Location	UW- Arlington- Blain Dairy
Photo taken by:	J. Hanrahan

Description: Enclosed feed bin in the calf hutch area at Blaine Dairy. Facing southwest from the southern end of the main calf hutch area.

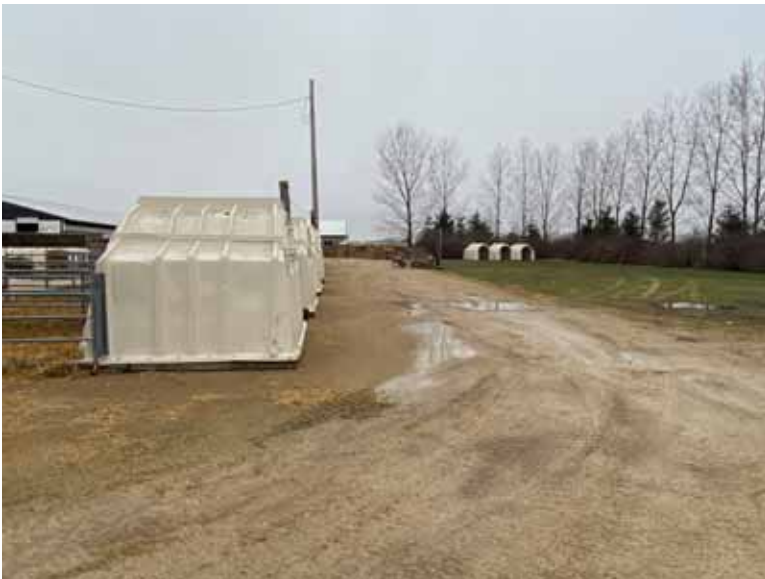
Photo #	9
Date/Time:	April 5, 2023
Location	UW- Arlington- Blain Dairy
Photo taken by:	J. Hanrahan

Description: Facing west from the northeast corner of the calf hutch area at Blaine Dairy. Flow towards photographer.

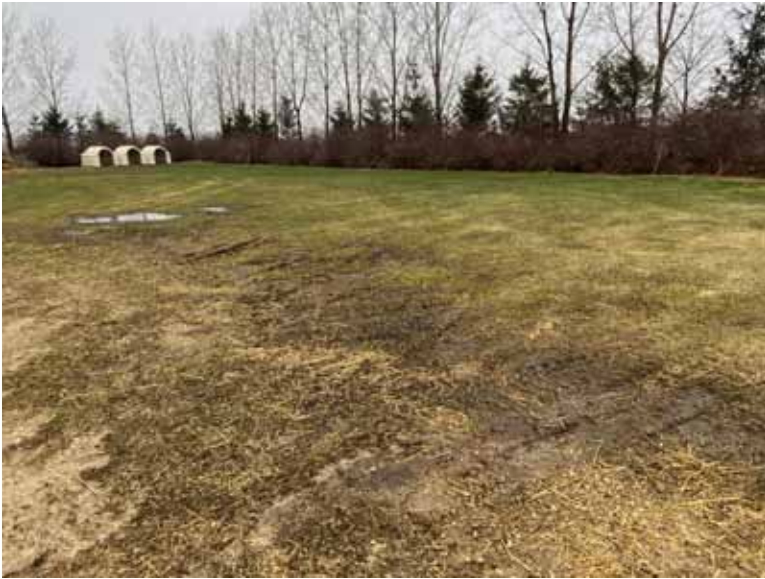
Photo #	10
Date/Time:	April 5, 2023
Location	UW- Arlington- Blain Dairy
Photo taken by:	J. Hanrahan

Description: Facing to the northwest corner of the calf hutch area at Blaine Dairy.

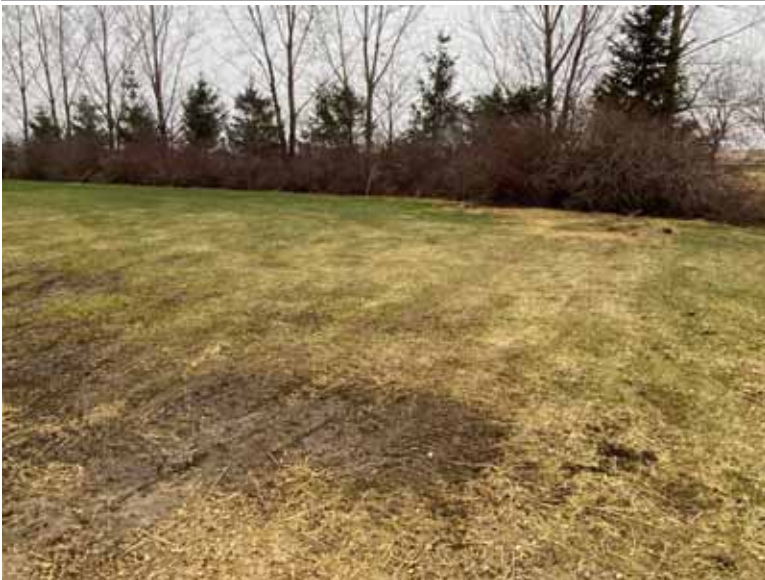
Photo #	11
Date/Time:	April 5, 2023
Location	UW- Arlington- Blain Dairy
Photo taken by:	J. Hanrahan

Description: Facing north from the north end of the calf hutch area to the VTA area.

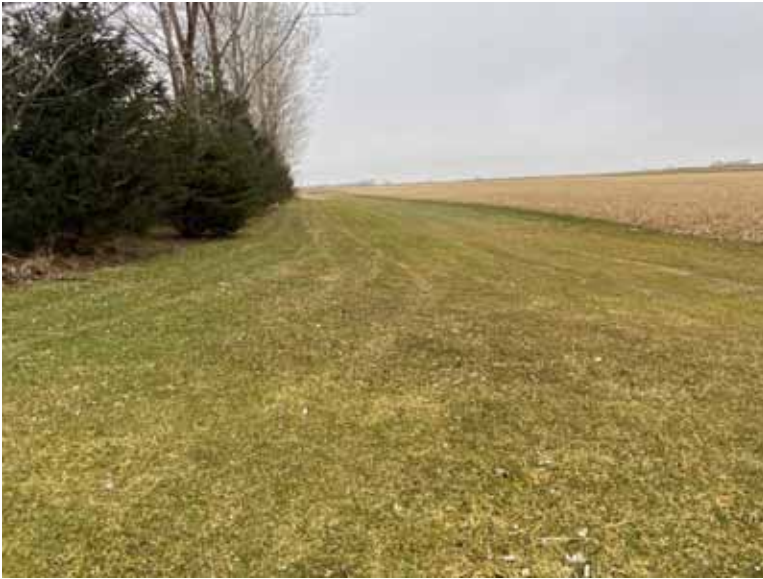
Photo #	12
Date/Time:	April 5, 2023
Location	UW- Arlington- Blain Dairy
Photo taken by:	J. Hanrahan

Description: North of the calf hutch area facing west to field and part of the VTA area.

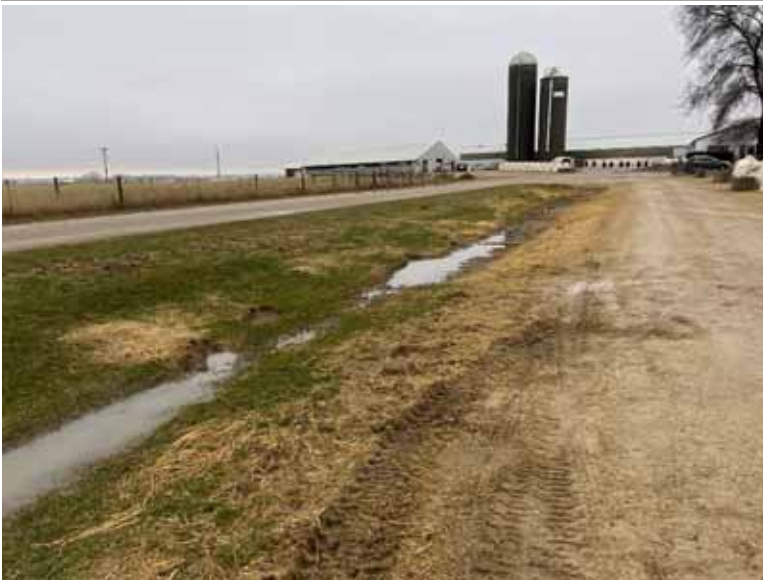
Photo #	13
Date/Time:	April 5, 2023
Location	UW- Arlington- Blain Dairy
Photo taken by:	J. Hanrahan

Description: Ditch that runs along the east side of the calf hutch area. Facing south, flow is to the north.

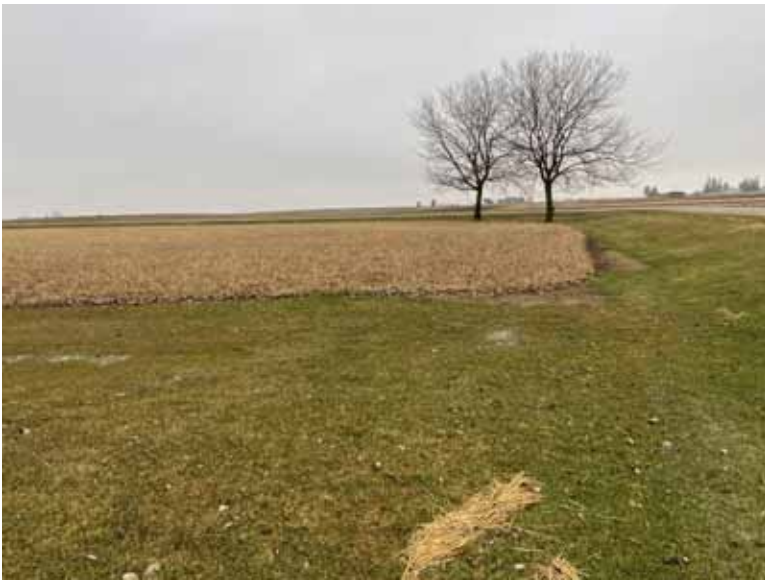
Photo #	14
Date/Time:	April 5, 2023
Location	UW- Arlington- Blain Dairy
Photo taken by:	J. Hanrahan

Description: Facing north from the edge of the ditch along the east side of the calf hutch area.

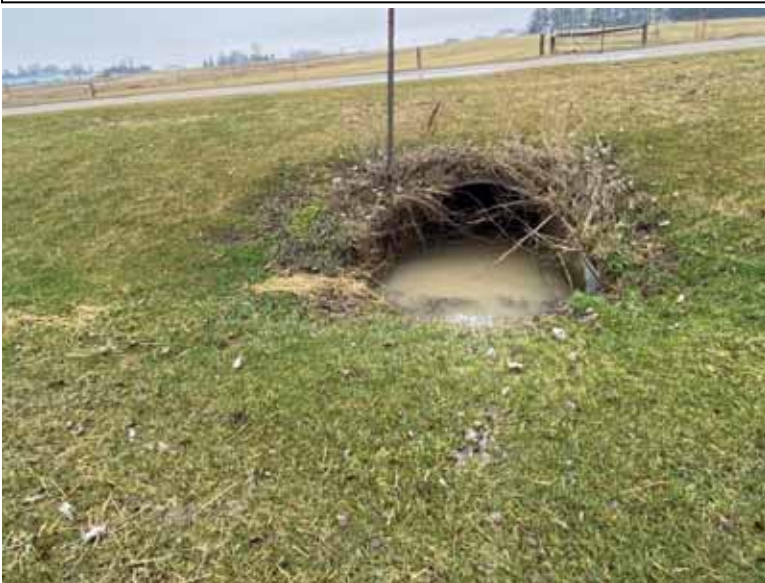
Photo #	15
Date/Time:	April 5, 2023
Location	UW- Arlington- Blain Dairy
Photo taken by:	J. Hanrahan

Description: Culvert along driveway and ditch along the east side of the calf hutch area. Facing east towards flow direction.

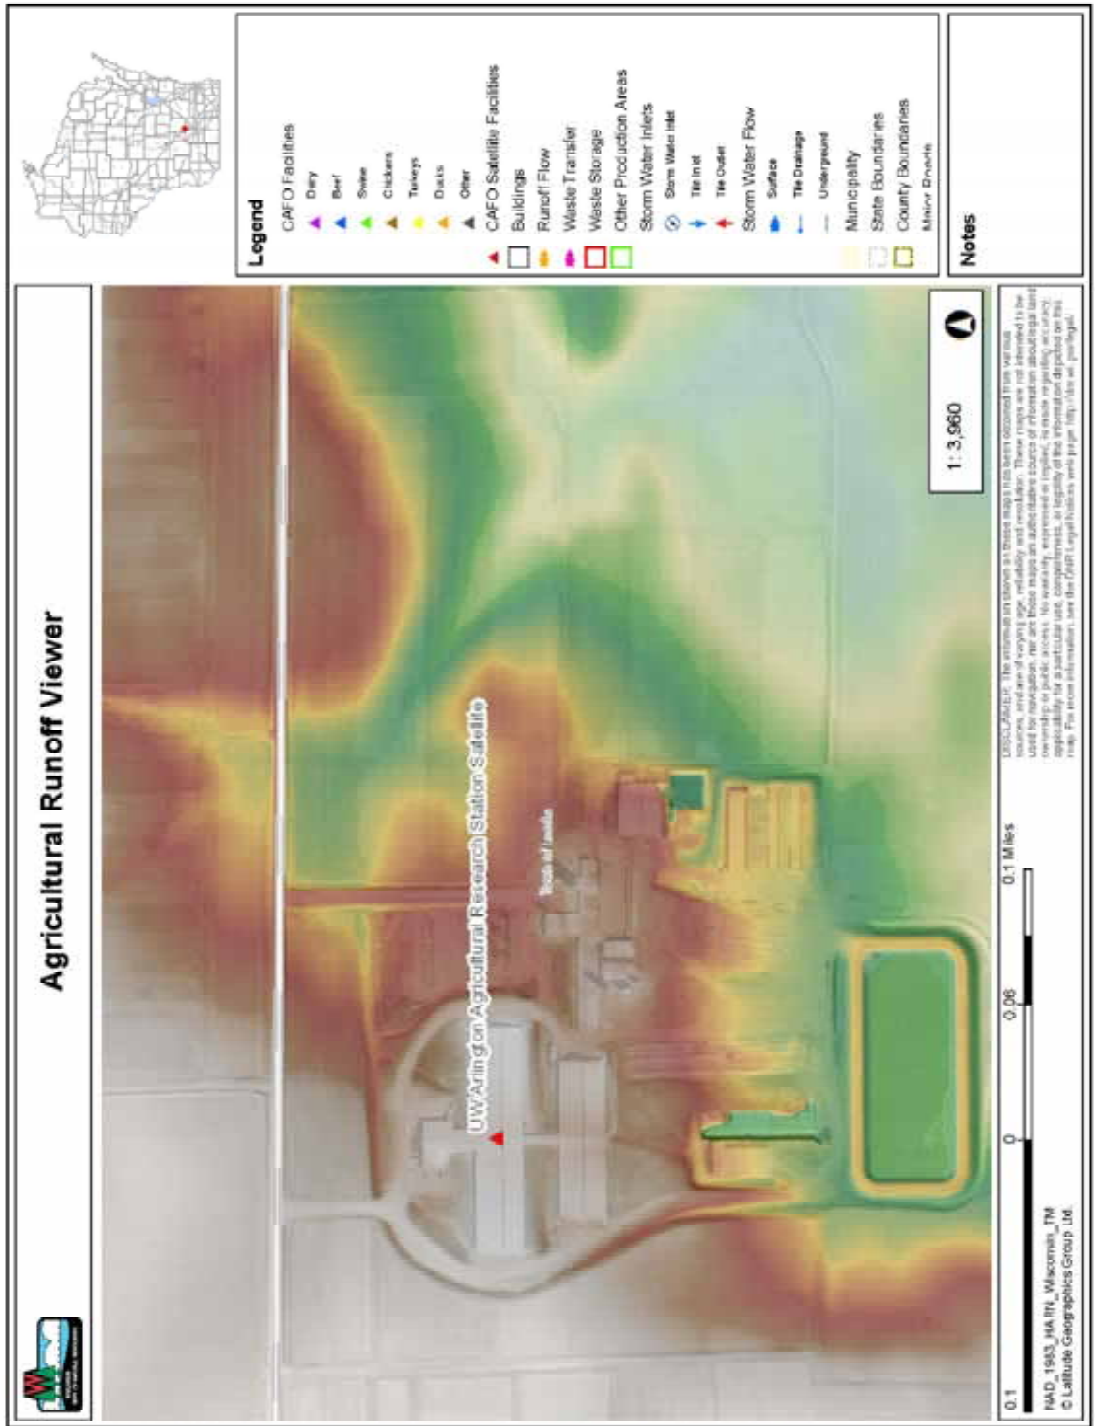
Map 3. WDNR Surface Water Data Viewer Lidar Layer with air photo overlay showing elevation hill shading revealing potential flow paths around the production area. Potential flow path flowing north along ditch to culvert and then to the east.

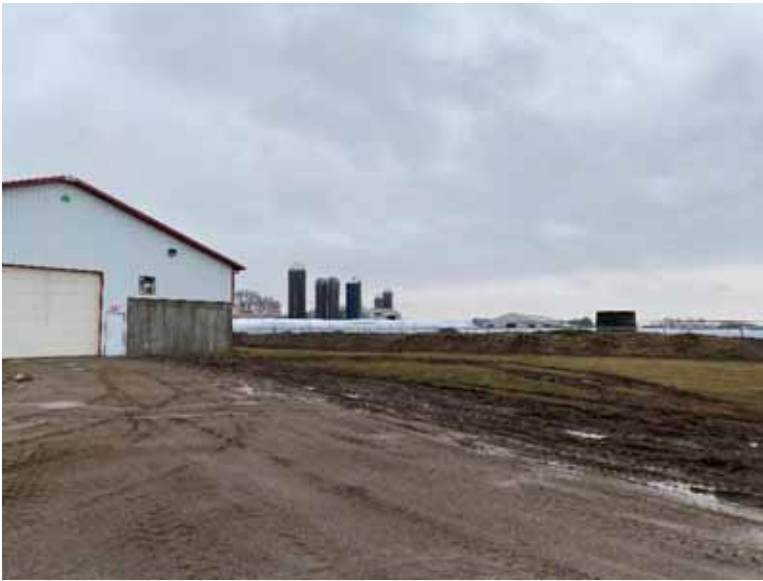
Photo #	16
Date/Time:	April 5, 2023
Location	UW- Arlington- Blain Dairy
Photo taken by:	J. Hanrahan

Description: Facing northeast at the sand separation building at Blain Dairy. Located on the west side of the production area north of the main WSF

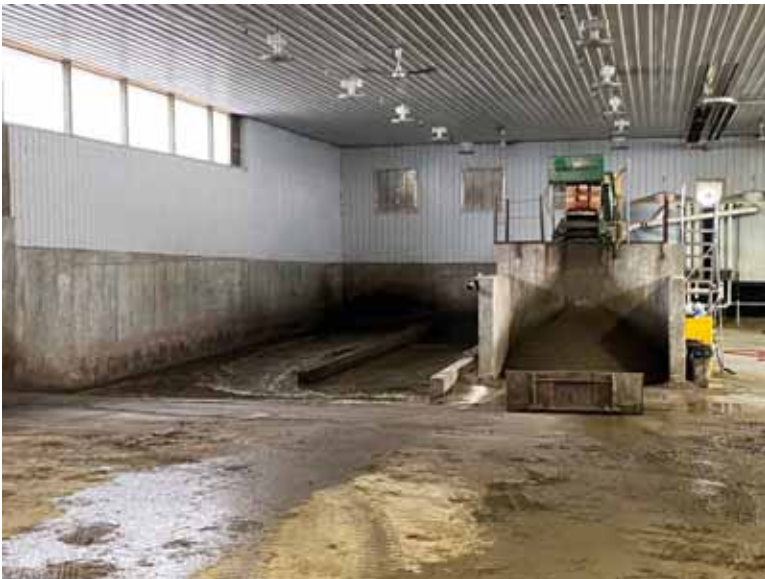
Photo #	17
Date/Time:	April 5, 2023
Location	UW- Arlington- Blain Dairy
Photo taken by:	J. Hanrahan

Description: Inside the sand separation building. Separated sand is stored inside to dry further before it is reused.

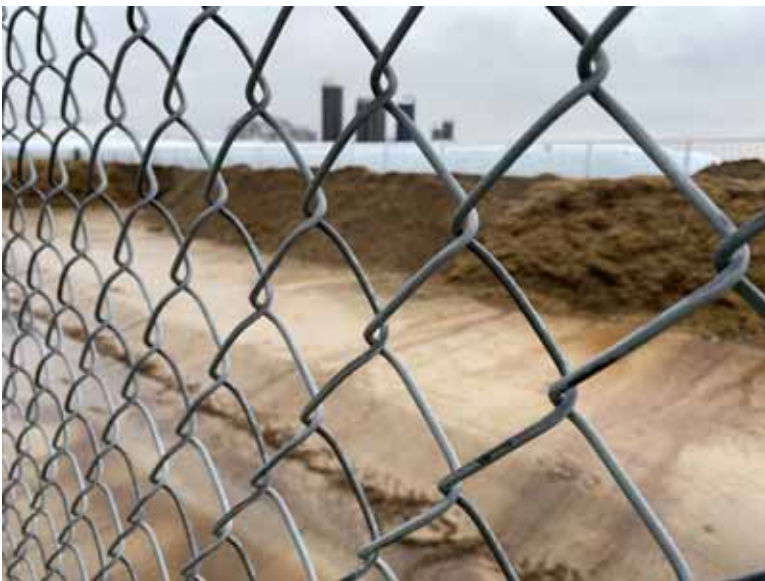
Photo #	18
Date/Time:	April 5, 2023
Location	UW- Arlington- Blain Dairy
Photo taken by:	J. Hanrahan

Description: Facing west at old sand land now used to store solid manure and separated sand. Old sand lane has complete collection of runoffs.

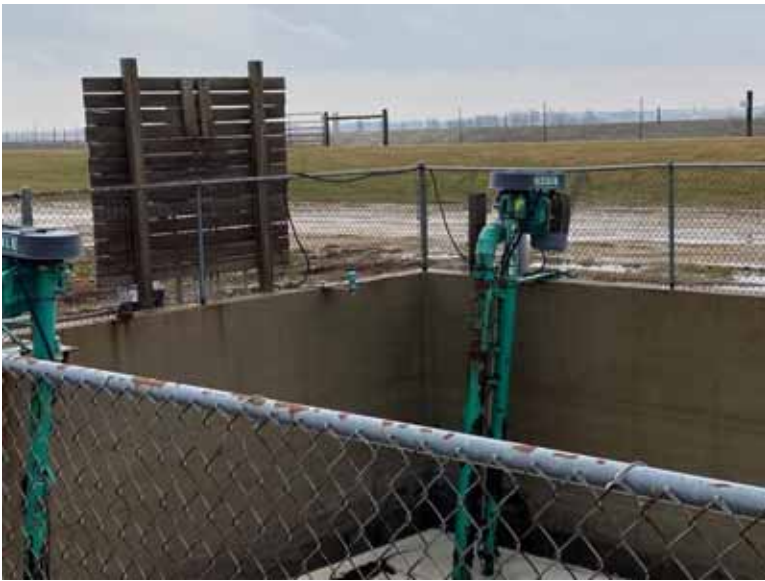
Photo #	19
Date/Time:	April 5, 2023
Location	UW- Arlington- Blain Dairy
Photo taken by:	J. Hanrahan

Description: Transfer tank from the old sand land and sand separation building. Pumps manure and wastewater to the main manure storage. Reception tank has a level monitor to automatically run the pump to transfer.

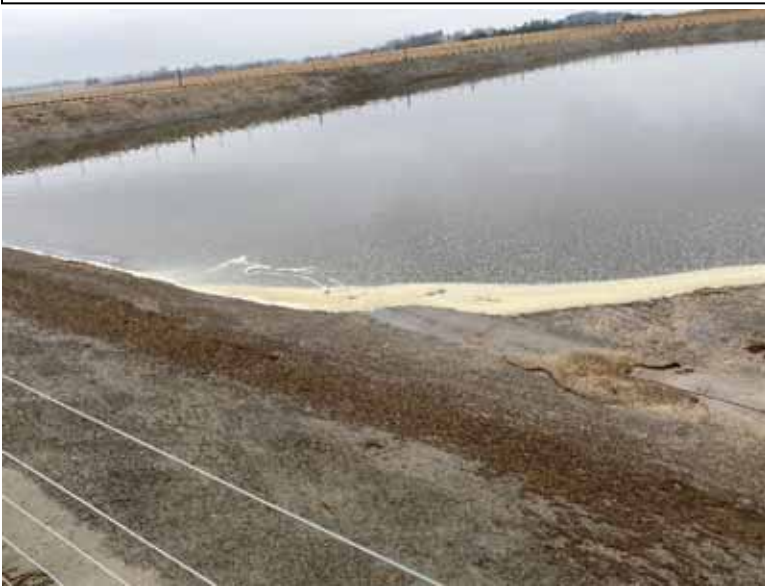
Photo #	20
Date/Time:	April 5, 2023
Location	UW- Arlington- Blain Dairy
Photo taken by:	J. Hanrahan

Description: West side of the main WSF at Blaine Dairy facing southeast. Fence installed around storage.

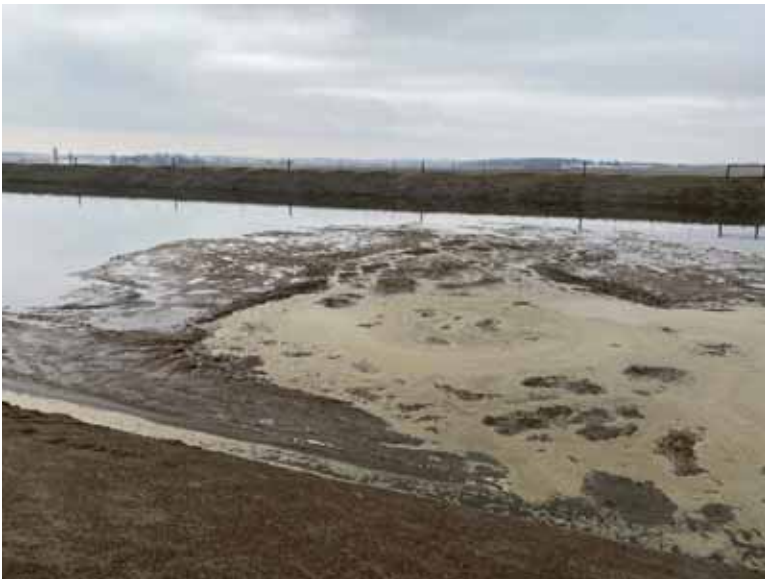
Photo #	21
Date/Time:	April 5, 2023
Location	UW- Arlington- Blain Dairy
Photo taken by:	J. Hanrahan

Description: Facing south from the north side of the main WSF at Blaine Dairy.

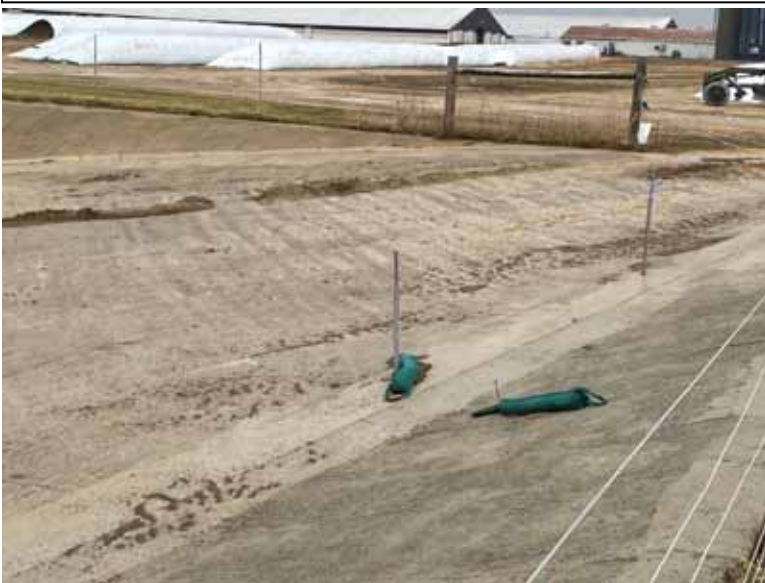
Photo #	22
Date/Time:	April 5, 2023
Location	UW- Arlington- Blain Dairy
Photo taken by:	J. Hanrahan

Description: Markers in the main WSF at Blaine Dairy, located on the access ramp in northeast corner.

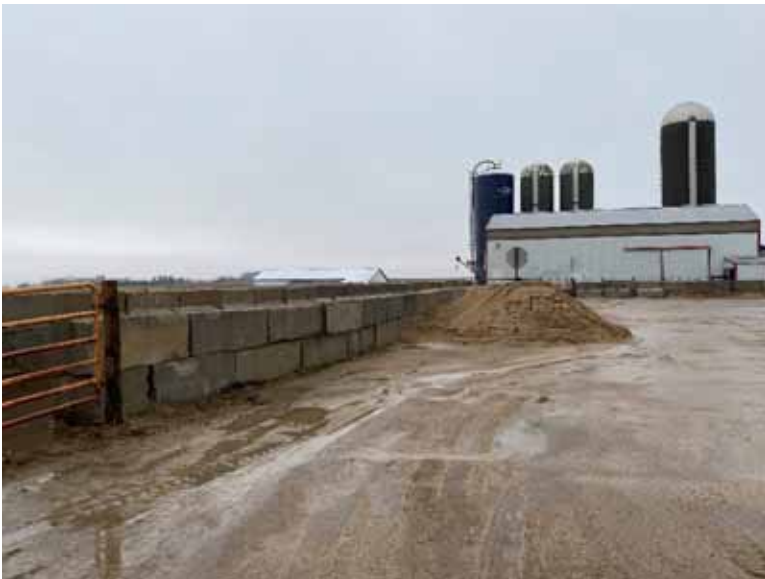
Photo #	23
Date/Time:	April 5, 2023
Location	UW- Arlington- Blain Dairy
Photo taken by:	J. Hanrahan

Description: Clean sand stored on former feed lot south of the old dairy barn.

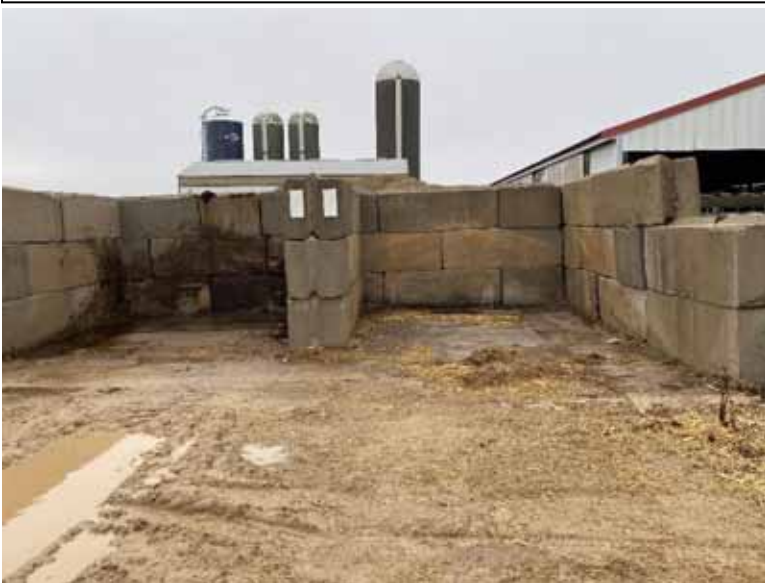
Photo #	24
Date/Time:	April 5, 2023
Location	UW- Arlington- Blain Dairy
Photo taken by:	J. Hanrahan

Description: Bunkers south of the old dairy barn used to store manure and bedding temporarily.

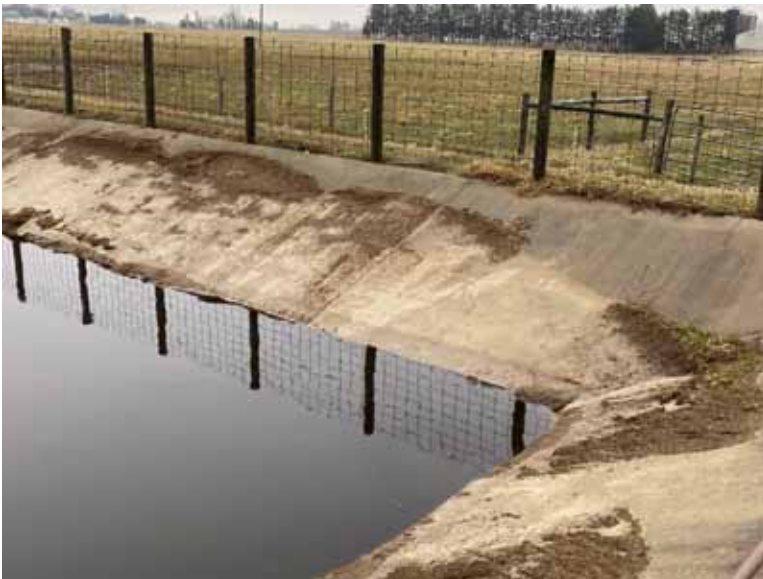
Photo #	25
Date/Time:	April 5, 2023
Location	UW- Arlington- Blain Dairy
Photo taken by:	J. Hanrahan

Description: Southeast corner of the WSF 730 south of the Dry Cow barn.

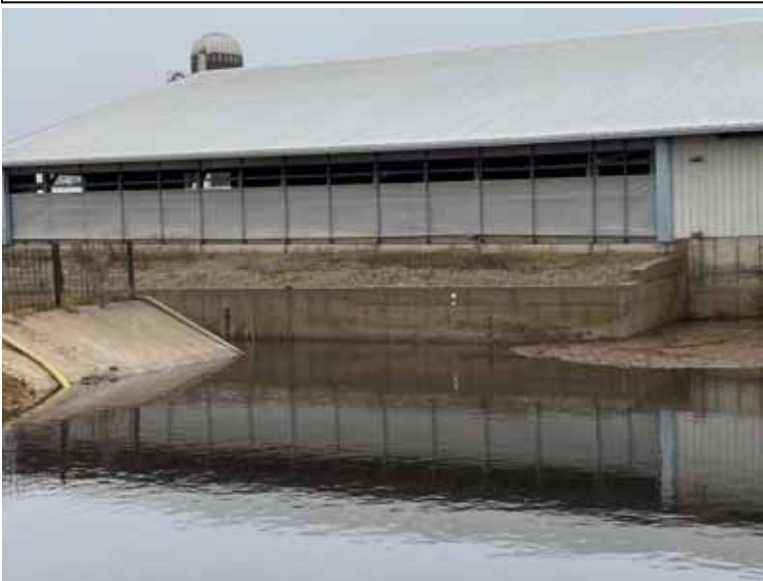
Photo #	26
Date/Time:	April 5, 2023
Location	UW- Arlington- Blain Dairy
Photo taken by:	J. Hanrahan

Description: Facing north to dry cow barn from south side of WSF 730. White markers on the wall of the storage.

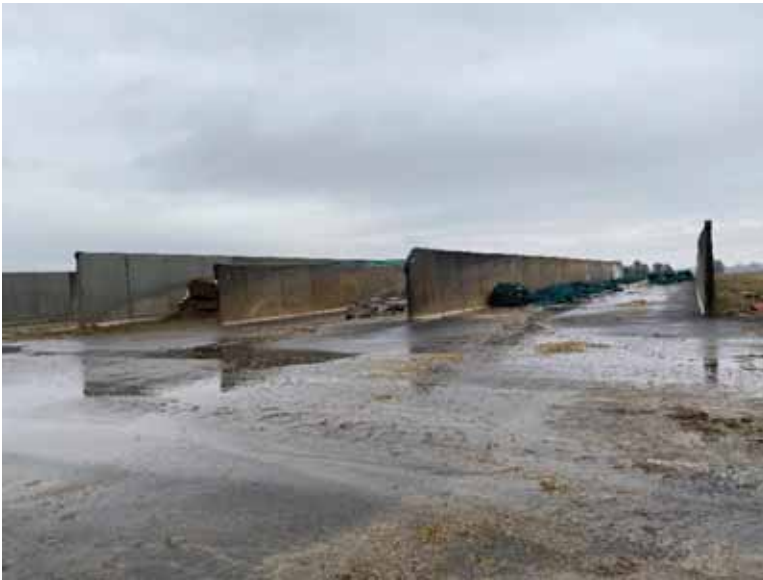
Photo #	27
Date/Time:	April 5, 2023
Location	UW- Arlington- Blain Dairy
Photo taken by:	J. Hanrahan
Description: West end of the bunkers, flow from the bunkers flows west and then south to collection point.

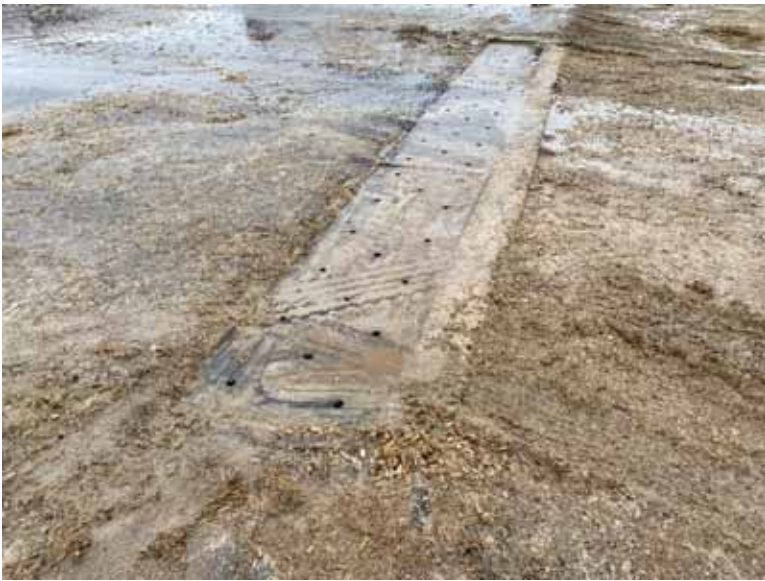
Photo #	28
Date/Time:	April 5, 2023
Location	UW- Arlington- Blain Dairy
Photo taken by:	J. Hanrahan

Description: Drive over grate on the southwest end of the feed storage area to collect runoff form the feed storage area.

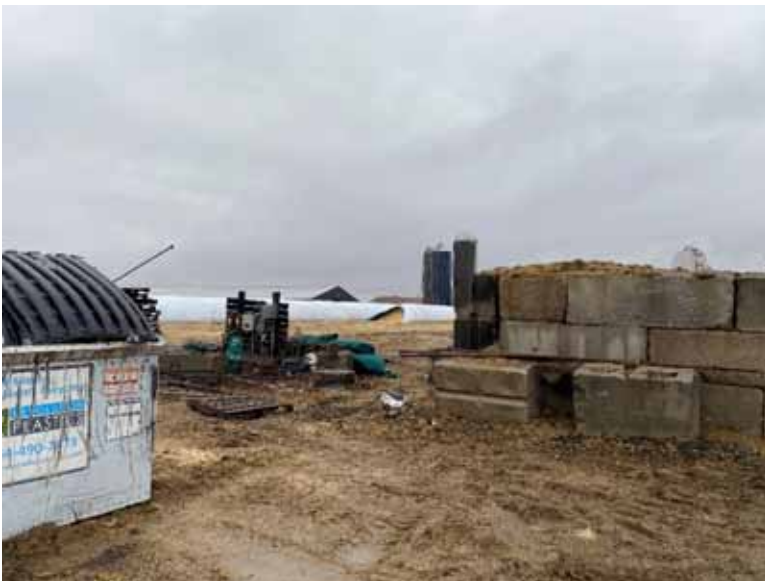
Photo #	29
Date/Time:	April 5, 2023
Location	UW- Arlington- Blain Dairy
Photo taken by:	J. Hanrahan

Description: First flush collection in the southwest corner of the bunker feed storage area.

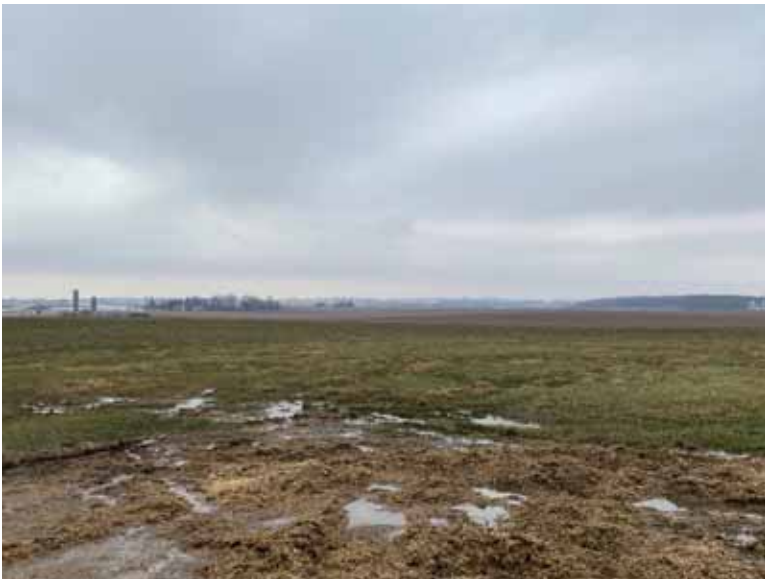
Photo #	30
Date/Time:	April 5, 2023
Location	UW- Arlington- Blain Dairy
Photo taken by:	J. Hanrahan

Description: Facing south at the VTA from the northern end of the VTA. Some ponding and debris from winter snow removal. No channelized flow visible.

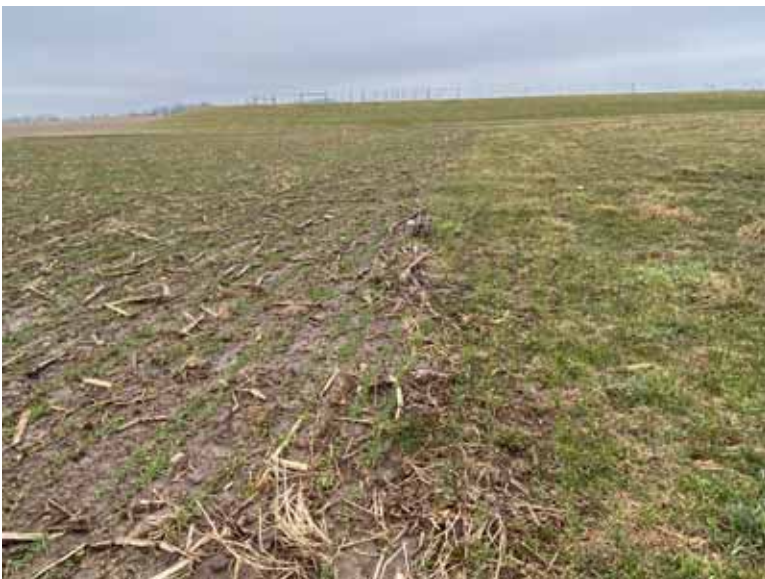
Photo #	31
Date/Time:	April 5, 2023
Location	UW- Arlington- Blain Dairy
Photo taken by:	J. Hanrahan

Description: Facing west at the southern end of the VTA for the feed storage area. Area is well vegetated and well maintained.

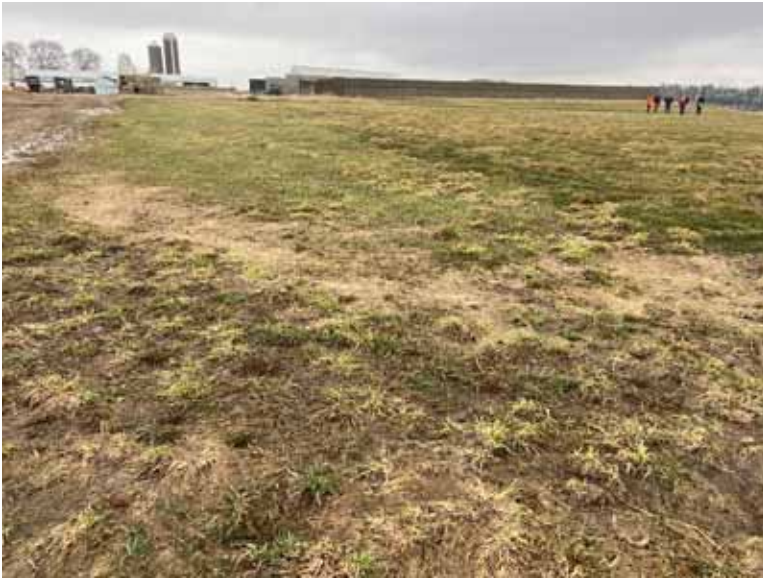
Photo #	32
Date/Time:	April 5, 2023
Location	UW- Arlington- Blain Dairy
Photo taken by:	J. Hanrahan

Description: Facing north northeast from the southwest corner of the VTA for the feed storage area.

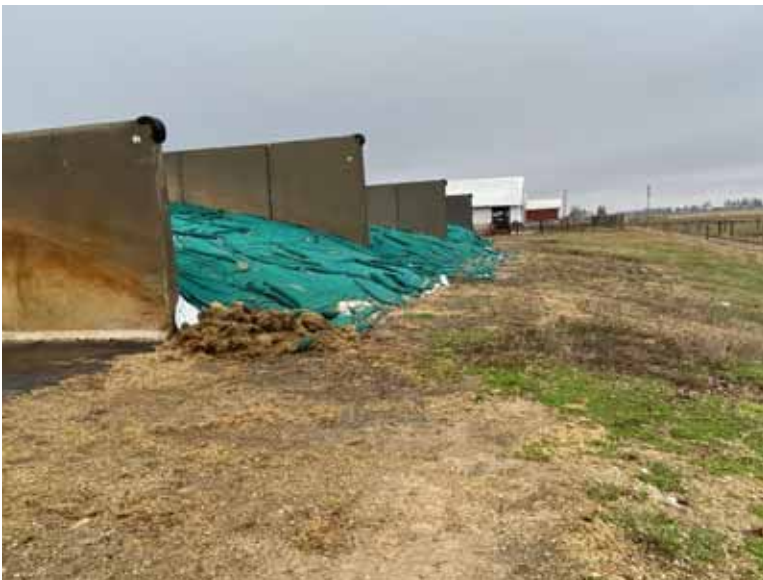
Photo #	33
Date/Time:	April 5, 2023
Location	UW- Arlington- Blain Dairy
Photo taken by:	J. Hanrahan

Description: East side for the feed storage area bunker silos. Feed stacked beyond the floor of the bunkers.

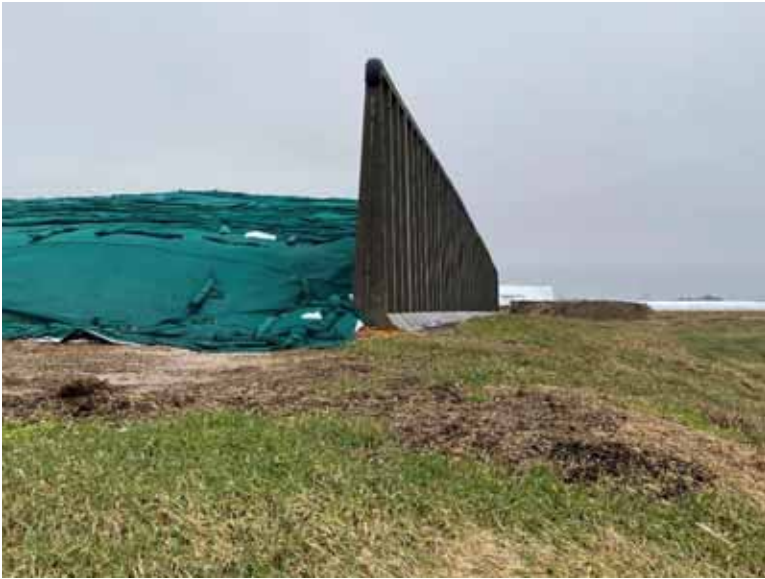
Photo #	34
Date/Time:	April 5, 2023
Location	UW- Arlington- Blain Dairy
Photo taken by:	J. Hanrahan

Description: Leachate flow from the northeast corner of the feed storage area bunkers.

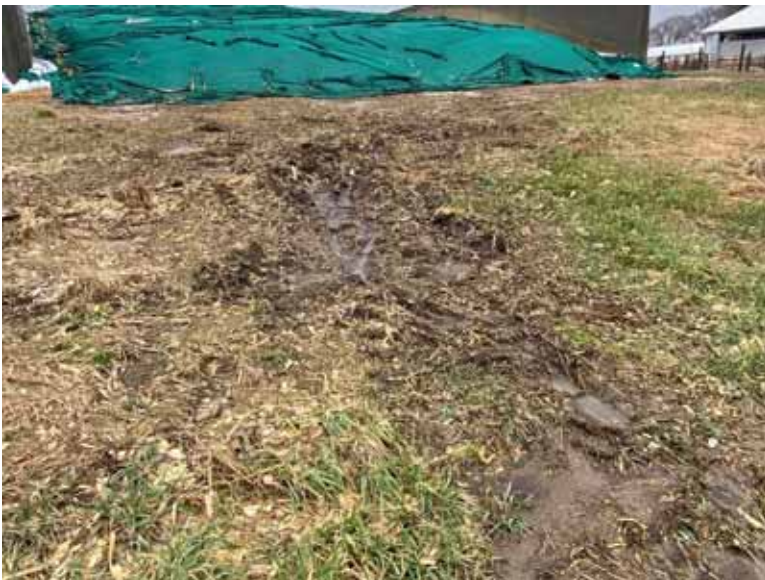
Photo #	35
Date/Time:	April 5, 2023
Location	UW- Arlington- Blain Dairy
Photo taken by:	J. Hanrahan

Description: Leachate flow path from the west end of the feed bunkers.

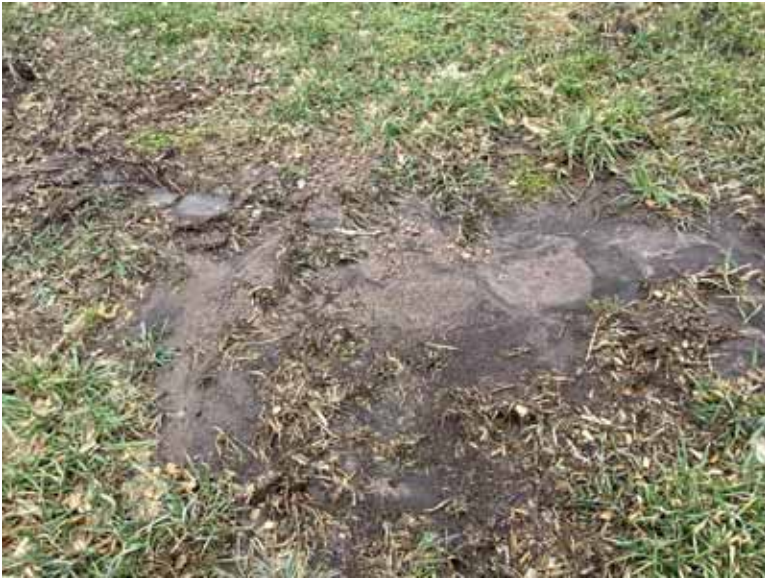
Photo #	36
Date/Time:	April 5, 2023
Location	UW- Arlington- Blain Dairy
Photo taken by:	J. Hanrahan

Description: Leachate and runoff from the west end of the bunkers not being collected by the first flush collection.

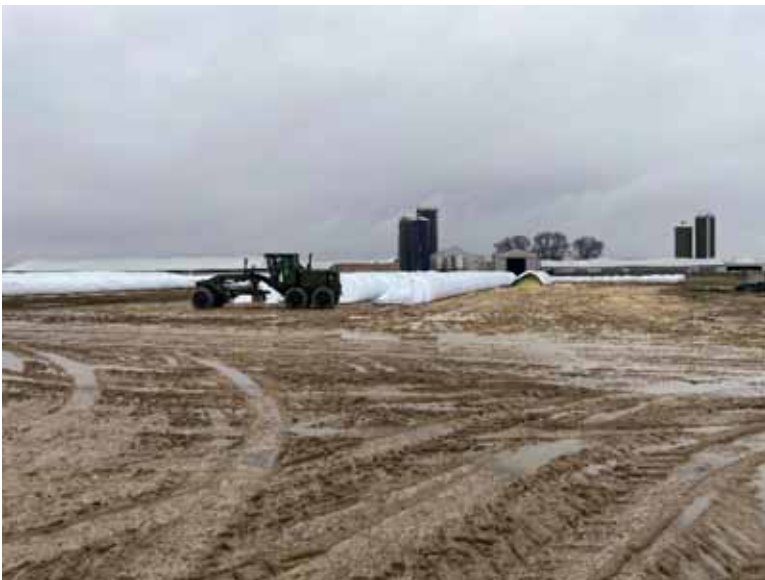
Photo #	37
Date/Time:	April 5, 2023
Location	UW- Arlington- Blain Dairy
Photo taken by:	J. Hanrahan

Description: Gravel area of the feed storage are used to store bagged feed. This area is not part of the first flush collection and is operated to not have runoff.

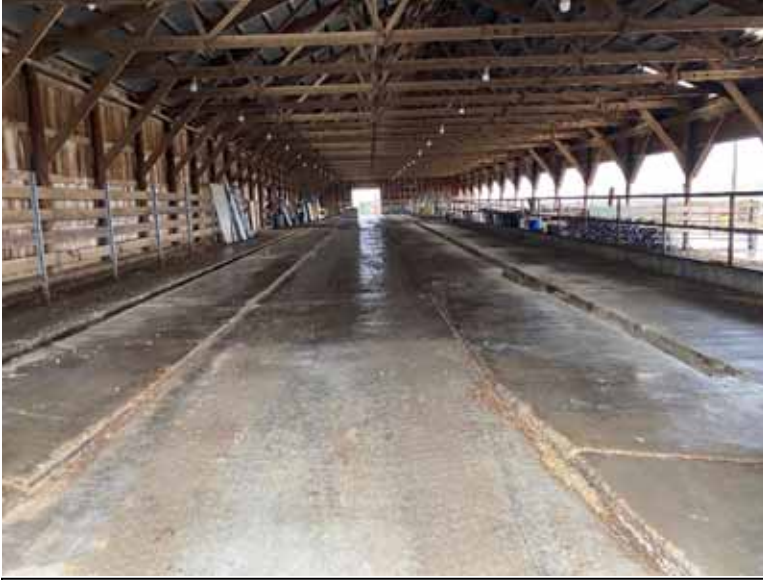
Photo #	38
Date/Time:	April 5, 2023
Location	UW- Arlington- Beef Grazing
Photo taken by:	J. Hanrahan

At the time of the inspection the Beef Grazing Facility was depopulated. A reception tank was installed in the northwest corner of barn #895. The tank will be used to collect wash wastewater from the facility. The long-term plan is to house calves at the facility requiring the wash area and collection. The lots and pastures around the facility were vacant and vegetated. Some of the pastures are now cropped. The VTA and settling basins were in good condition.

Description: Inside barn #895 at Beef Grazing, barn being remodeled and repurposed for future research.

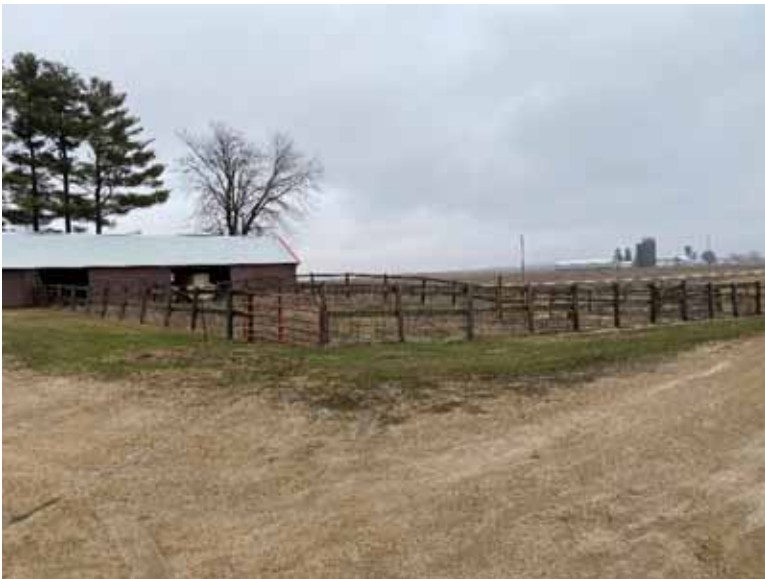
Photo #	39
Date/Time:	April 5, 2023
Location	UW- Arlington- Beef Grazing
Photo taken by:	J. Hanrahan

Description: Lots outside Barns 894 currently empty, used to house horses.

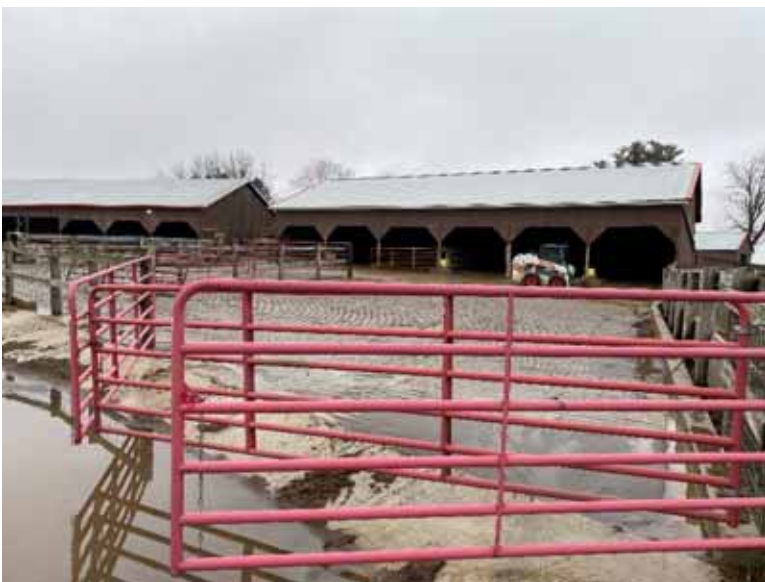
Photo #	40
Date/Time:	April 5, 2023
Location	UW- Arlington- Beef Grazing
Photo taken by:	J. Hanrahan

Description: Lots outside barn 899 and 897 runoff flows to a settling basin before entering VTA. Some runoff collected by WSF 899.

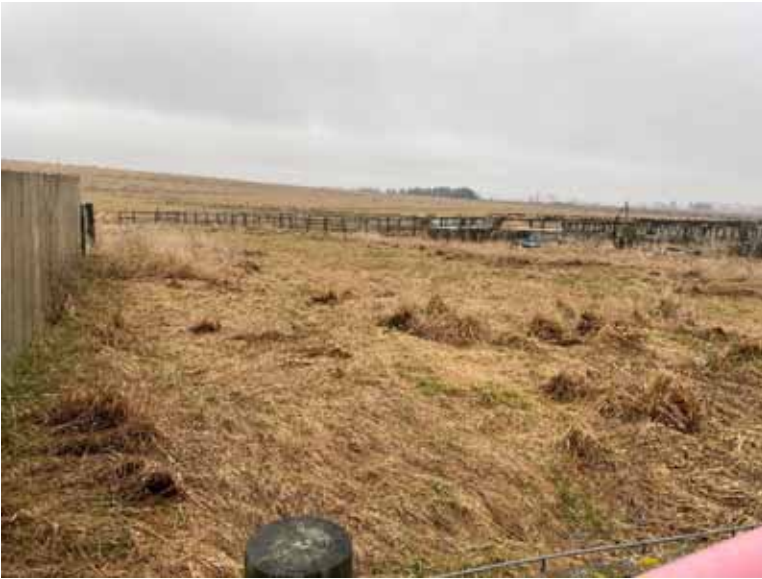
Photo #	41
Date/Time:	April 5, 2023
Location	UW- Arlington- Beef Grazing
Photo taken by:	J. Hanrahan

Description: VTA for Lot 899. Was vegetated but mowing and harvesting was not recent as the site has been depopulated.

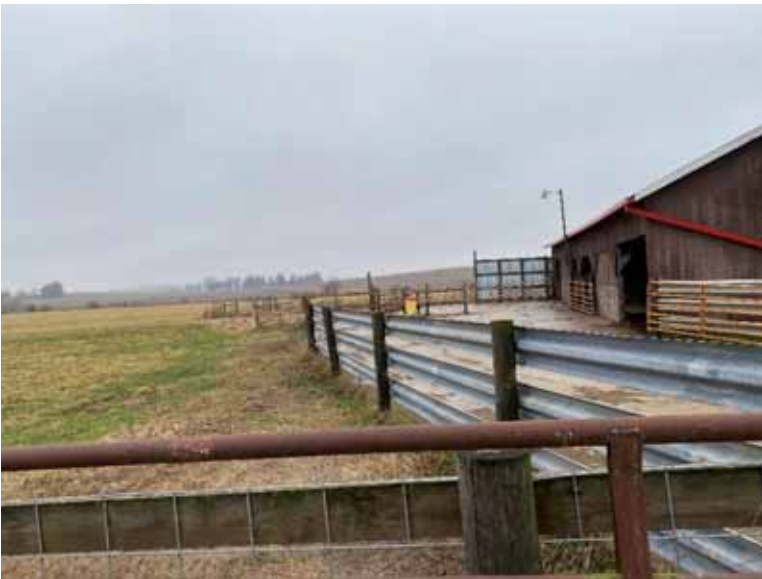
Photo #	42
Date/Time:	April 5, 2023
Location	UW- Arlington- Beef Grazing
Photo taken by:	J. Hanrahan

Description: Facing west at barn 896. No animals or waste present, runoff flows east then south to WSF 895.
