Permit Fact Sheet

Permit Number:	WI-0063908-03-0
Permittee Name:	UW Arlington Agricultural Research Station
Address:	N695 Hopkins Rd
City/State/Zip:	Arlington WI 53911
Discharge Location:	<p>Blaine Dairy, W6723 Badger Lane, Arlington WI 53911, Town of Leeds, Columbia County, NE-SW, Sect. 29, T10N, R10E.</p> <p>Beef Grazing, W7431 County Road K, Arlington WI 53911, Town of Arlington, Columbia County, NW-NE, Sect. 36, T10N, R09E.</p> <p>Beef Nutrition, N551 Ramsey Road, Arlington WI 53911, Town of Leeds, Columbia County, SW-SW, Sect. 30, T10N, R10E.</p> <p>Sheep South, 4857 Meek Road, Arlington WI 53911, Town of Vienna, Dane County, NW-NE, Sect. 01, T09N, R09E.</p> <p>Sheep North, 4857 Meek Road, Arlington WI 53911, Town of Arlington, Columbia County, SW-SE, Sect. 36, T10N, R09E.</p> <p>Swine Facility, N636 County Road I, Arlington WI 53911, Town of Leeds, Columbia County, NW-SW, Sect. 31, T10N, R09E.</p> <p>Bookhout Farm, W7114 Ramsey Road, Arlington WI 53911, Town of Leeds, Columbia County, SE-SW, Sect. 30, T10N, R10E</p>

Receiving Water:	Unnamed tributaries of the Headwaters Yahara River Watershed and groundwaters of the state
Stream Classification:	Yahara River 303d
Discharge T

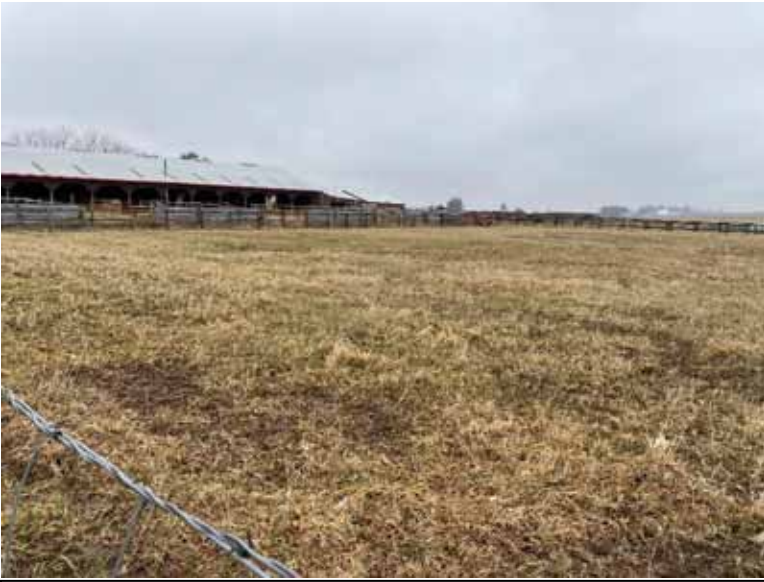
Photo #	43
Date/Time:	April 5, 2023
Location	UW- Arlington- Beef Grazing
Photo taken by:	J. Hanrahan

Description: Facing northeast from the center of the west side of the VTA for Lot 895. VTA was vegetated and in good condition.

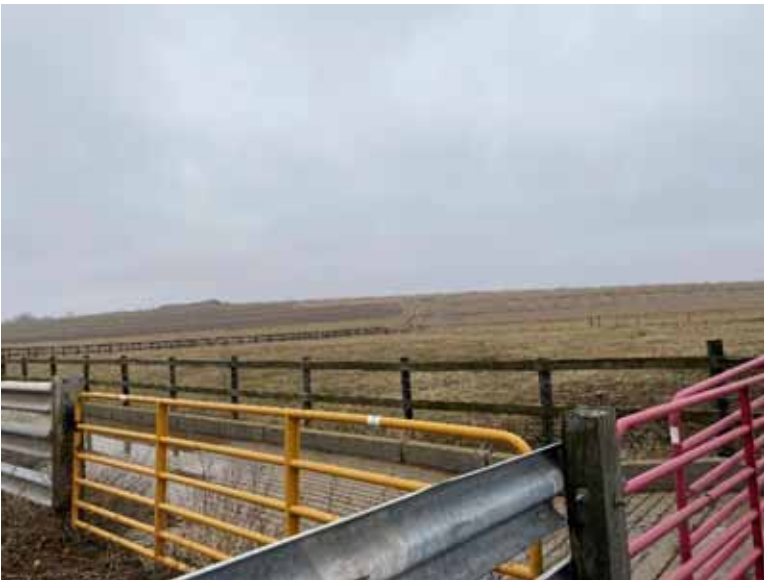
Photo #	44
Date/Time:	April 5, 2023
Location	UW- Arlington- Beef Grazing
Photo taken by:	J. Hanrahan

Description: Facing south from the settling basin and spreader bar for Lot 895 and the associated VTA.

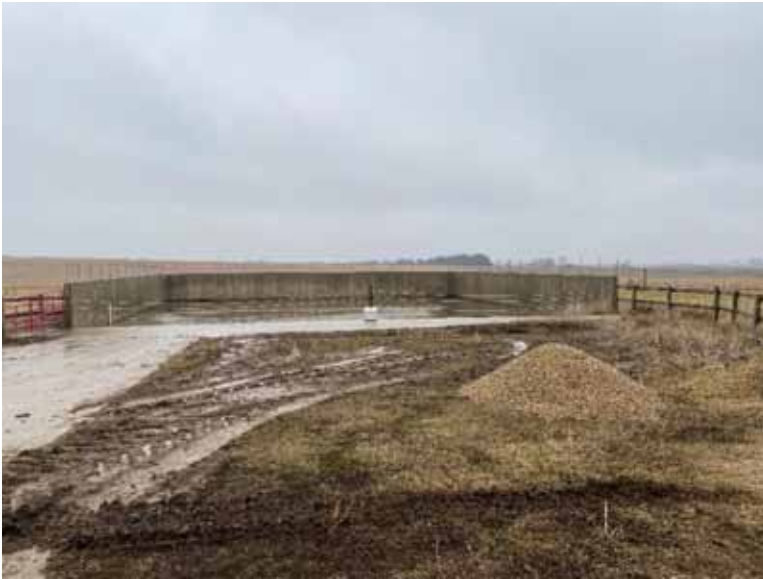
Photo #	45
Date/Time:	April 5, 2023
Location	UW- Arlington- Beef Grazing
Photo taken by:	J. Hanrahan
Description: WSF 895 facing South.

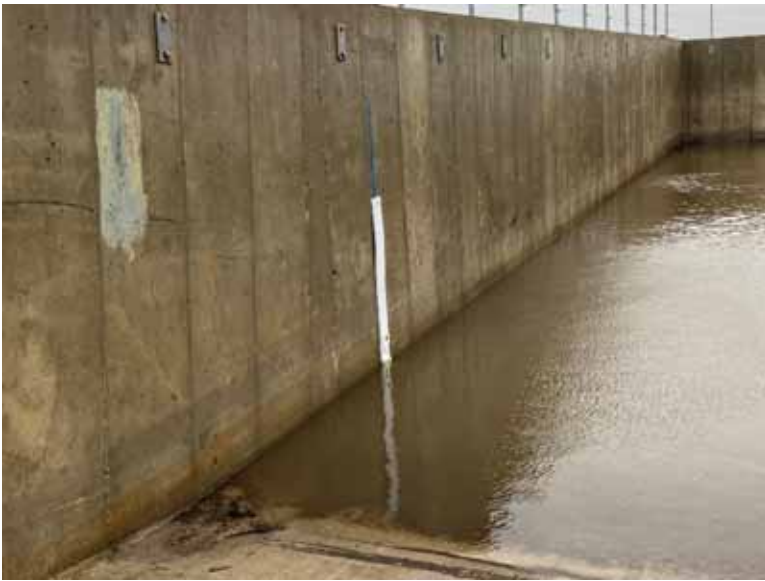
Photo #	46
Date/Time:	April 5, 2023
Location	UW- Arlington- Beef Grazing
Photo taken by:	J. Hanrahan
Description: Markers located in WSF 895 east wall.

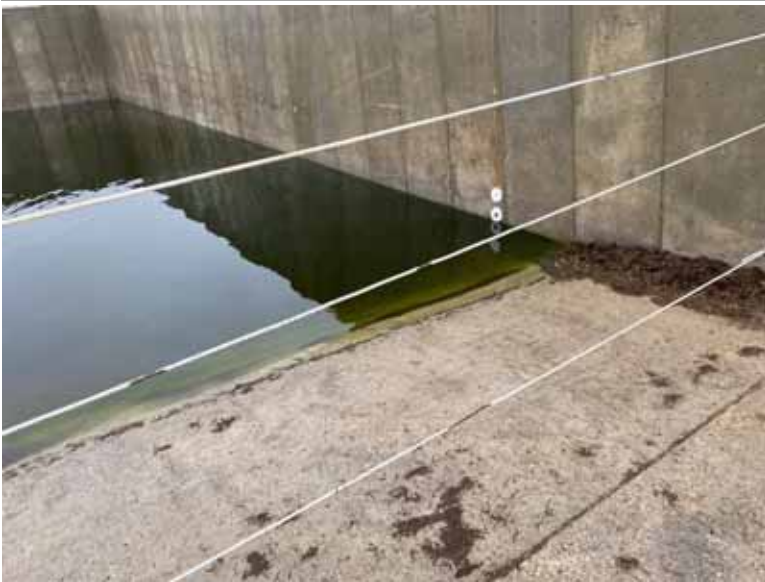
Photo #	47
Date/Time:	April 5, 2023
Location	UW- Arlington- Beef Grazing
Photo taken by:	J. Hanrahan
Description: Markers in WSF 899 east wall.

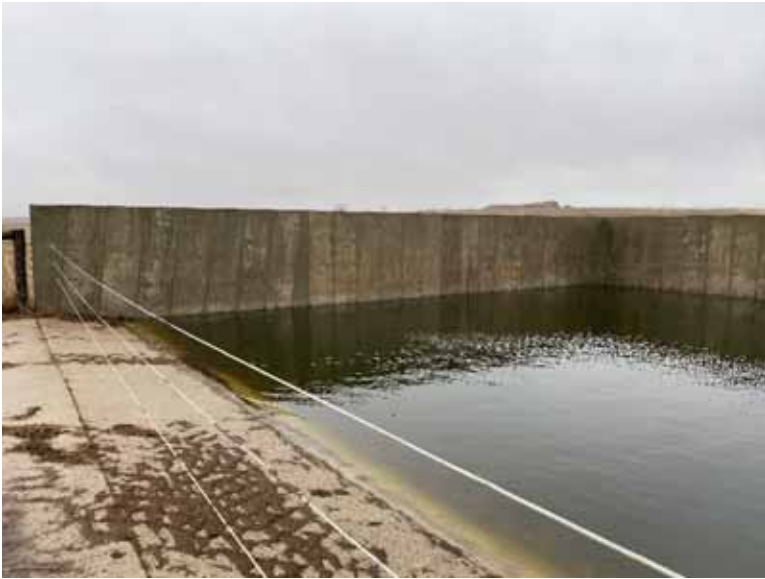
Photo #	48
Date/Time:	April 5, 2023
Location	UW- Arlington- Beef Grazing
Photo taken by:	J. Hanrahan

Description: West wall of WSF 899.

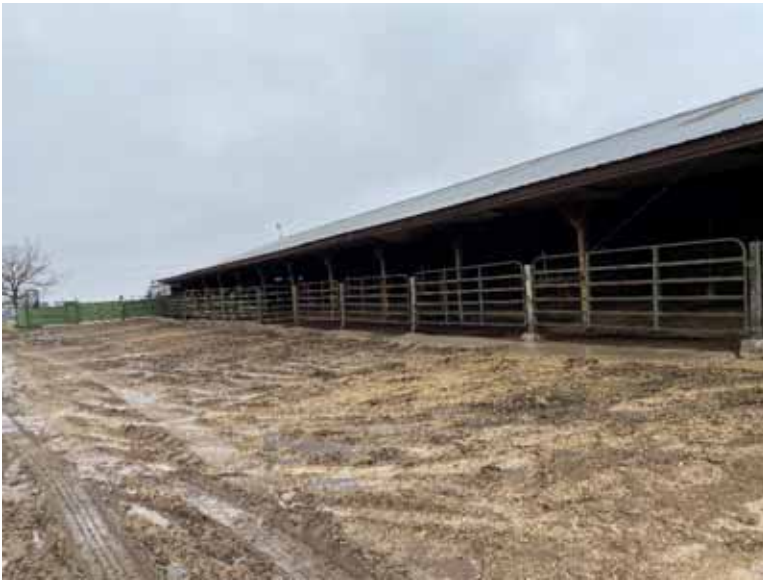
Photo #	50
Date/Time:	April 5, 2023
Location	UW- Arlington- Beef Nutrition
Photo taken by:	J. Hanrahan

Description: Barn 967 all animals under roof. Facing east from the center of the barn.

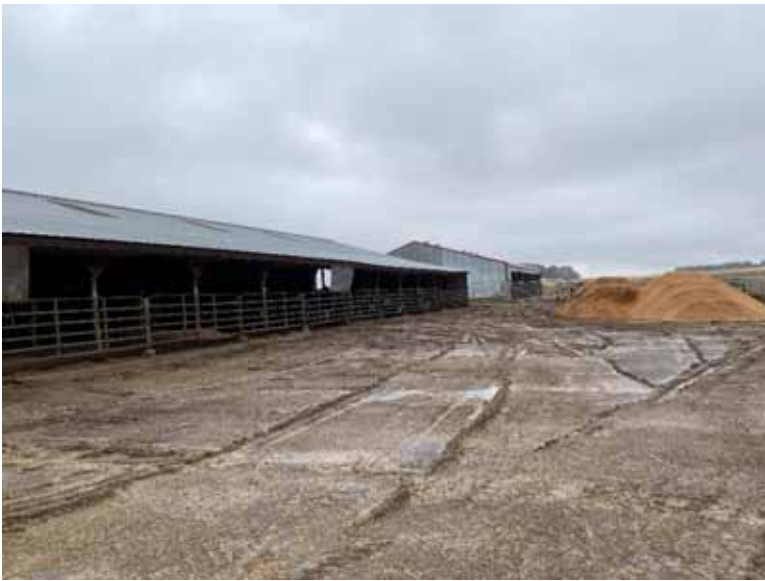
Photo #	51
Date/Time:	April 5, 2023
Location	UW- Arlington- Beef Nutrition
Photo taken by:	J. Hanrahan

Description: Barn 967 all animals under roof. Facing west from the center of the barn.

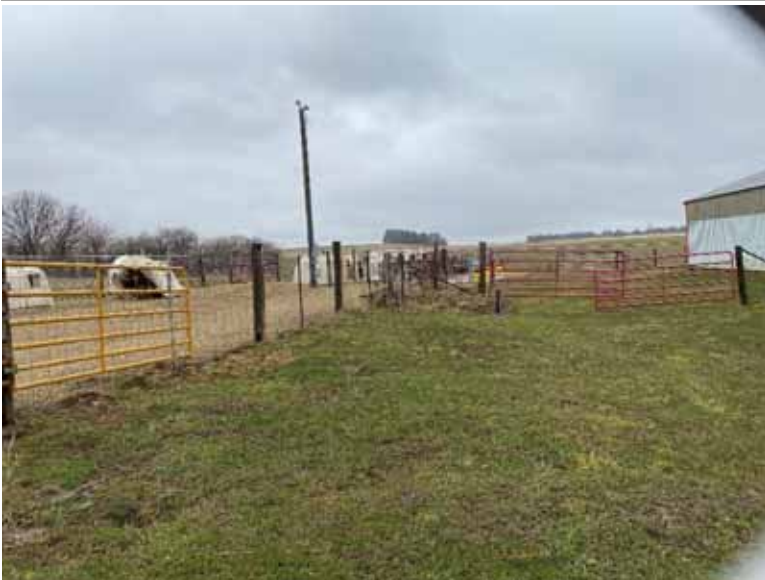
Photo #	52
Date/Time:	April 5, 2023
Location	UW- Arlington- Beef Nutrition
Photo taken by:	J. Hanrahan

Description: Calf hutch area 973, located north of Barn 973. Facing east from the northwest side for barn 973.

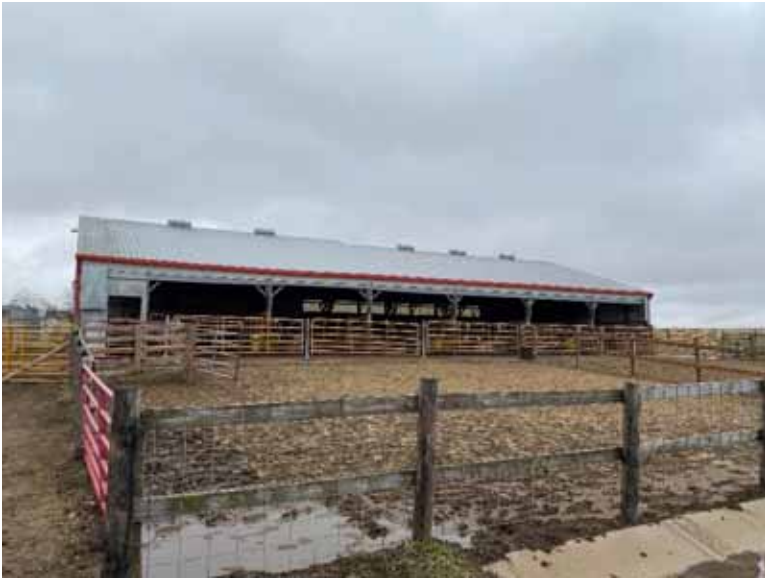
Photo #	53
Date/Time:	April 5, 2023
Location	UW- Arlington- Beef Nutrition
Photo taken by:	J. Hanrahan

Description: Facing north to barn 973 from the settling basin. Animals have access to lot 973.

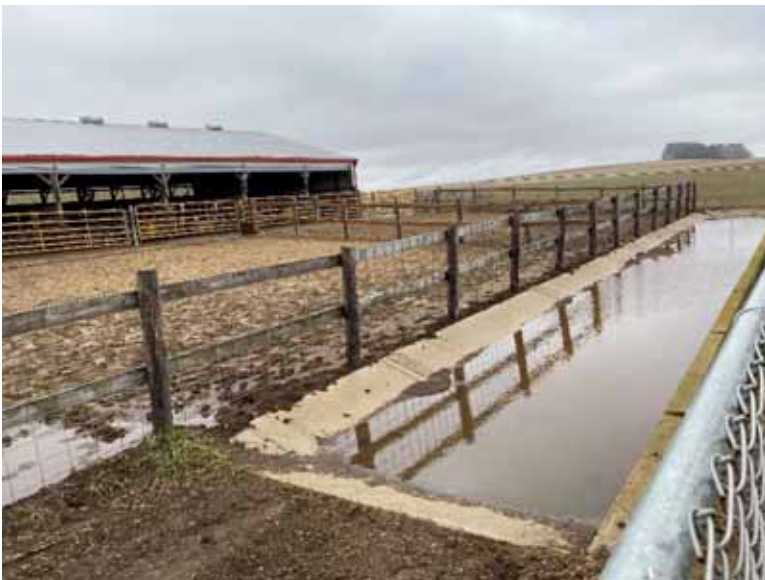
Photo #	54
Date/Time:	April 5, 2023
Location	UW- Arlington- Beef Nutrition
Photo taken by:	J. Hanrahan

Description: Settling basin for lot 973. Facing east.

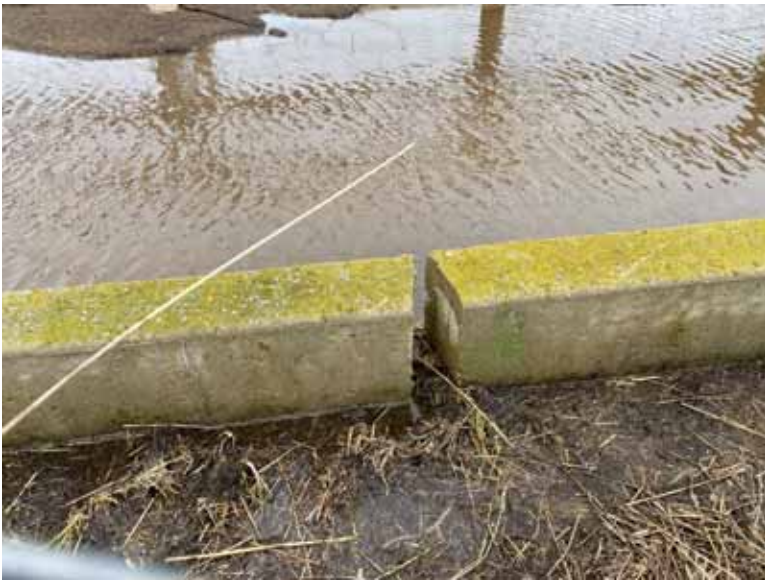
Photo #	55
Date/Time:	April 5, 2023
Location	UW- Arlington- Beef Nutrition
Photo taken by:	J. Hanrahan
Description: slots in the settling basin acting as a spreader bar.

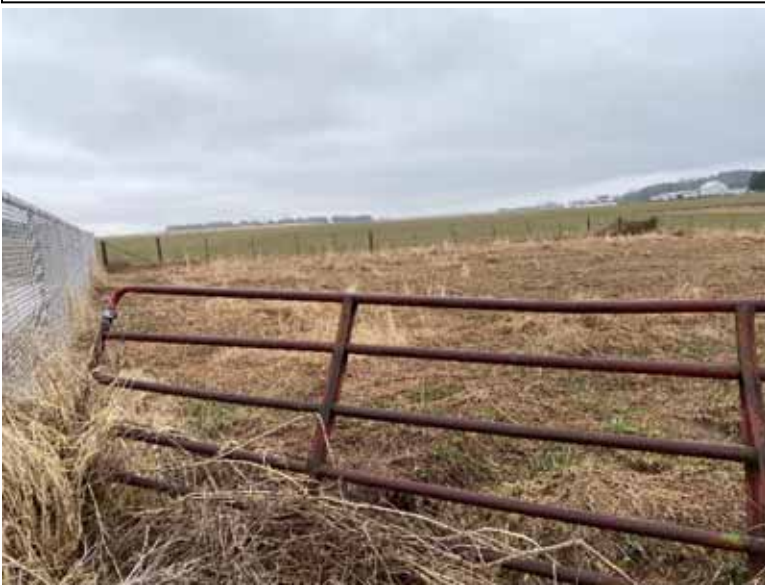
Photo #	56
Date/Time:	April 5, 2023
Location	UW- Arlington- Beef Nutrition
Photo taken by:	J. Hanrahan
Description: VTA for lot 973 at Beef Nutrition.

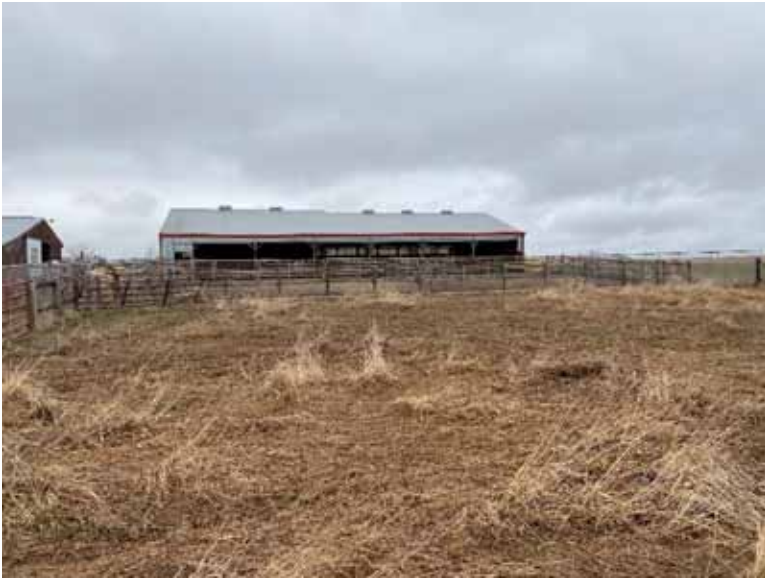
Photo #	57
Date/Time:	April 5, 2023
Location	UW- Arlington- Beef Nutrition
Photo taken by:	J. Hanrahan

Description: Facing north to barn 973 from the southern end of the associated VTA. Mowing and harvesting is needed to maintain the proper operation of a VTA.

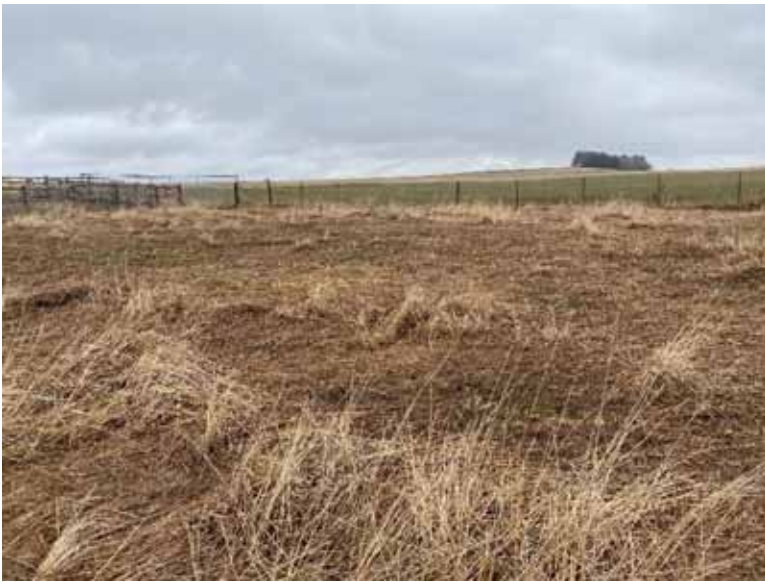
Photo #	58
Date/Time:	April 5, 2023
Location	UW- Arlington- Beef Nutrition
Photo taken by:	J. Hanrahan

Description: Facing east at the lot 973 VTA. Overgrown vegetation but no signs of runoff or channelization.

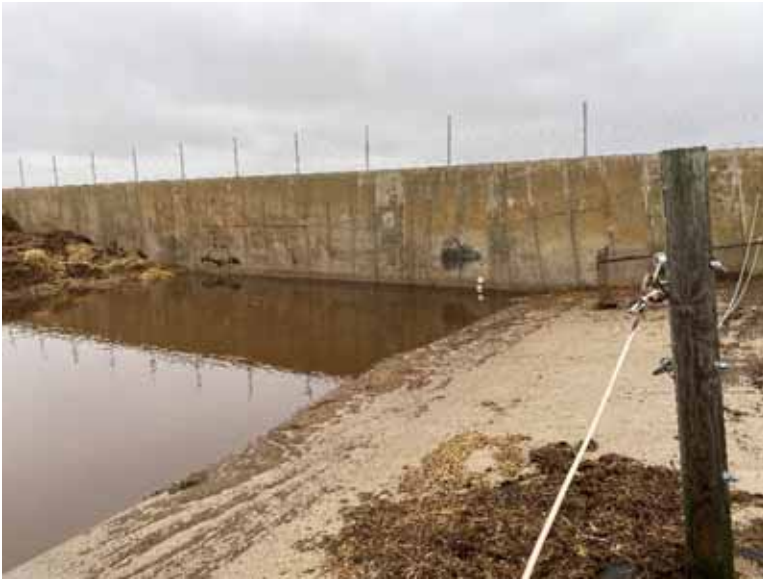
Photo #	59
Date/Time:	April 5, 2023
Location	UW- Arlington- Beef Nutrition
Photo taken by:	J. Hanrahan

Description: Markers on the west wall of WSF 967

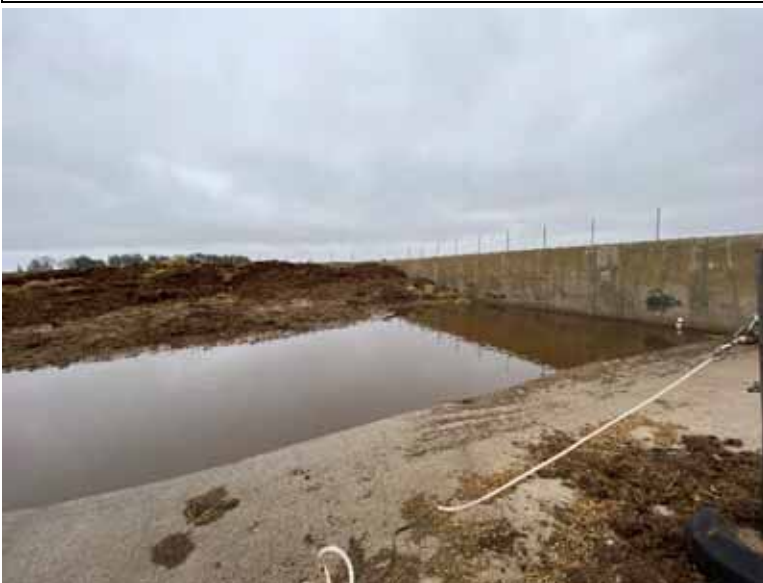
Photo #	60
Date/Time:	April 5, 2023
Location	UW- Arlington- Beef Nutrition
Photo taken by:	J. Hanrahan

Description: Manure stacked in WSF 967 and collected rainwater.

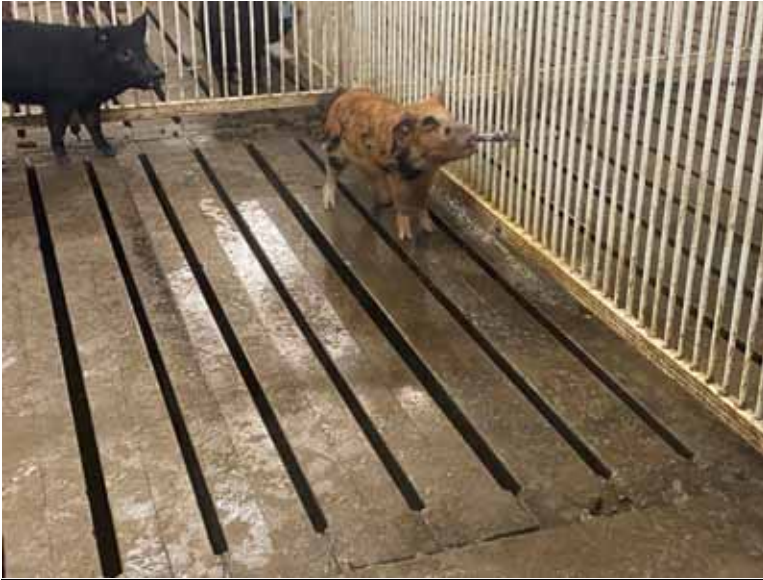
Photo #	61
Date/Time:	April 5, 2023
Location	UW- Arlington- Swine Facility
Photo taken by:	J. Hanrahan

Description: Viewing area at entrance of the Swine facility. Piglet using a waterer and slatted floor for waste to drop through for collection.

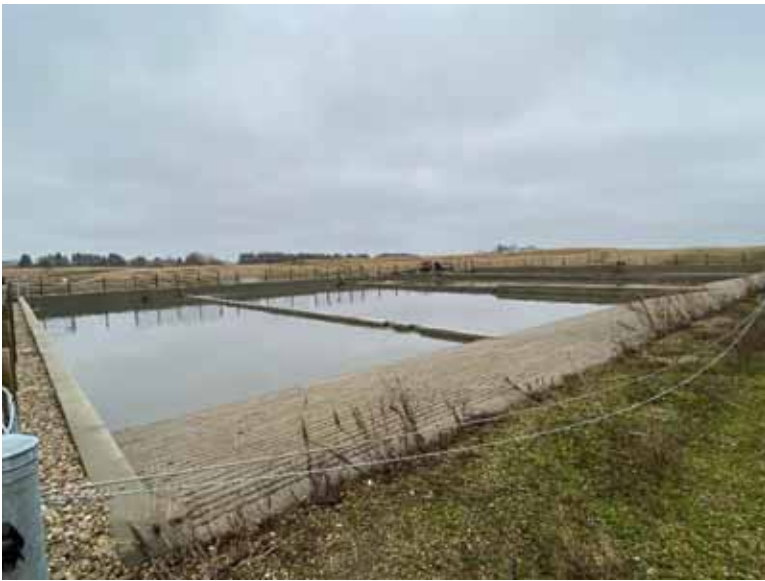
Photo #	62
Date/Time:	April 5, 2023
Location	UW- Arlington- Swine Facility
Photo taken by:	J. Hanrahan

Description: WSF 886 facing southeast.

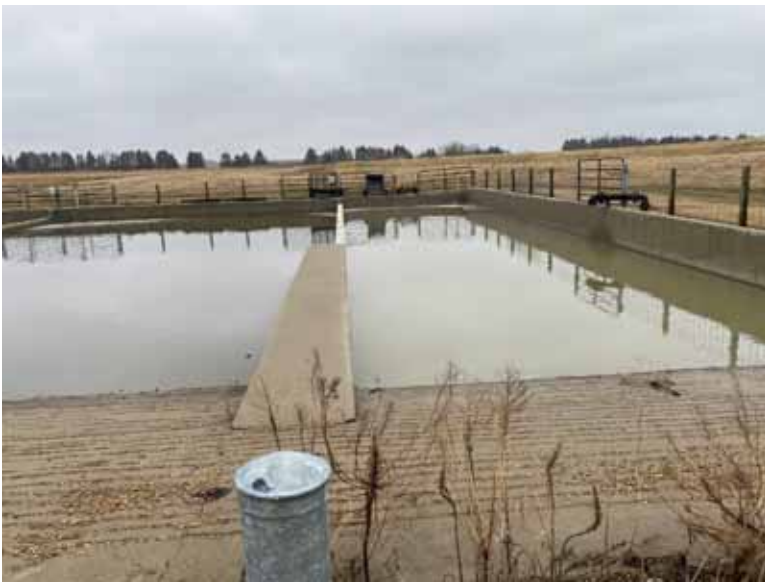
Photo #	63
Date/Time:	April 5, 2023
Location	UW- Arlington- Swine Facility
Photo taken by:	J. Hanrahan

Description: Facing east at the WSF 886, the storage acts as a solid settling lane as the flow moves through the four basins.

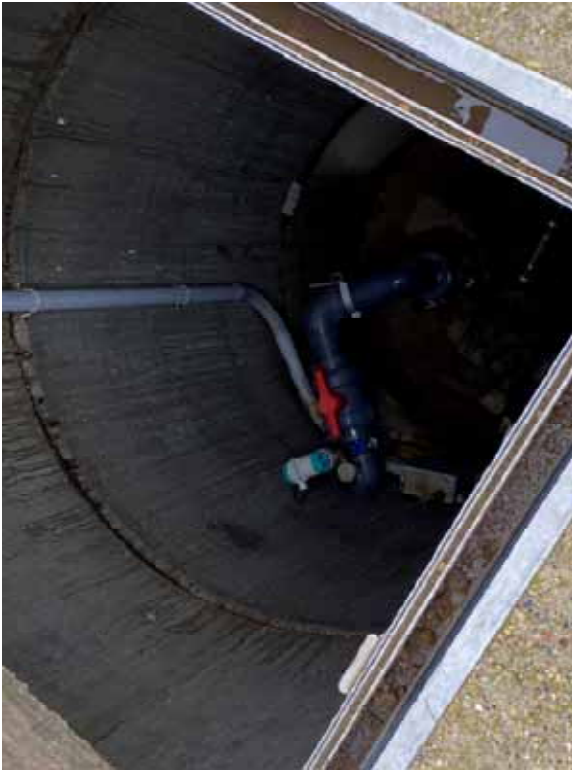
Photo #	64
Date/Time:	April 5, 2023
Location	UW- Arlington- Swine Facility
Photo taken by:	J. Hanrahan

Description: Sump/reception tank located on the west side of WSF 863. Waste from WSF 886 collects here and is pumped to WSF 863.

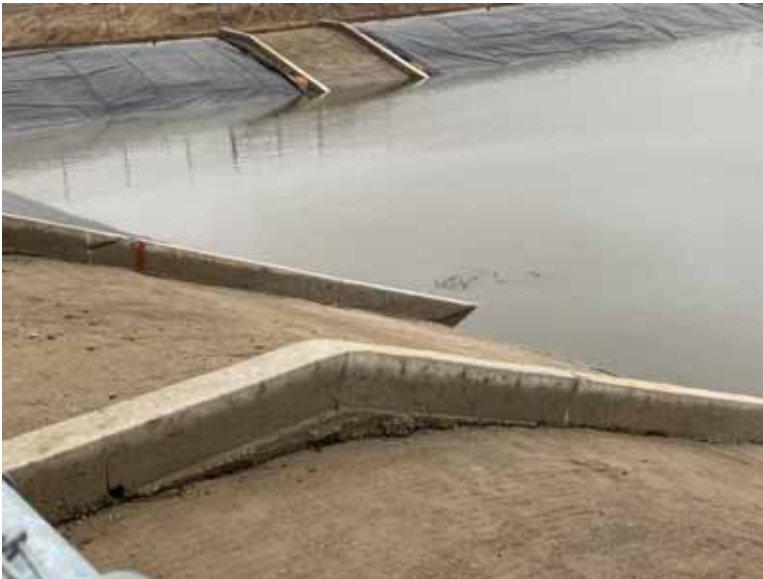
Photo #	65
Date/Time:	April 5, 2023
Location	UW- Arlington- Swine Facility
Photo taken by:	J. Hanrahan

Description: Access ramp and markers on the west side of WSF 863.

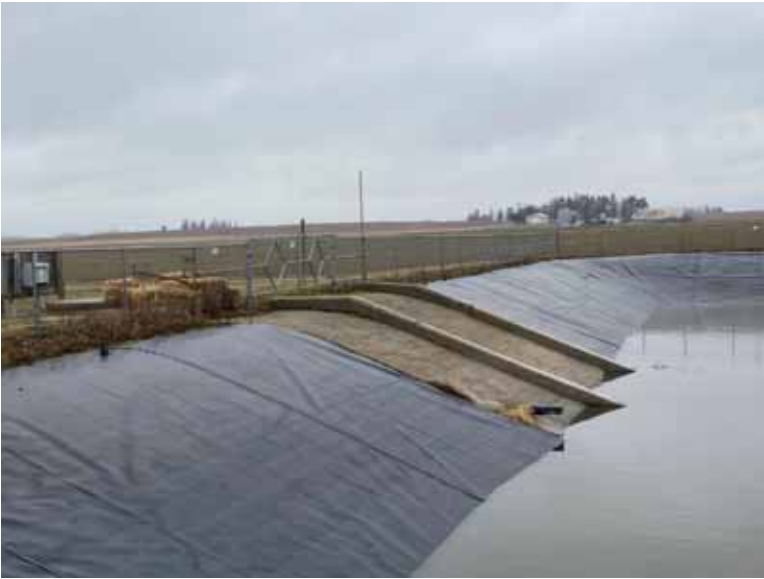
Photo #	66
Date/Time:	April 5, 2023
Location	UW- Arlington- Swine Facility
Photo taken by:	J. Hanrahan

Description: Facing north at the access ramp on the west side of WSF 863 and pump station.

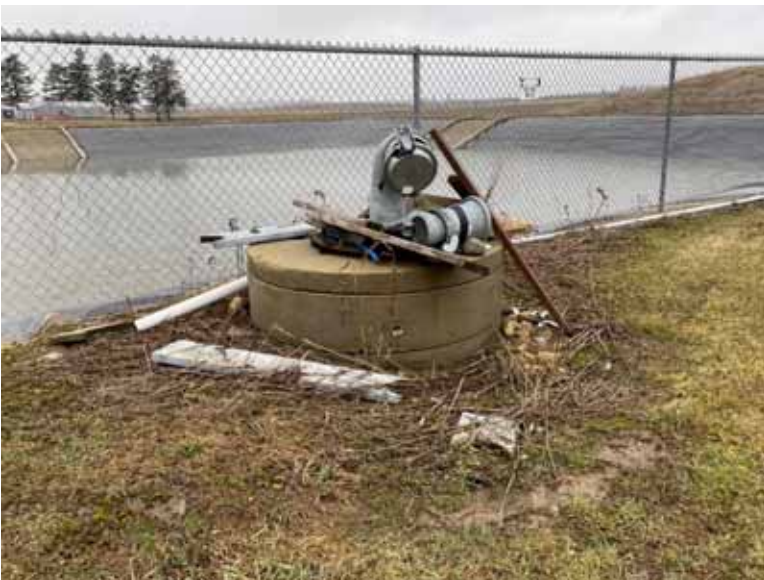
Photo #	67
Date/Time:	April 5, 2023
Location	UW- Arlington- Swine Facility
Photo taken by:	J. Hanrahan

Description: Pump and sump for the under-drain system for WSF 863. Located on the east side of the storage.

- Finish repairing VTA at Sheep North
- VTA repair at Bookhout Farm prior to populating lots
- Locate as built plans for Swine Facility for WSF #863 under drains

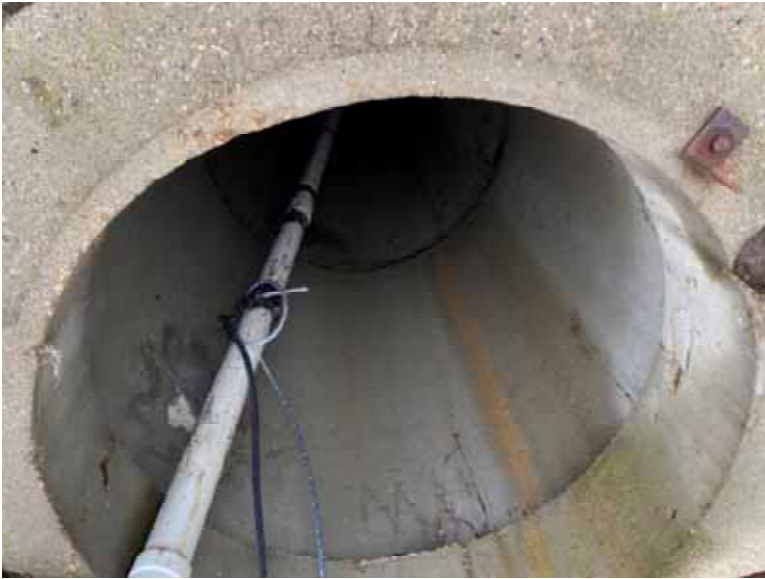
Photo #	68
Date/Time:	April 5, 2023
Location	UW- Arlington- Swine Facility
Photo taken by:	J. Hanrahan

Description: Manhole for sump and pump for the underdrain system for WSF 863, sampled for leak detection.

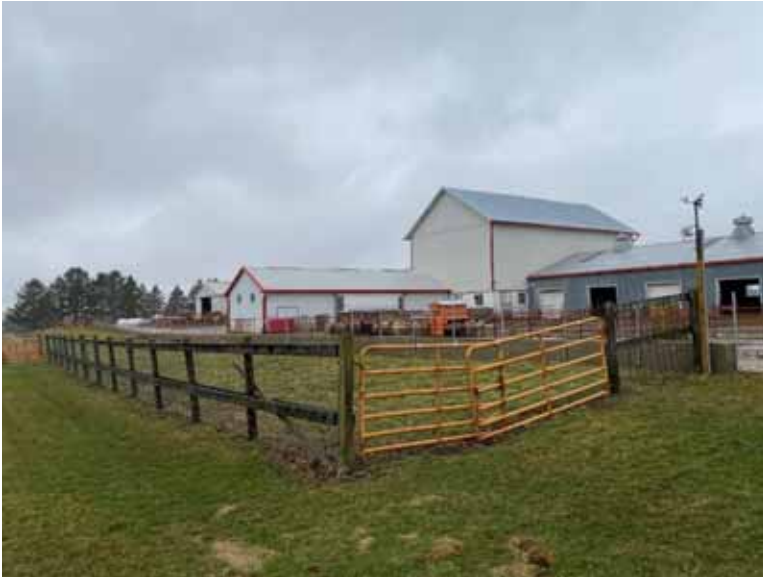
Photo #	69
Date/Time:	April 5, 2023
Location	UW- Arlington- Sheep North
Photo taken by:	J. Hanrahan

Description: Facing northwest at barn 826. Left of picture is Meek Road ditch.

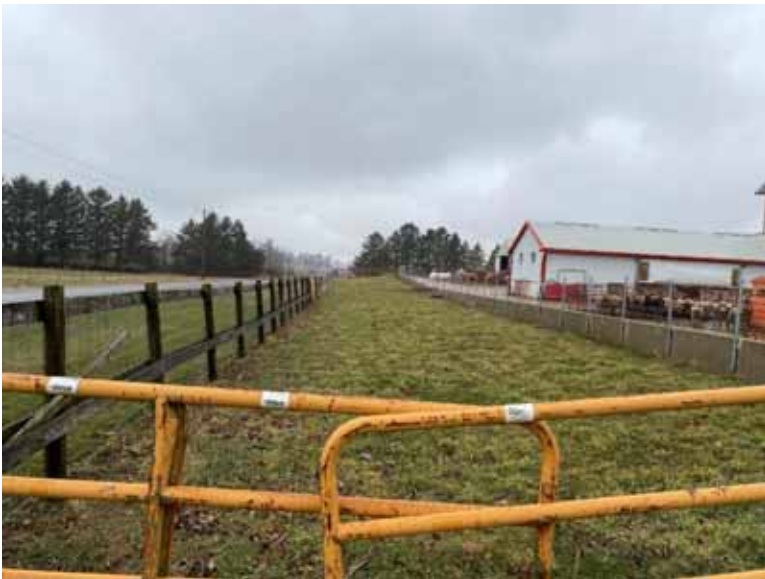
Photo #	70
Date/Time:	April 5, 2023
Location	UW- Arlington- Sheep North
Photo taken by:	J. Hanrahan

Description: Facing west at pasture walkway area between Meek Road and feed lot for barn 826.

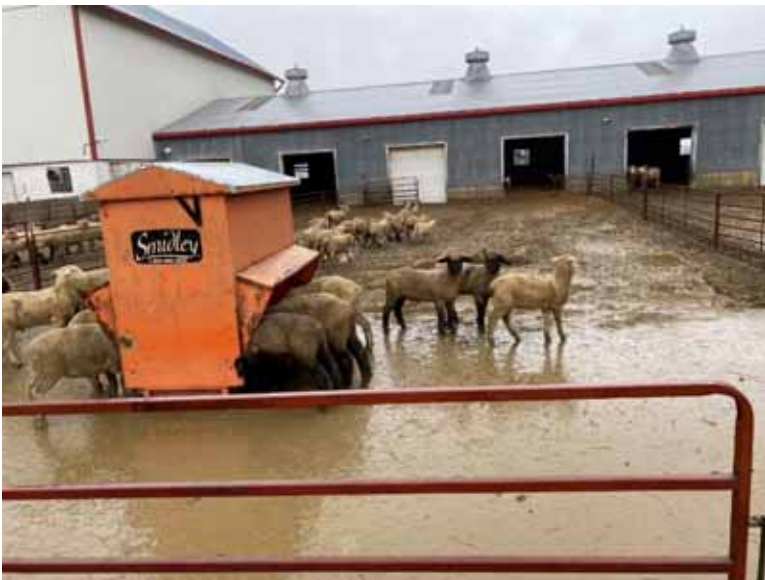
Photo #	71
Date/Time:	April 5, 2023
Location	UW- Arlington- Sheep North
Photo taken by:	J. Hanrahan

Description: Facing west at feed lot and barn 826.

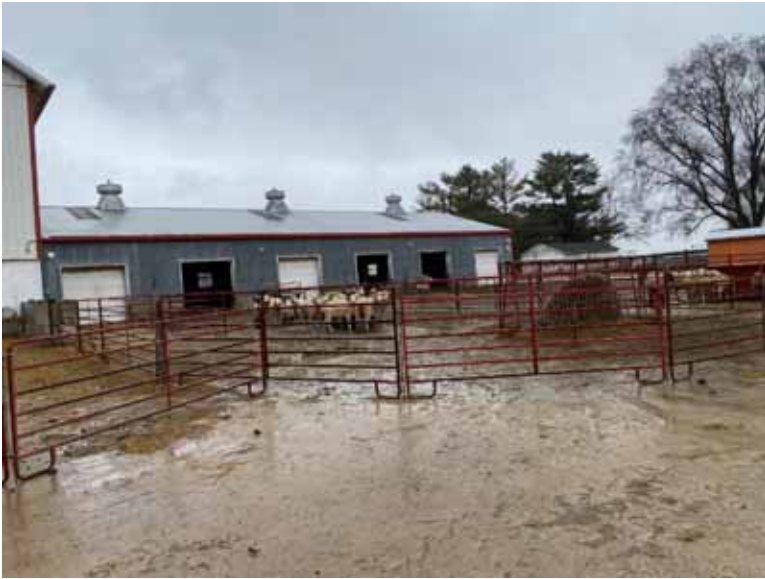
Photo #	72
Date/Time:	April 5, 2023
Location	UW- Arlington- Sheep North
Photo taken by:	J. Hanrahan

Description: Facing northeast at barn and lot 826, flow is coming towards photographer.

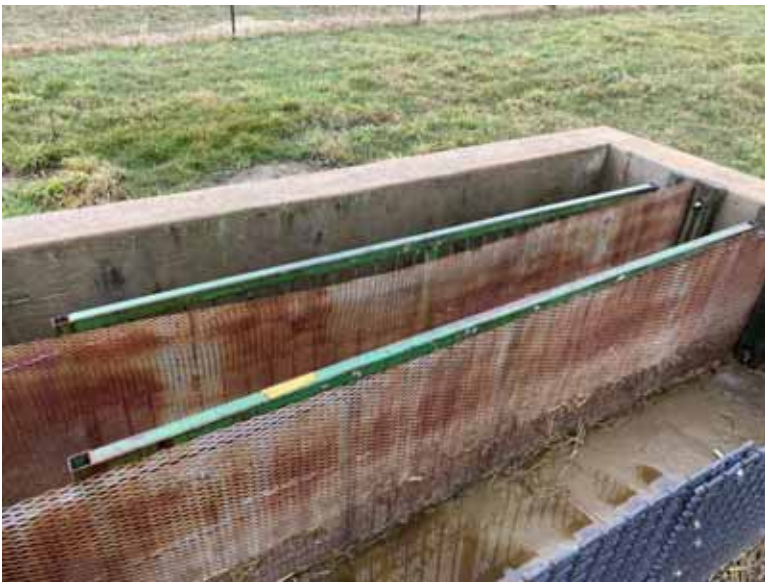
Photo #	73
Date/Time:	April 5, 2023
Location	UW- Arlington- Sheep North
Photo taken by:	J. Hanrahan

Description: Settling basin for lot 826, screens in place and appear to be in good condition.

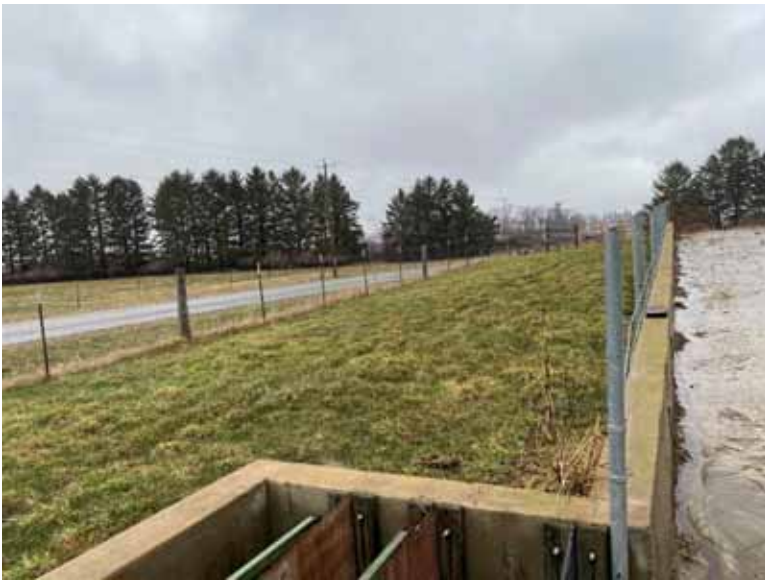
Photo #	74
Date/Time:	April 5, 2023
Location	UW- Arlington- Sheep North
Photo taken by:	J. Hanrahan

Description: Facing west towards VTA. Settling basin drains underground to VTA.

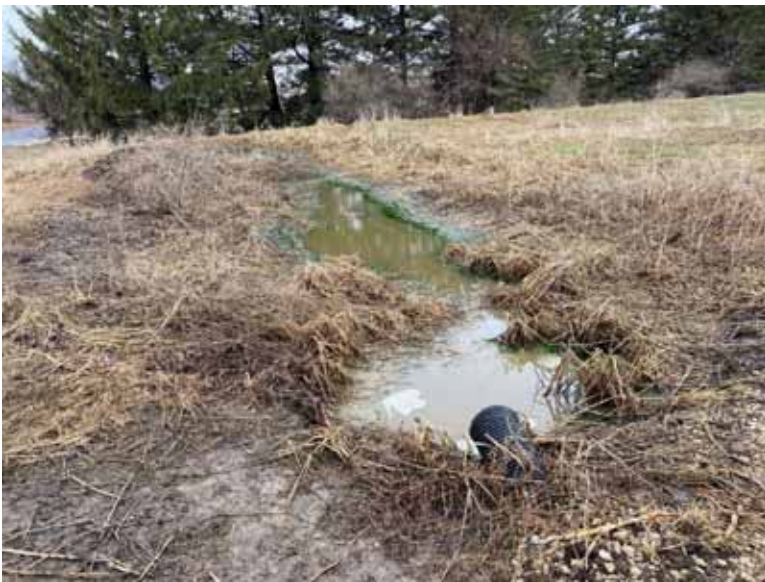
Photo #	75
Date/Time:	April 5, 2023
Location	UW- Arlington- Sheep North
Photo taken by:	J. Hanrahan

Description: Discharge point of settling basin from Lot 826. Facing west, ponded runoff present in the first part of the VTA.

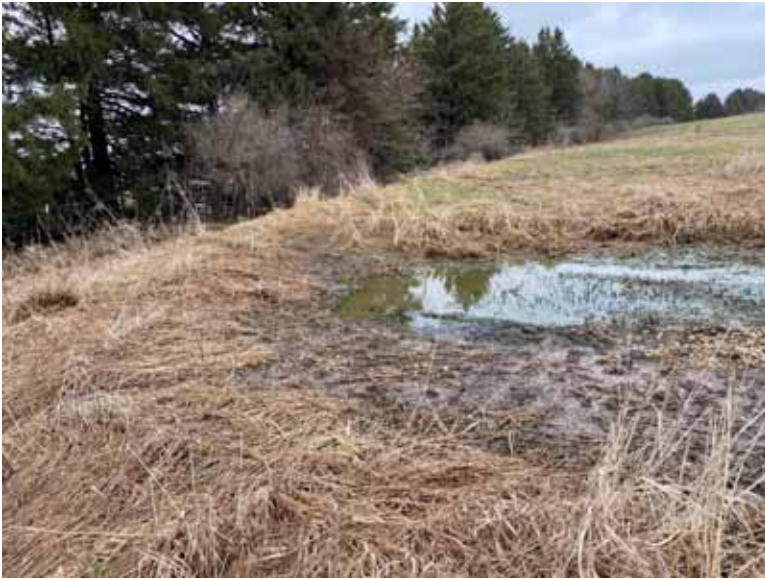
Photo #	76
Date/Time:	April 5, 2023
Location	UW- Arlington- Sheep North
Photo taken by:	J. Hanrahan

Description: West side of the VTA facing north, ponded runoff in beginning area of VTA. Maintenance started and some of the spreader bar has been removed.

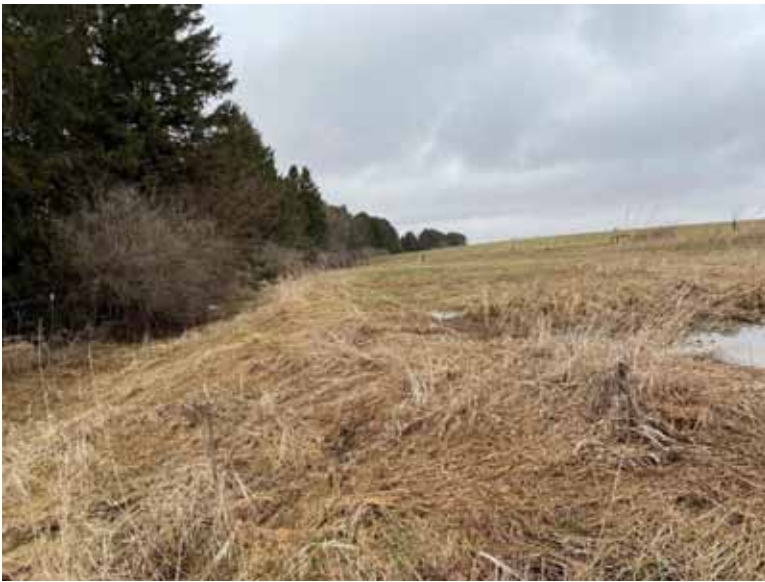
Photo #	77
Date/Time:	April 5, 2023
Location	UW- Arlington- Sheep North
Photo taken by:	J. Hanrahan

Description: West side of VTA facing north on the outside of berm. No runoff observed outside of the VTA at the south end and west side at the time of the inspection.

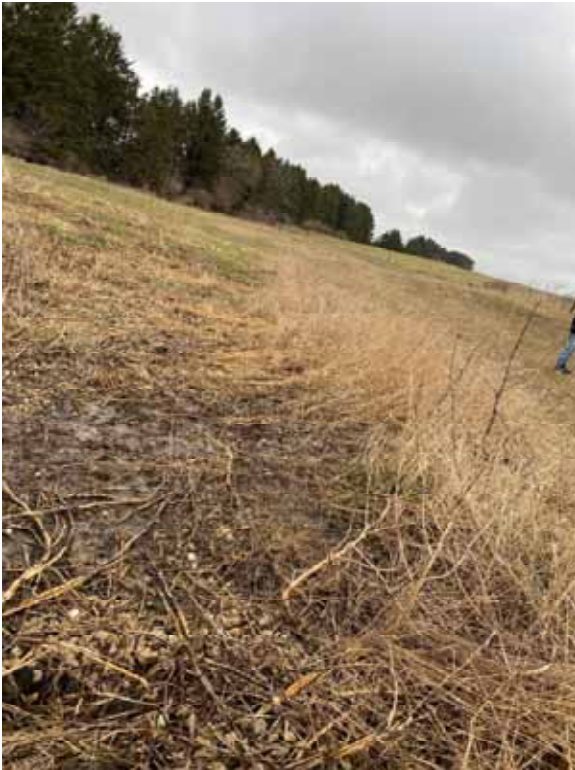
Photo #	78
Date/Time:	April 5, 2023
Location	UW- Arlington- Sheep North
Photo taken by:	J. Hanrahan

Description: Facing northwest from the east side of the VTA. No flow paths identified in the VTA; vegetation well maintained.

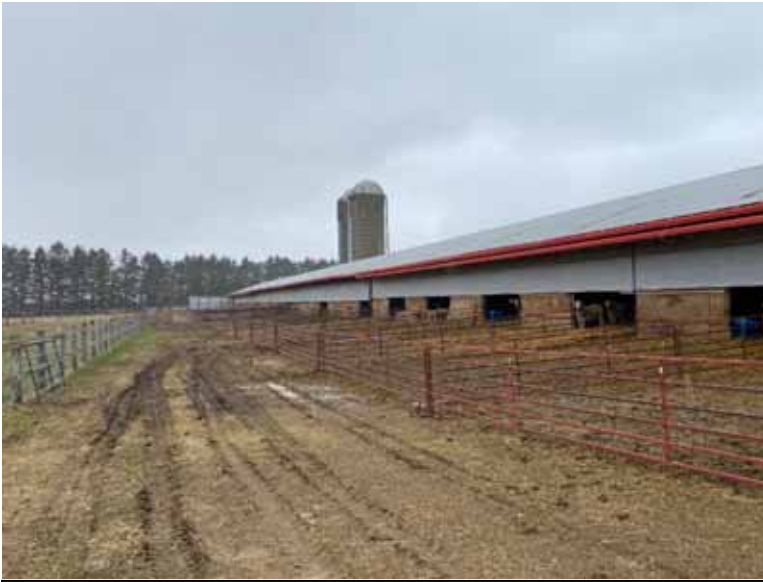
Photo #	79
Date/Time:	April 5, 2023
Location	UW- Arlington- Sheep South
Photo taken by:	J. Hanrahan

Description: Facing east at barn and lots 931. Runoff flow from the lots travels to the middle of the barn lots and then south.

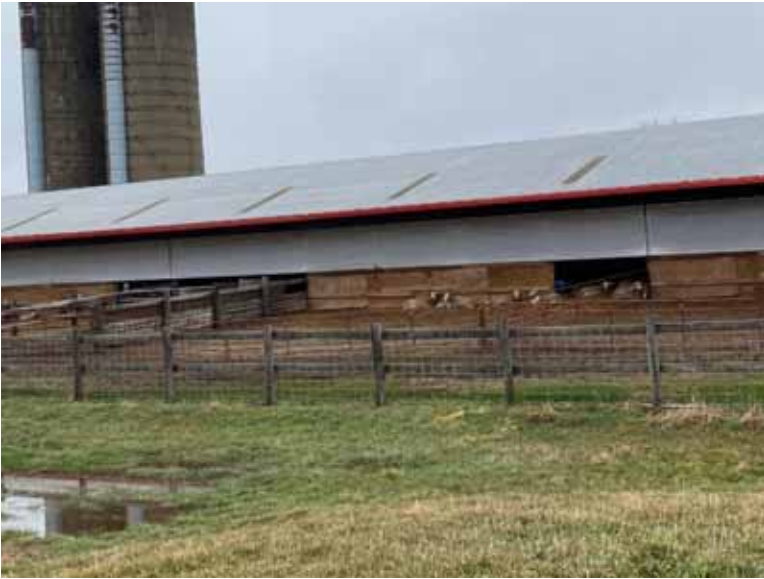
Photo #	80
Date/Time:	April 5, 2023
Location	UW- Arlington- Sheep South
Photo taken by:	J. Hanrahan

Description: Facing north at barn 931, midpoint of barn where flow meets and begins to flow south.

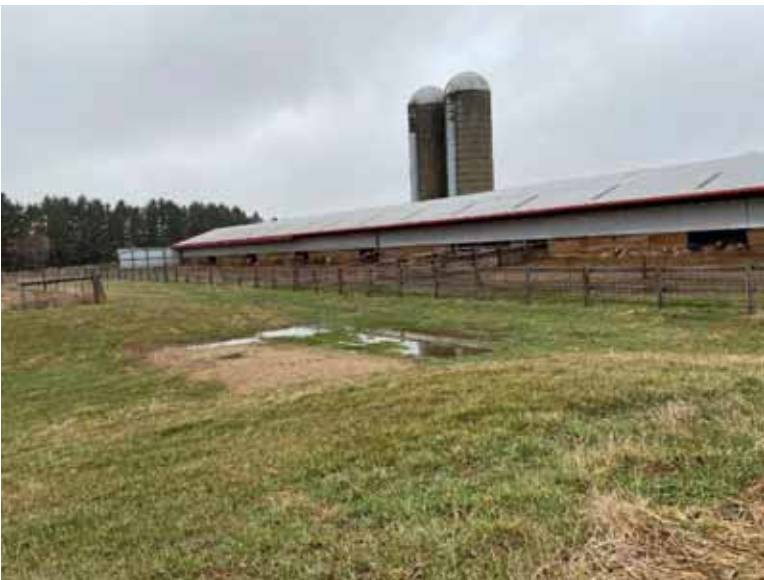
Photo #	81
Date/Time:	April 5, 2023
Location	UW- Arlington- Sheep South
Photo taken by:	J. Hanrahan

Description: Collection settling area at the beginning of VTA. Some water standing before gravel spreader bar. No concentrated flow paths and good vegetation present.

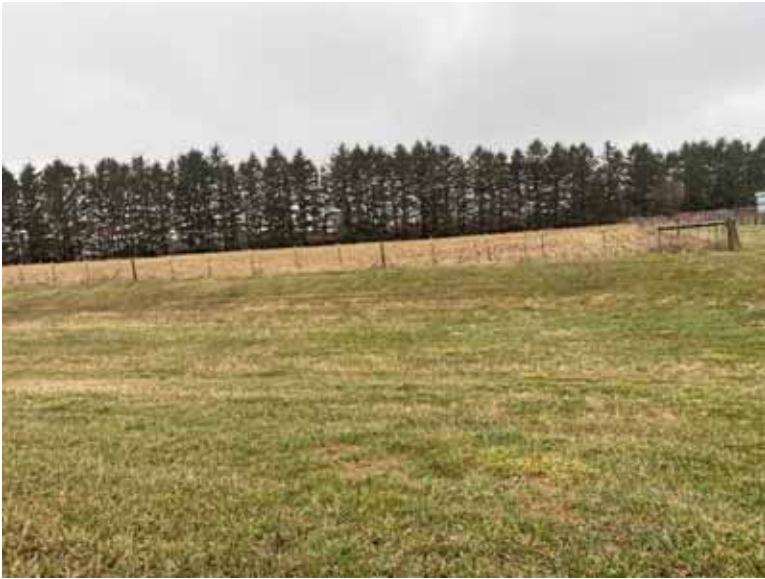
Photo #	82
Date/Time:	April 5, 2023
Location	UW- Arlington- Sheep South
Photo taken by:	J. Hanrahan

Description: First half of the VTA facing west. Good vegetation and proper maintenance has been preformed prior to the inspection.

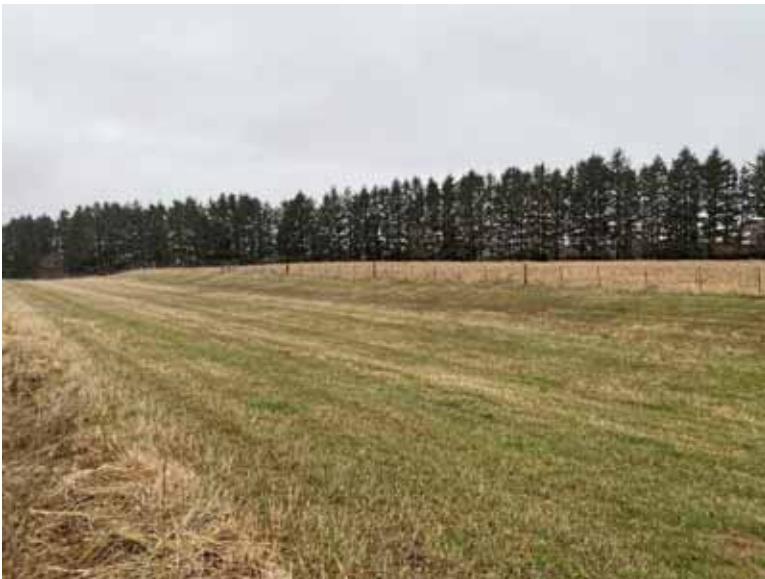
Photo #	83
Date/Time:	April 5, 2023
Location	UW- Arlington- Sheep South
Photo taken by:	J. Hanrahan

Description: Facing south southwest, towards the end of the VTA. Good vegetation present throughout VTA. VTA ends at cropped field followed by tree line and railroad grade.

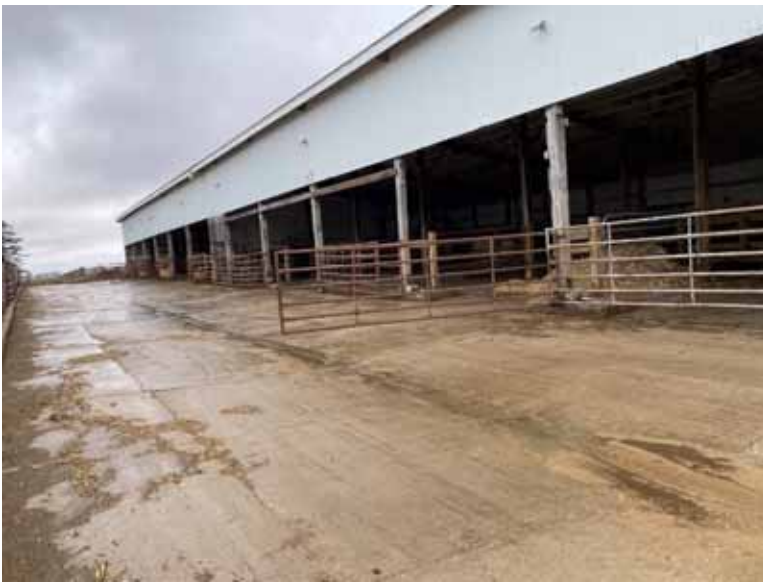
Photo #	84
Date/Time:	April 5, 2023
Location	UW- Arlington- Sheep South
Photo taken by:	J. Hanrahan
Description: Barn and lot 945, facing northwest.

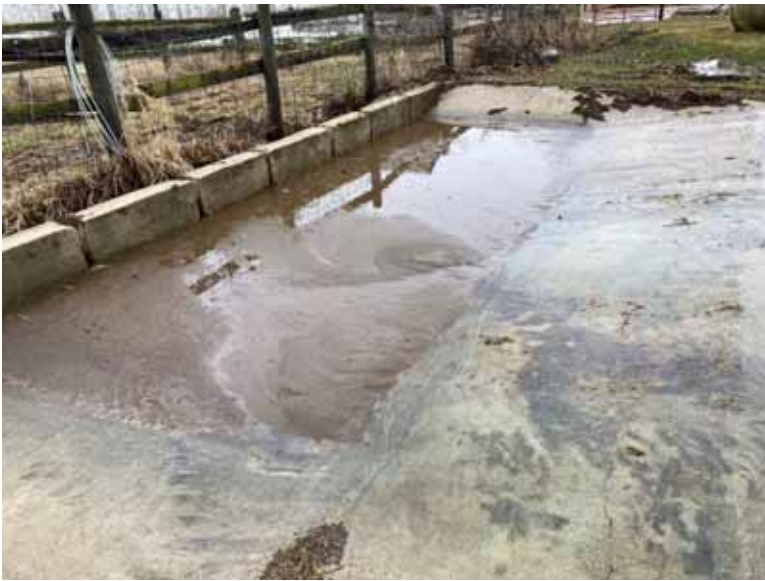
Photo #	85
Date/Time:	April 5, 2023
Location	UW- Arlington- Bookhout
Photo taken by:	J. Hanrahan

Description: Settling basin for runoff from lot 945.

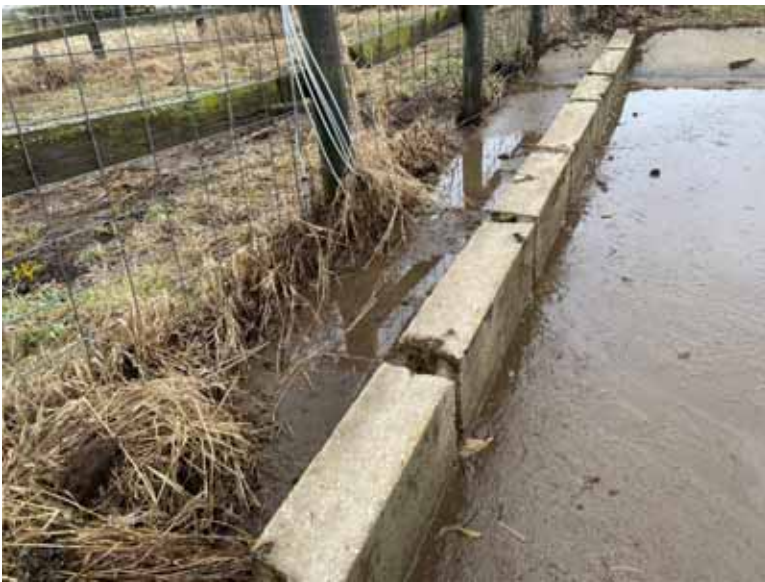
Photo #	86
Date/Time:	April 5, 2023
Location	UW- Arlington- Bookhout
Photo taken by:	J. Hanrahan

Description: Back side of settling basin for lot 945. Solid build up behind spreader bar has occurred along with some overgrown vegetation.

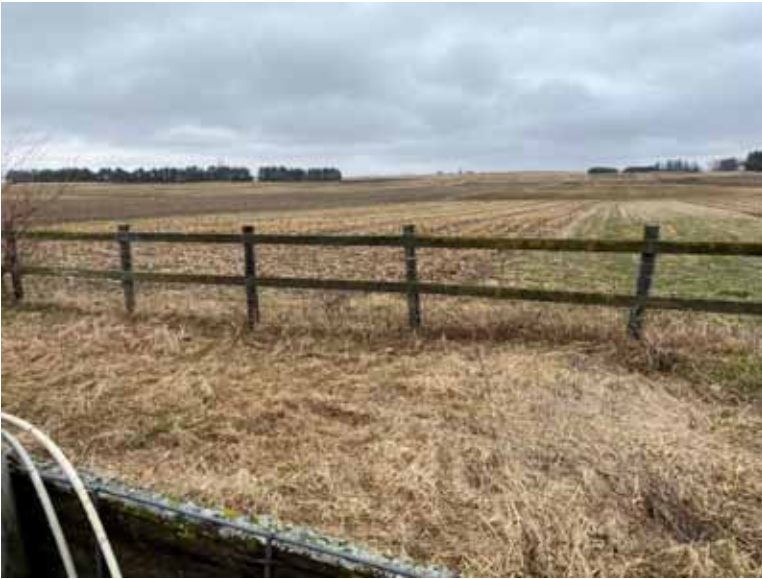
Photo #	87
Date/Time:	April 5, 2023
Location	UW- Arlington- Bookhout
Photo taken by:	J. Hanrahan

Description: Facing east at VTA for lot 945. The walkway had some overgrown vegetation but remainder of VTA was in good condition.

- Finish repairing VTA at Sheep North
- VTA repair at Bookhout Farm prior to populating lots
- Locate as built plans for Swine Facility for WSF #863 under drains
- Prepare of submittal of Reissuance Application

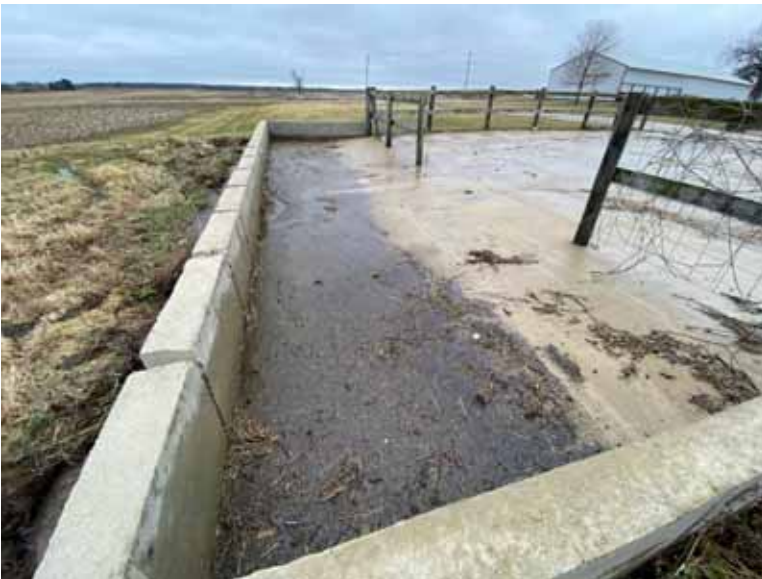
Photo #	88
Date/Time:	April 5, 2023
Location	UW- Arlington- Bookhout
Photo taken by:	J. Hanrahan

Description: Settling basin and spreader bar for lots 940 and 844. Facing South from north end of basin.
