Permit Fact Sheet

Permit Number:	WI-0063908-03-0
Permittee Name:	UW Arlington Agricultural Research Station
Address:	N695 Hopkins Rd
City/State/Zip:	Arlington WI 53911
Discharge Location:	<p>Blaine Dairy, W6723 Badger Lane, Arlington WI 53911, Town of Leeds, Columbia County, NE-SW, Sect. 29, T10N, R10E.</p> <p>Beef Grazing, W7431 County Road K, Arlington WI 53911, Town of Arlington, Columbia County, NW-NE, Sect. 36, T10N, R09E.</p> <p>Beef Nutrition, N551 Ramsey Road, Arlington WI 53911, Town of Leeds, Columbia County, SW-SW, Sect. 30, T10N, R10E.</p> <p>Sheep South, 4857 Meek Road, Arlington WI 53911, Town of Vienna, Dane County, NW-NE, Sect. 01, T09N, R09E.</p> <p>Sheep North, 4857 Meek Road, Arlington WI 53911, Town of Arlington, Columbia County, SW-SE, Sect. 36, T10N, R09E.</p> <p>Swine Facility, N636 County Road I, Arlington WI 53911, Town of Leeds, Columbia County, NW-SW, Sect. 31, T10N, R09E.</p> <p>Bookhout Farm, W7114 Ramsey Road, Arlington WI 53911, Town of Leeds, Columbia County, SE-SW, Sect. 30, T10N, R10E</p>

Receiving Water:	Unnamed tributaries of the Headwaters Yahara River Watershed and groundwaters of the state
Stream Classification:	Yahara River 303d
Discharge T

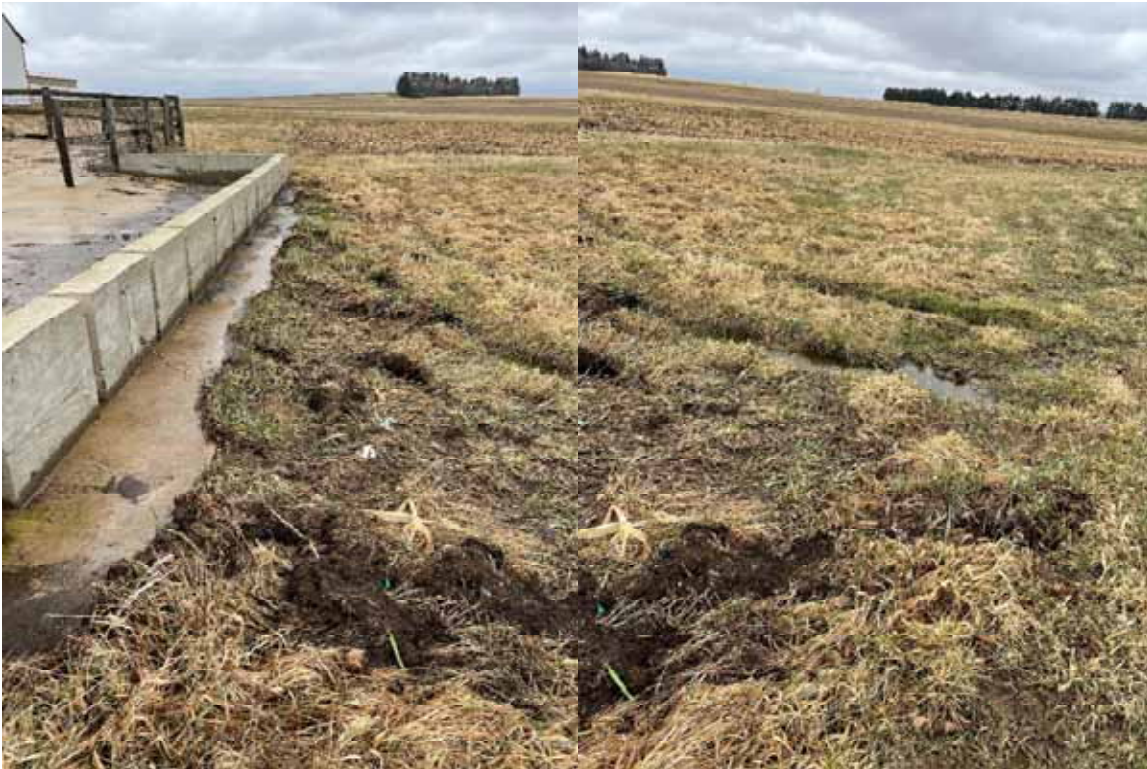
Photo #	89 & 90
Date/Time:	April 5, 2023
Location	UW- Arlington- Bookhout
Photo taken by:	J. Hanrahan

Description: Facing north from the south side of the settling basin for lot 940 and 844. Some channelization and vegetation build up has occurred.

- Finish repairing VTA at Sheep North
- VTA repair at Bookhout Farm prior to populating lots
- Locate as built plans for Swine Facility for WSF #863 under drains

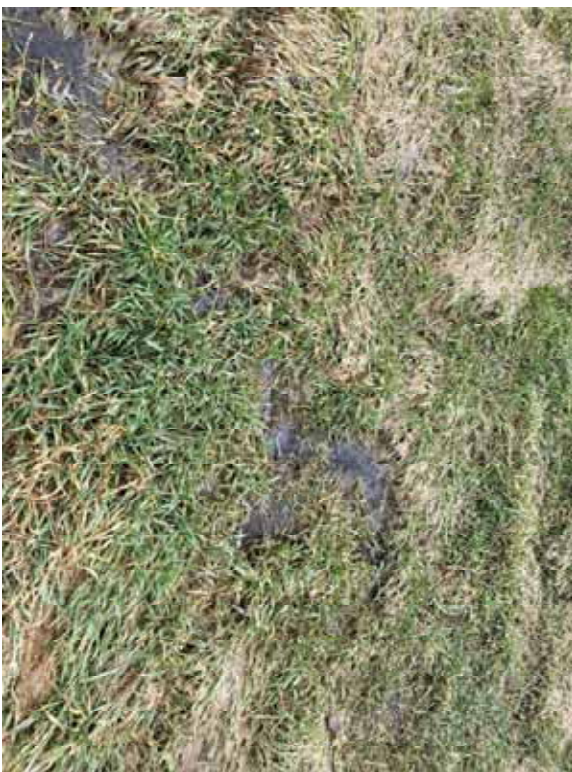
Photo #	91
Date/Time:	April 5, 2023
Location	UW- Arlington- Bookhout
Photo taken by:	J. Hanrahan

Description: Area of concentrated flow paths developing in the beginning of the VTA for Lot 940.

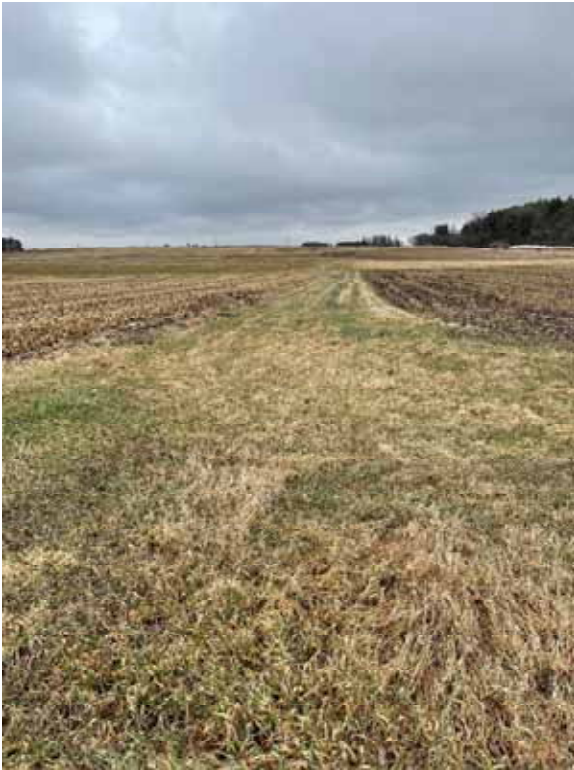
Photo #	92
Date/Time:	April 5, 2023
Location	UW- Arlington- Bookhout
Photo taken by:	E. Struck

Description: Facing east down the VTA for lot 940. Remainder of VTA was in good condition and well maintained.

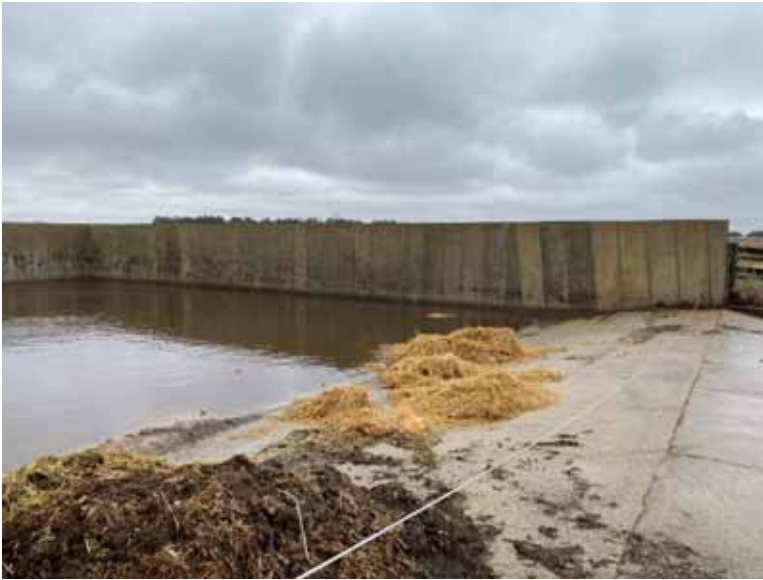
Photo #	93
Date/Time:	April 5, 2023
Location	UW- Arlington- Bookhout
Photo taken by:	J. Hanrahan
Description: Facing northeast at WSF 940

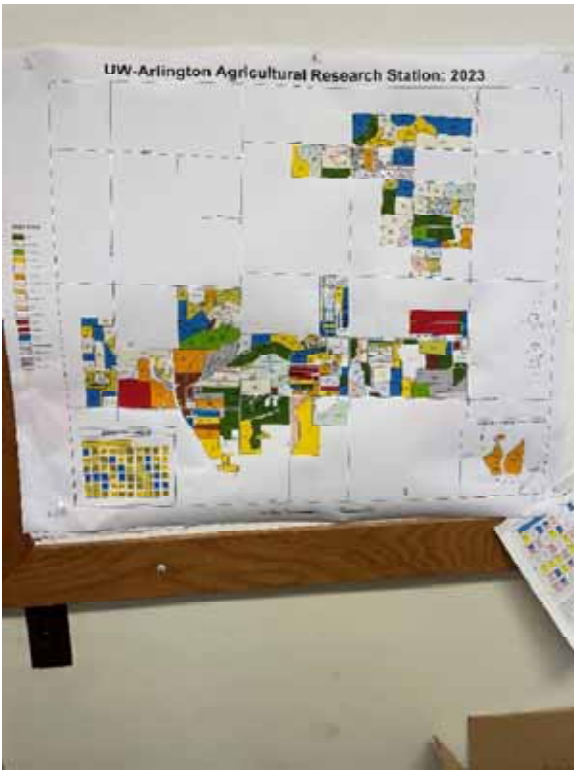
Photo #	100
Date/Time:	April 5, 2023
Location	UW- Arlington -Main Office
Photo taken by:	E. Struck

Description: Copy of UW-Arlington's nutrient management plan.
