## **Upper East Twin River Trout Survey-2009**

Steve Hogler and Steve Surendonk  
WDNR-Mishicot, WI.

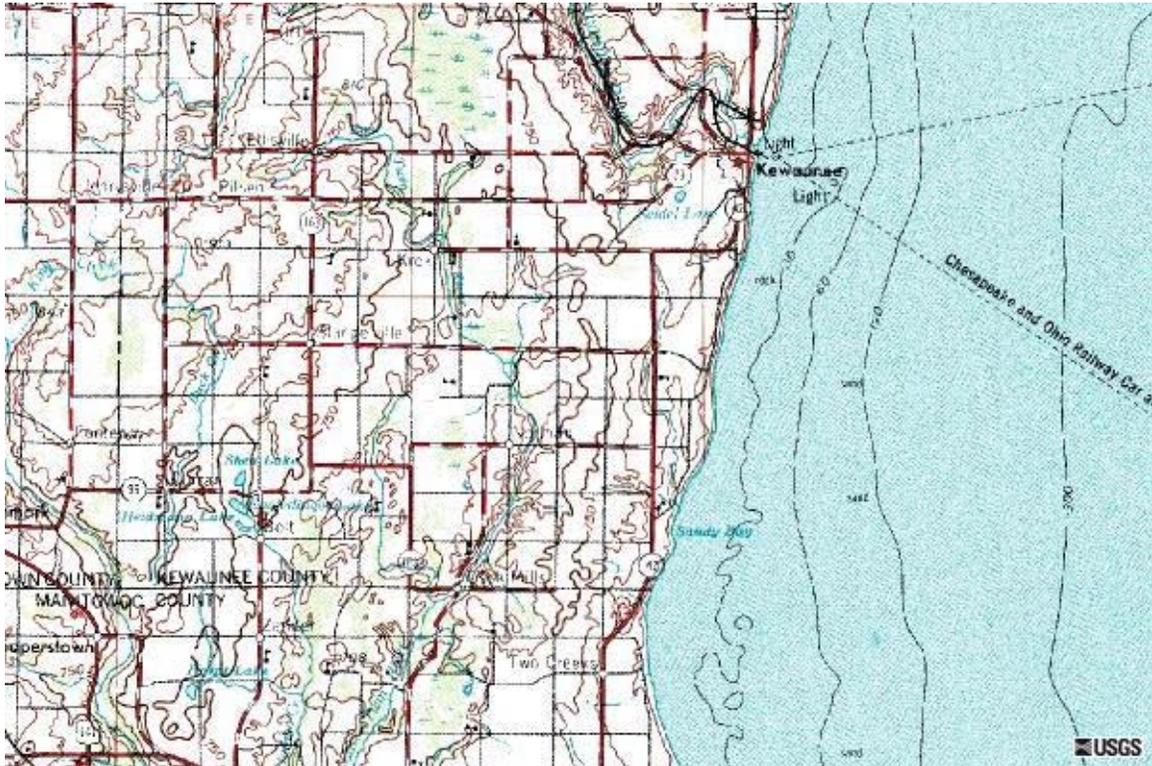
The three survey sites that were selected on the East Twin River were upstream of Townline Road, at Krok Road and upstream of County Highway J (Figure 2). The Townline Road site was located in the Class 1 section of the East Twin River and other two sites were located in the Class 2 section of the river. The Townline and HWY J sites were also sampled during the 2001 survey (Hogler and Cahow 2002). The site on Krok Creek was upstream of Highway 29 and the site on Tisch Mills Creek was upstream of County Highway BB. Both of these sites were also sampled in 2001.

**Figure 2. Trout sampling locations on the East Twin River, Tisch Mills Creek and Krok Creek surveyed in 2009. Site 1 is upstream of Townline Road, site 2 is at Krok Road, site 3 is upstream of HWY J, site 4 is Krok Creek upstream of Highway 29 and site 5 is on Tisch Mills Creek upstream of County Highway BB.**

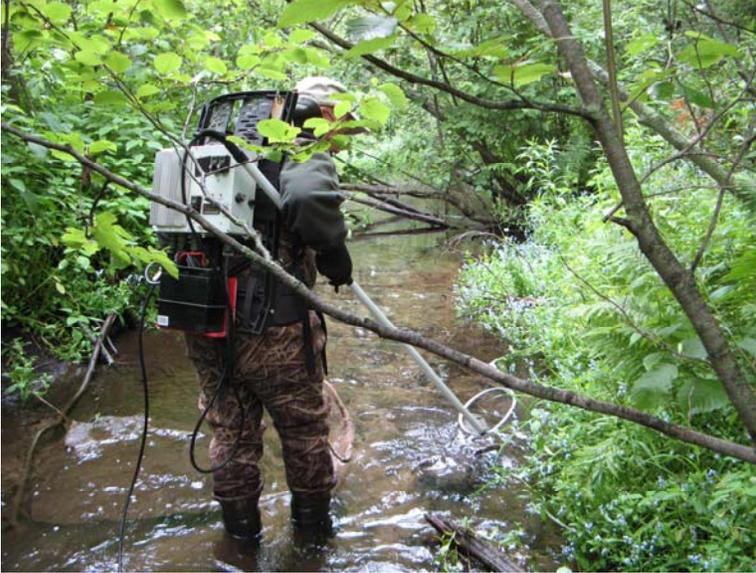
The site at Townline Road was located upstream of the road and ran for 150 meters. At this location the East Twin River is a 3<sup>rd</sup> order stream with a gradient of 1.15 meters per kilometer and a sinuosity of 1.45:1. The surveyed section of river ran through mainly a shrub-woodland landscape (Figure 3).

**Figure 3. Fisheries staff member using a backpack shocker upstream of Townline Road on the East Twin River. At this location the stream is well buffered and runs through a shrub-woodland complex.**

The East Twin River above Townline Road was surveyed in 2001 and 2009 and habitat was assessed during both survey years. Habitat in this section of the East Twin River appears to be good with some limited changes noted between the survey years. In 2001 fine sediments were found near areas of bank erosion while in 2009, fine sediment coverage was more extensive. Fine sediment did not appear to be local in nature and likely came from upstream river sections although we did note in 2001 and 2009 several areas of erosion near the upstream end of the survey site.

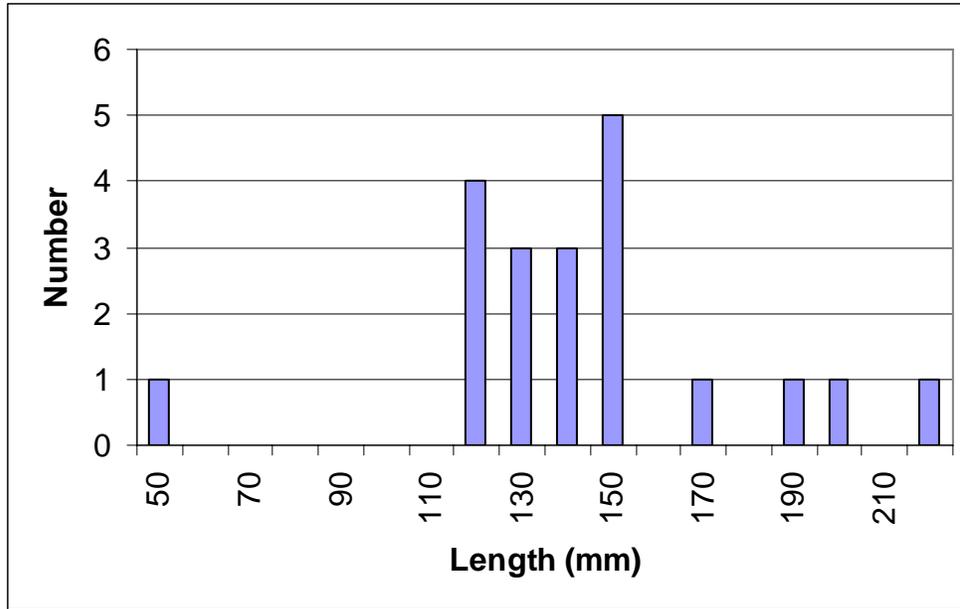
Mottled sculpin dominated the catch followed by central mudminnow and brook trout. The twenty brook trout ranged in length from 55 mm to 220 mm in length with an average length of 147 mm. Nine of twenty (45%) captured brook trout were greater than 150 mm, three of twenty (15%) were greater than the 178 mm size limit and two of twenty (10%) were greater than 200 mm in length. It appears from length frequency analysis that at least two age classes of brook trout were present in our sample (Figure 4). Brook trout CPE was 13.4 per 100 meters shocked.

**Figure 4. Brook trout length frequency of fish captured and measured during electroshocking at Townline Road.**

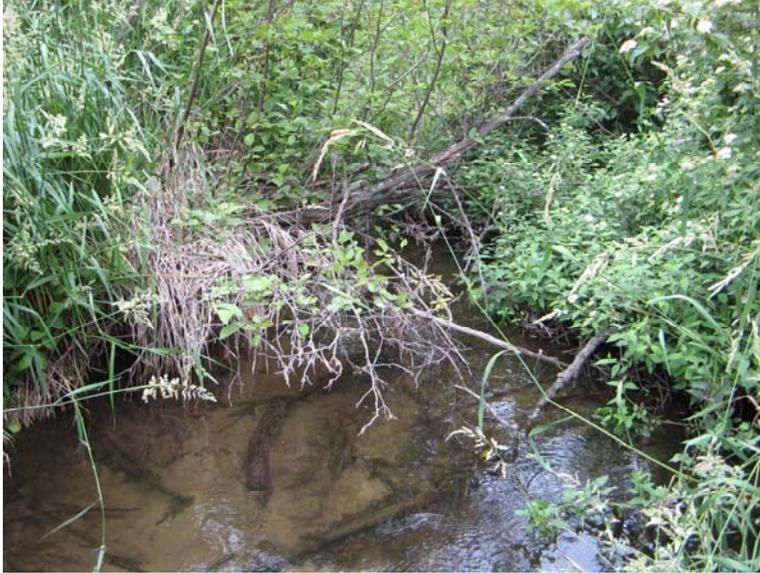
The site at Krok Road was located between Church Road and Townline Road where the river crosses into the ditch line of the road (starting location N44.42909, W-87.63942). At this location the East Twin River is a 3<sup>rd</sup> order stream with a gradient of 1.13 meters per kilometer and a sinuosity of 1.85:1. The river at this location runs through a grassland-shrub complex (Figure 5).

**Figure 5. This photo looks upstream at the East Twin River near Krok Road.**

Following shocking, staff evaluated stream habitat using the qualitative habitat scoring sheet. At this location the river had high rankings for limited bank erosion and low rankings for shallow depth and extensive fine sediment coverage. Overall the stream at this location scored 47 points indicating fair qualitative habitat.

Habitat in the survey site near Krok Road was rated fair. This section of river had very monotonous habitat with few bends, no riffles, shallow water and extensive fine sediment coverage. This site was not surveyed in 2001 so we can not determine if a change has occurred since 2001.

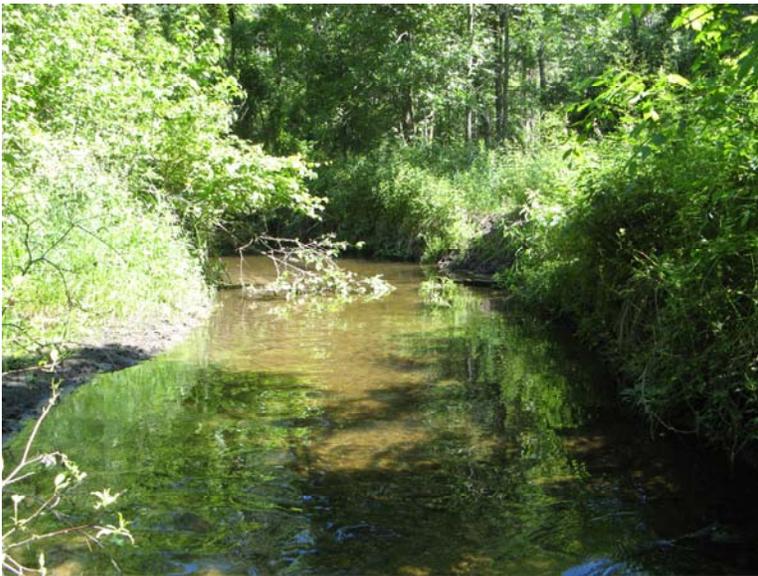
The East Twin River at this location is a 3<sup>rd</sup> order stream that has a gradient of 0.53 meters per kilometer and a sinuosity of 1.87:1. The lower portion of the site appears to have been channelized to allow for easier passage under HWY J. This site is characterized as following through a woodland complex that contains a mixture of tree species (Figure 6).

**Figure 6. Looking upstream at the East Twin River at HWY J as it flows through woodland complex.**

Following shocking, staff evaluated stream habitat using the qualitative habitat scoring sheet. At this location the river had high rankings for buffers, limited erosion and fish cover and lower rankings for depth and extensive fine sediment coverage and limited habitat diversity. Overall the stream at this location scored 53 points indicating good qualitative habitat.

Habitat at HWY J also appeared to be good although more sediment was noted in 2009 than in 2001. Lower sections of this location appear to have been straightened when the culvert under HWY J was last replaced. Stream straightening homogenizes habitat reducing the diverse habitat needed by fish.

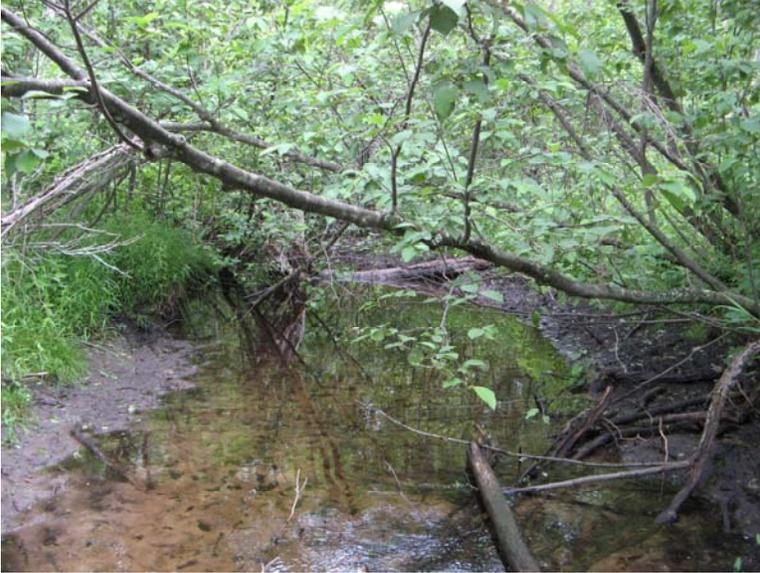
Krok Creek upstream of HWY 29 is a second order stream that has a gradient of 0.92 meters per kilometer and a sinuosity of 1.18:1. The stream flows through a thick cover of tag alder and has a perched culvert about 80 meters upstream of HWY 29 (Figure 7).

**Figure 7. Looking upstream on Krok Creek at the dense tag alder cover that was common throughout the survey site.**

Following shocking, staff evaluated stream habitat using the qualitative habitat scoring sheet. At this location the river had high rankings for buffers width and low rankings for depth, extensive fine sediment coverage and limited habitat diversity. Overall the stream at this location scored 28 points indicating fair qualitative habitat.

Although Krok Creek had a fair habitat ranking for habitat in both 2001 and 2009 we considered the habitat poor and not conducive for trout. Surveys in both years noted overgrown tag alder, shallow water, sand dominated sediments and a perched culvert all of which contribute to our belief trout populations would be limited in this river section. However, since water temperatures are cool, a coldwater community consisting of forage species could exist in Krok Creek above Highway 29 in the habitat that currently exists. It is possible with habitat work a small brook trout population could become established at this location.

- Determine the feasibility of stream improvements on Krok Creek to improve brook trout populations. Work with Kewaunee County and adjacent landowners to remove the perched culvert on Krok Creek.

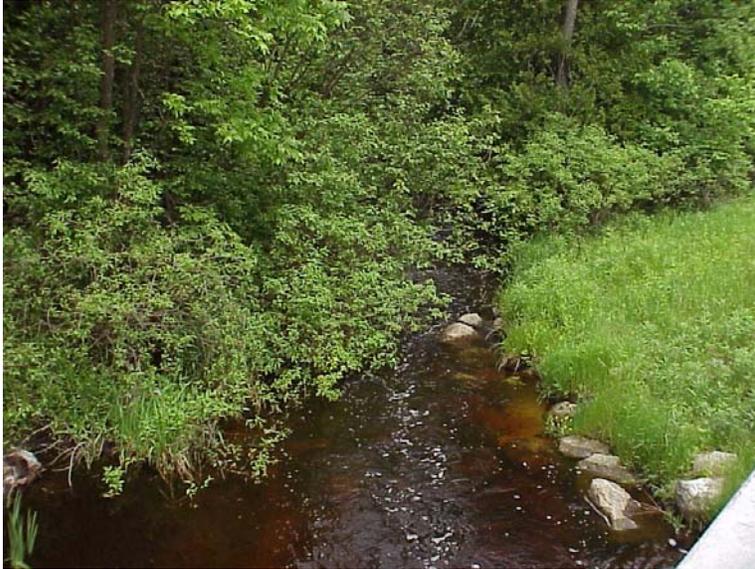
Upstream of Highway BB Tisch Mills Creek is a 1<sup>st</sup> order stream with a gradient of 1.2 meters per kilometer and a sinuosity of 1.5:1. Tisch Mills Creek at this location runs through mostly woodland with some grassland and shrub cover present (Figure 8).

**Figure 8. Looking upstream at Tisch Mills Creek from the County Highway BB bridge.**

Despite the lack of direct comparisons, Tisch Mills Creek appears to have the "best" trout habitat based on both surveys with very little change observed between the two surveys. Habitat was diverse consisting of a mix of runs, riffles and pools, fish cover types and there was little fine sediment in the surveyed section of river.

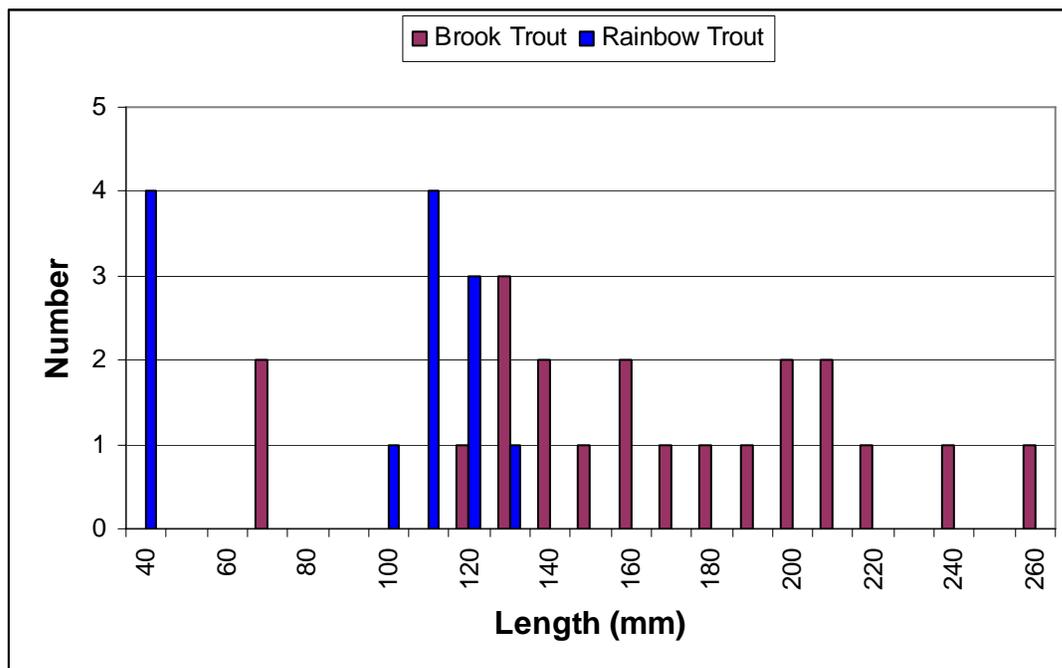
During shocking we captured 21 brook trout and 13 rainbow trout. The brook trout ranged in length from 74 mm to 260 mm and had an average length of 169 mm. Thirteen of twenty-one (61.9%) captured brook trout were greater than 150 mm in length, 9 of 21 (42.9%) were greater than 178 mm size minimum and 7 of 21 (33.0%) were greater than 200 mm in length. The rainbow trout ranged in

length from 41 mm to 135 mm and had an average length of 95 mm. All captured rainbow trout were less than 150 mm in length. Based on the distribution of length, it appears that we captured at least three classes of brook trout including young of year and 2 year classes of rainbow trout including young of year (Figure 9). Brook trout CPE at this location was 6.93 per 100 meters shocked and the rainbow trout CPE was 4.29 per 100 meters shocked.

**Figure 9. The length distribution of brook and rainbow trout captured by backpack shocking on Tisch Mills Creek.**
