Willow River State Park Little Falls Dam Final Alternatives Analysis

State of Wisconsin
DEPARTMENT OF NATURAL RESOURCES
February 2016

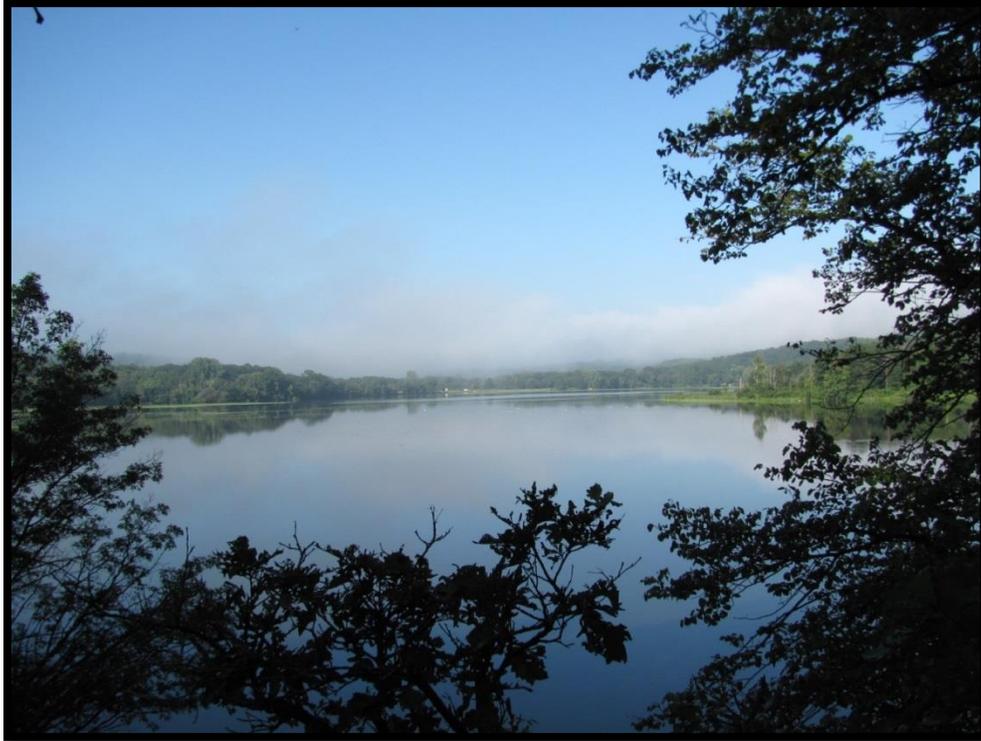
Little Falls Lake has collected sediment over time. Over one-third of the lake is less than three feet deep. Immediately upstream of the dam is the deepest area of the impoundment. Depths decrease further to the east where the Willow River enters the flowage. This is due to years of sediment transport from the larger watershed collecting in what was a series of impoundments. There was a significant delivery of sediment to Little Falls Lake when the Willow Falls dam flowage was drawn down for emergency

repairs. More sediment moved in as a result of the draw down and ultimate removals of the Willow Falls and Mounds dams. Much of this sediment collected at the headwater of the lake on the east end.

Photo 3: View of Little Falls Lake

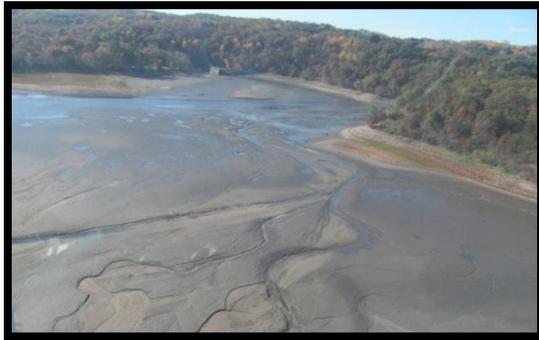
The initial drawdown exposed open mudflat habitat that was used temporarily by migratory shorebirds. As the drawdown progressed, the reduced amount of surface water

concentrated aquatic invertebrates and fish creating excellent foraging opportunities for wading birds including; waterfowl, kingfisher, grebes, and herons. Once the lake bed dries out, these mudflats will quickly vegetate by various types of plants.

Photo 6: Looking west toward dam

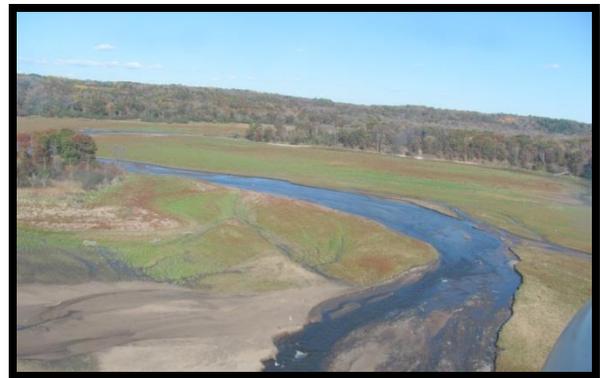
Photo 7: Looking east of Little Falls Dam. Note the contrast between areas exposed after initial drawdown compared to areas more recently exposed after breach.
