Little Falls Dam

Reconstruction Pre-Design Feasibility Study

Prepared for:

**Wisconsin Department of Administration
Madison, WI**

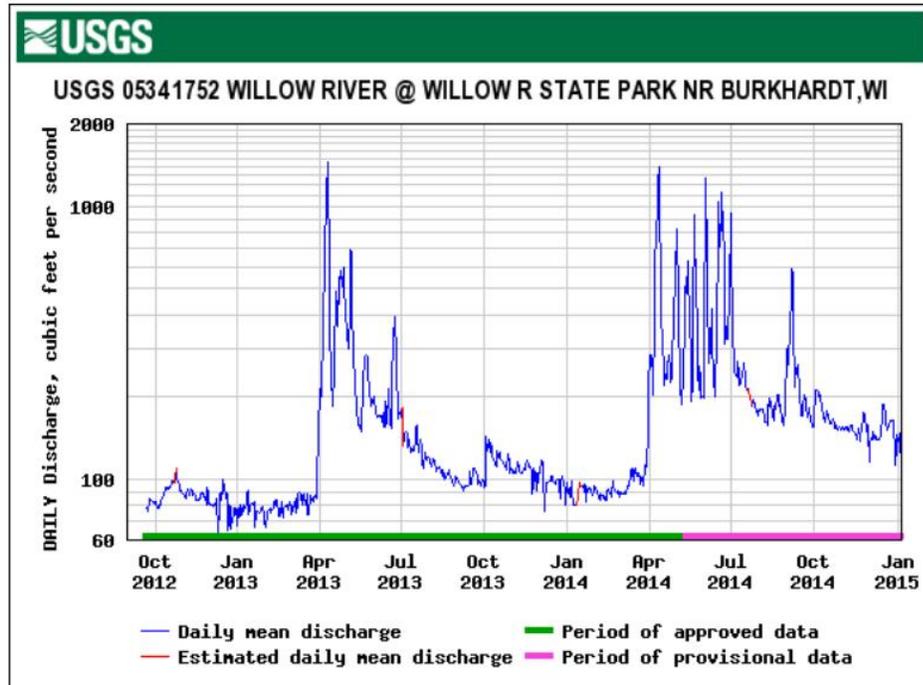
Figure 2 – USGS Gage Data

The base flow for the Willow River at the Little Falls Dam is between 100 and 200 cfs. This information is based on the flow data available from USGS Gage 05341753 Willow River @ Willow River State Park NR Burkhardt, WI see Figure 2. Note that 2012 was a draught year and we did not include that in our estimate of base flow.

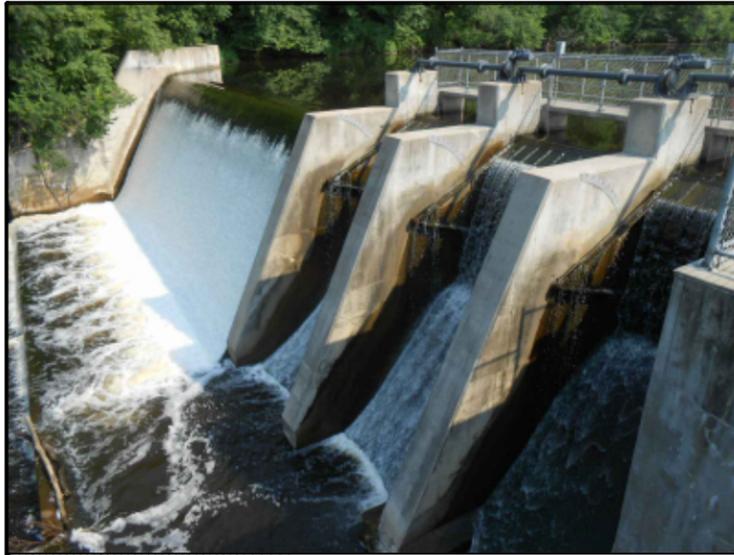
1 DOWNSTREAM PHOTO OF RIGHT SIDE OF DAM
NTS

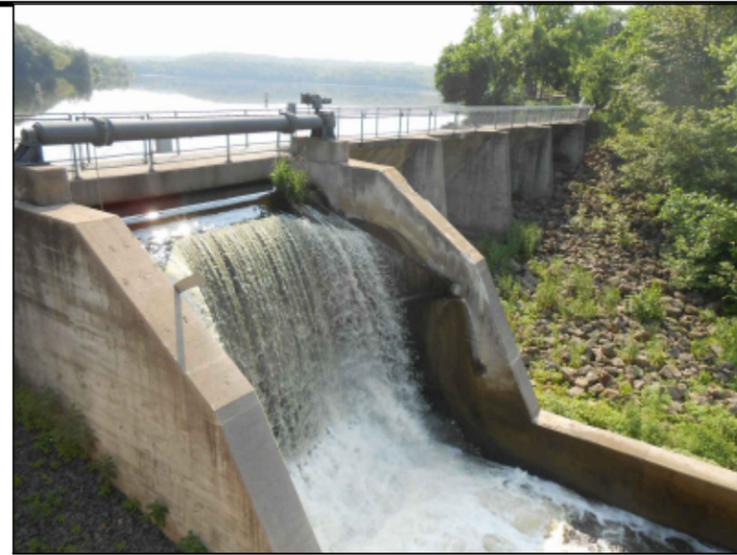
2 DOWNSTREAM PHOTO OF LEFT SIDE OF DAM
NTS

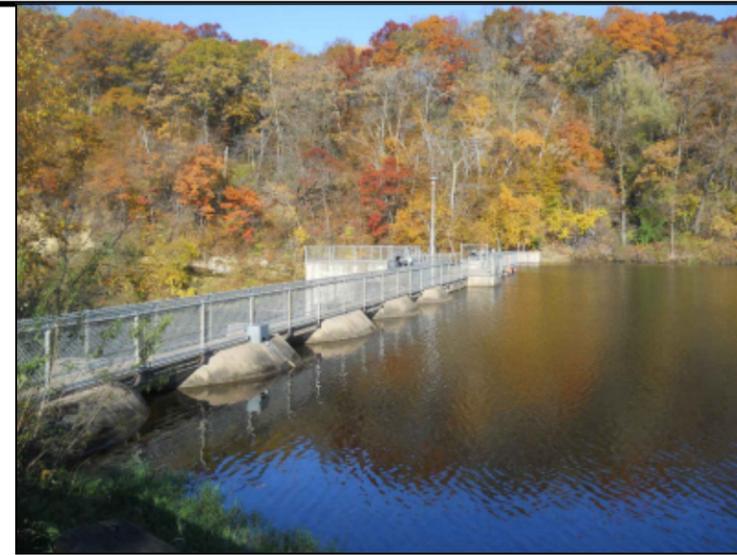
3 UPSTREAM PHOTO OF DAM
NTS

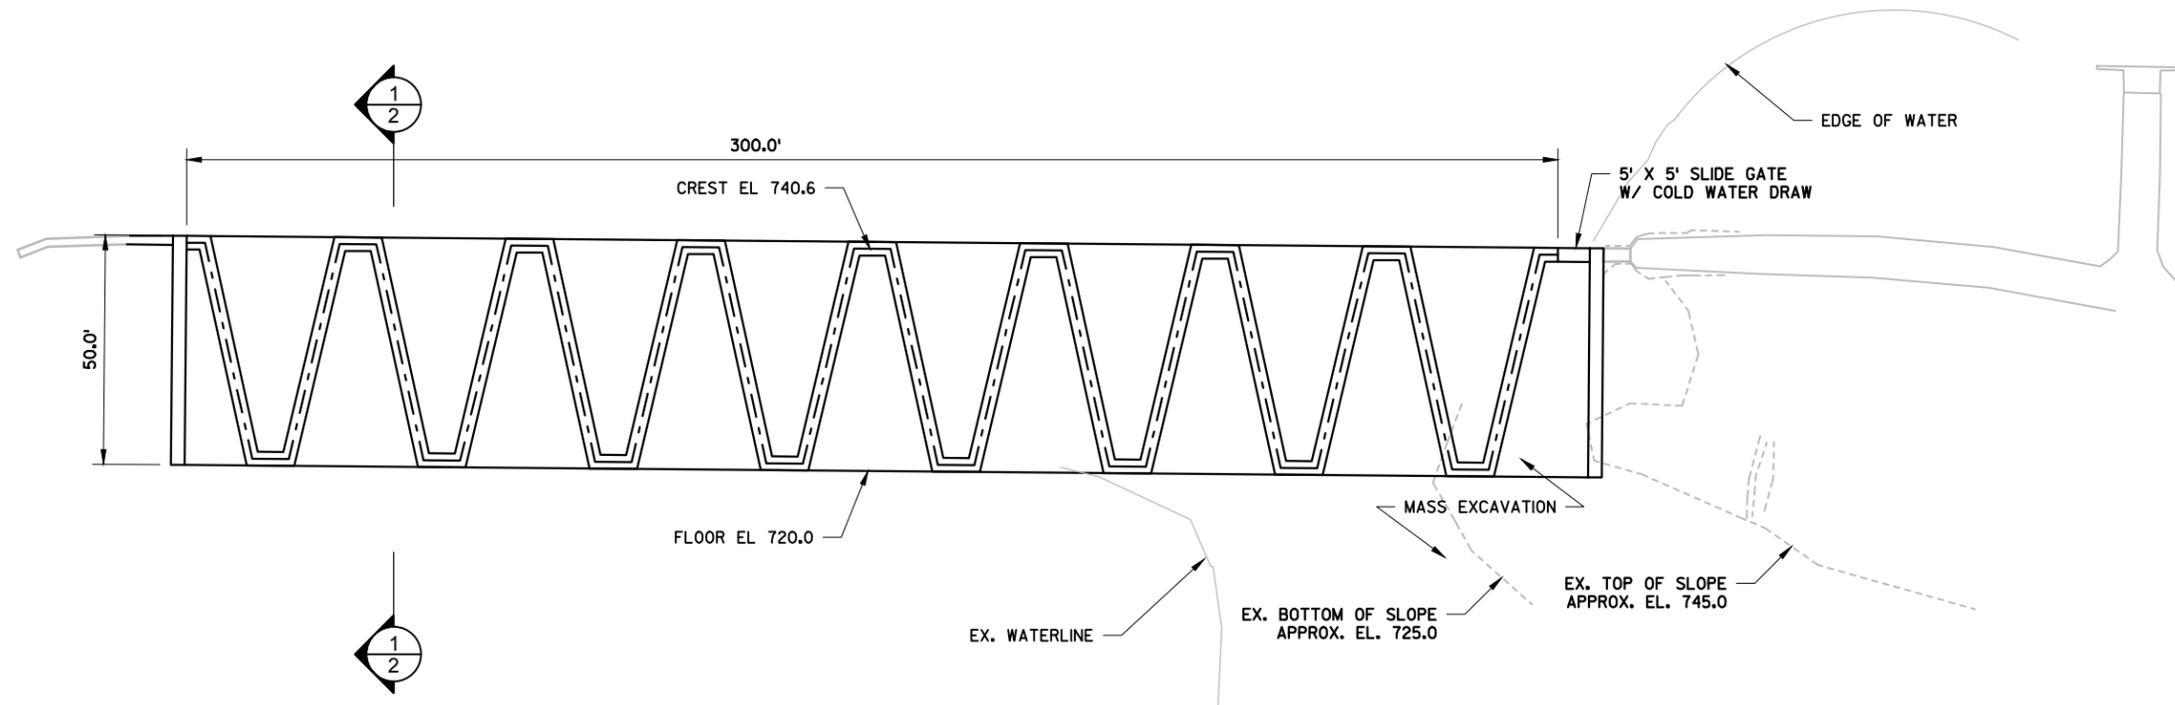
ALTERNATIVE #1 - PLAN VIEW

- REPLACE EXISTING DAM WITH LABYRINTH SPILLWAY.
- INSTALL 5'x5' LOW LEVEL OUTLET GATE WITH COLD WATER DRAW AT LEFT ABUTMENT.

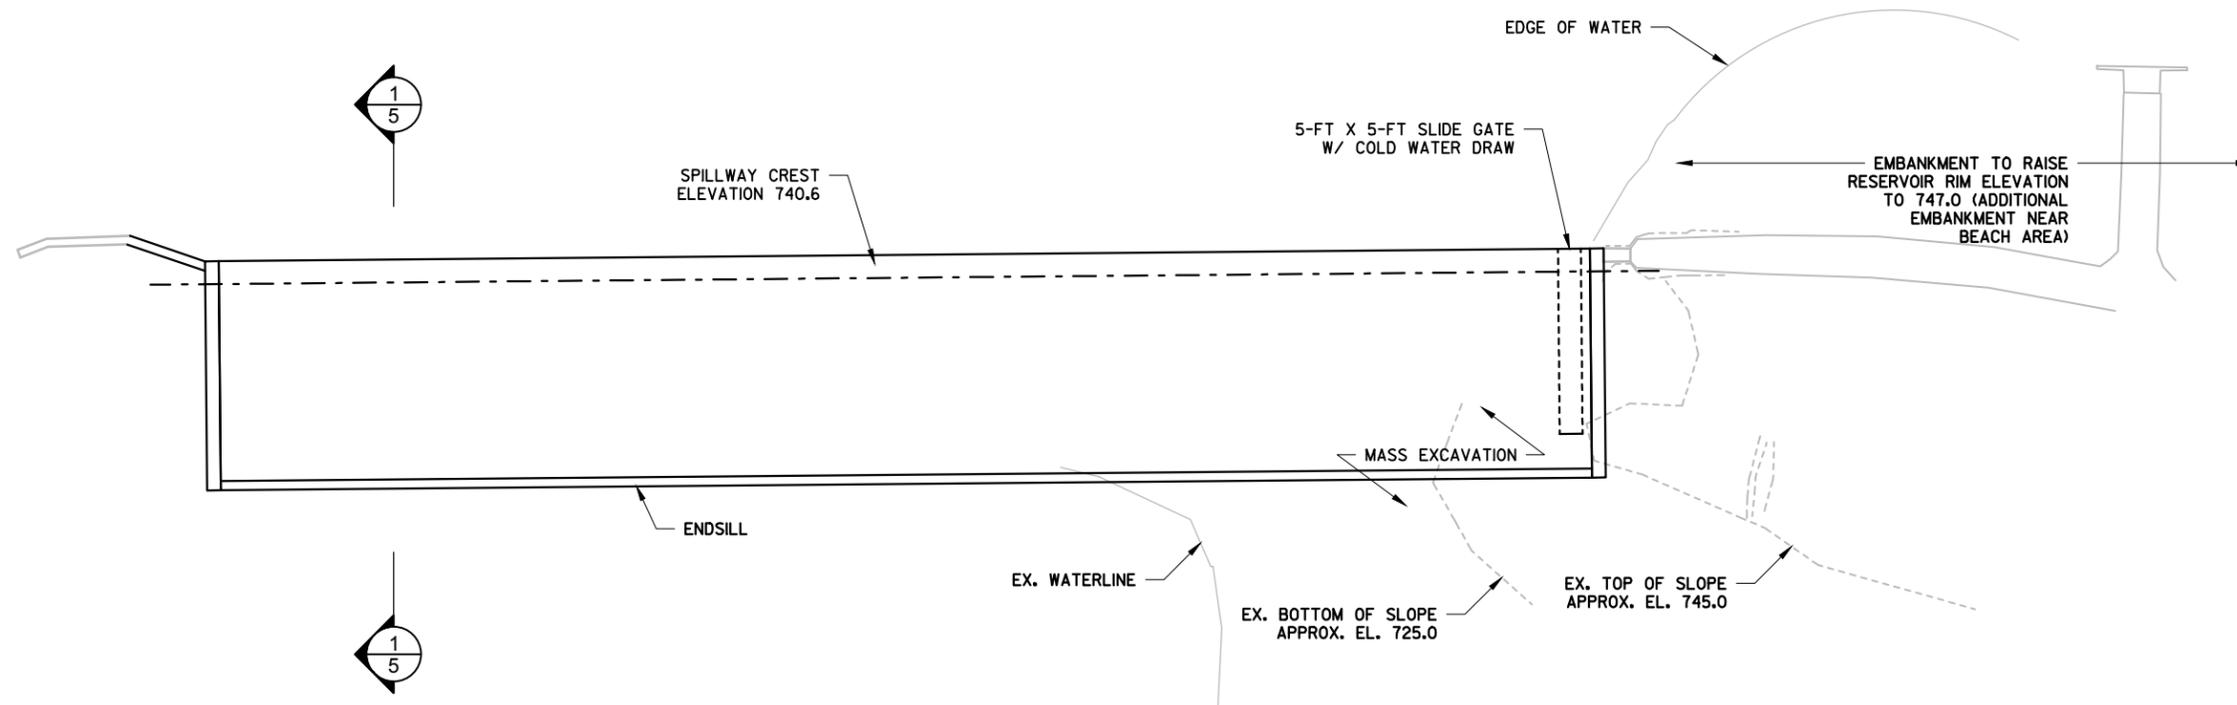
ALTERNATIVE #2 - PLAN VIEW

- REPLACE EXISTING DAM WITH 300-FT LONG FIXED CREST SPILLWAY AT ELEVATION 740.6.
- INSTALL 5'x5' LOW LEVEL OUTLET GATE WITH COLD WATER DRAW AT LEFT ABUTMENT.
- APPROX. 1500-LF OF 4-FT TALL EMBANKMENT REQUIRED AT LOW POINTS AROUND RESERVOIR TO RAISE RIM ELEVATION.

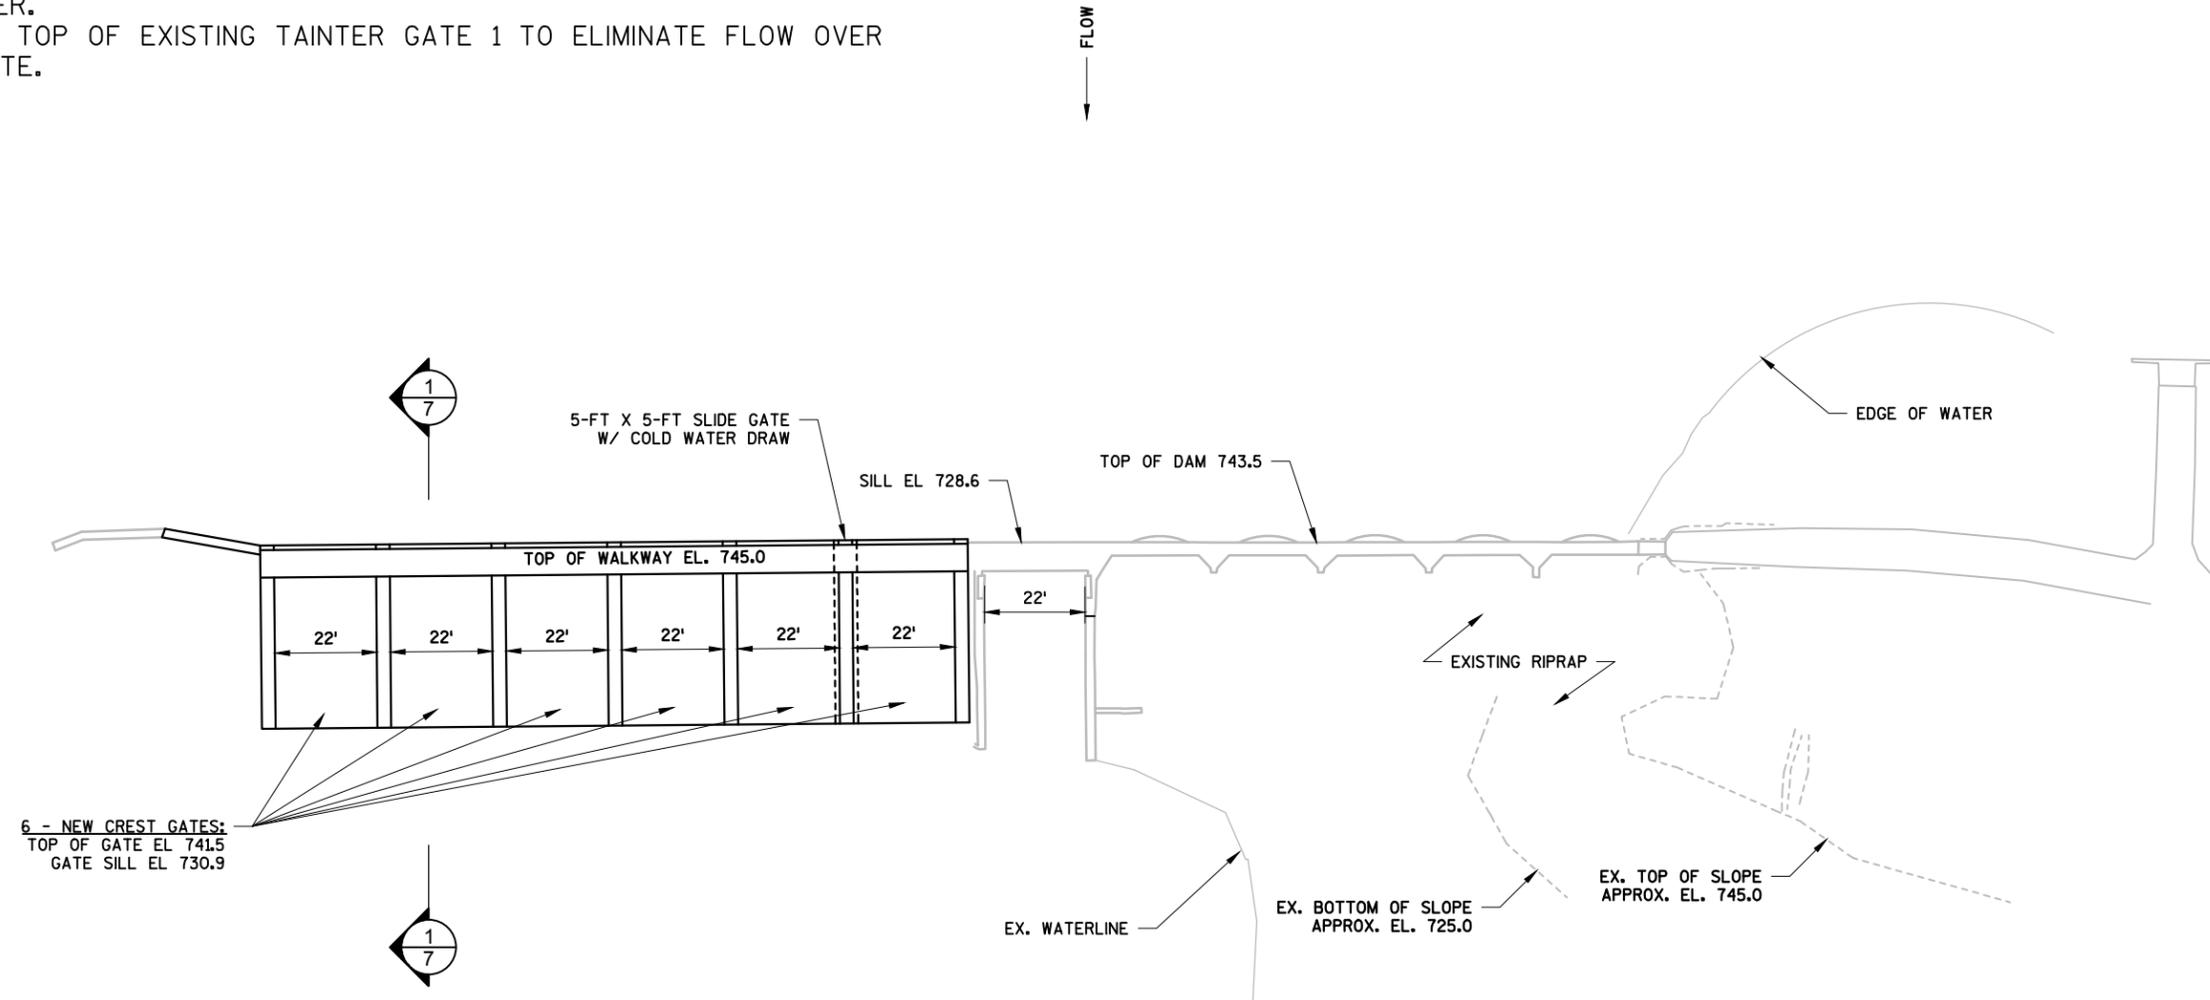
ALTERNATIVE #3 - PLAN VIEW

- REPLACE EXISTING OVERFLOW SPILLWAY, TANTER GATES 2-4, AND POWERHOUSE WITH 6 NEW HYDRAULIC OPERATED CREST GATES.
- EXISTING TANTER GATE 1 AND ARCH BUTTRESS SECTION TO REMAIN AS EXISTING.
- INSTALL NEW COLD WATER DRAW CONSTRUCTED THROUGH GATE SILL/PIER.
- EXTEND TOP OF EXISTING TANTER GATE 1 TO ELIMINATE FLOW OVER THE GATE.

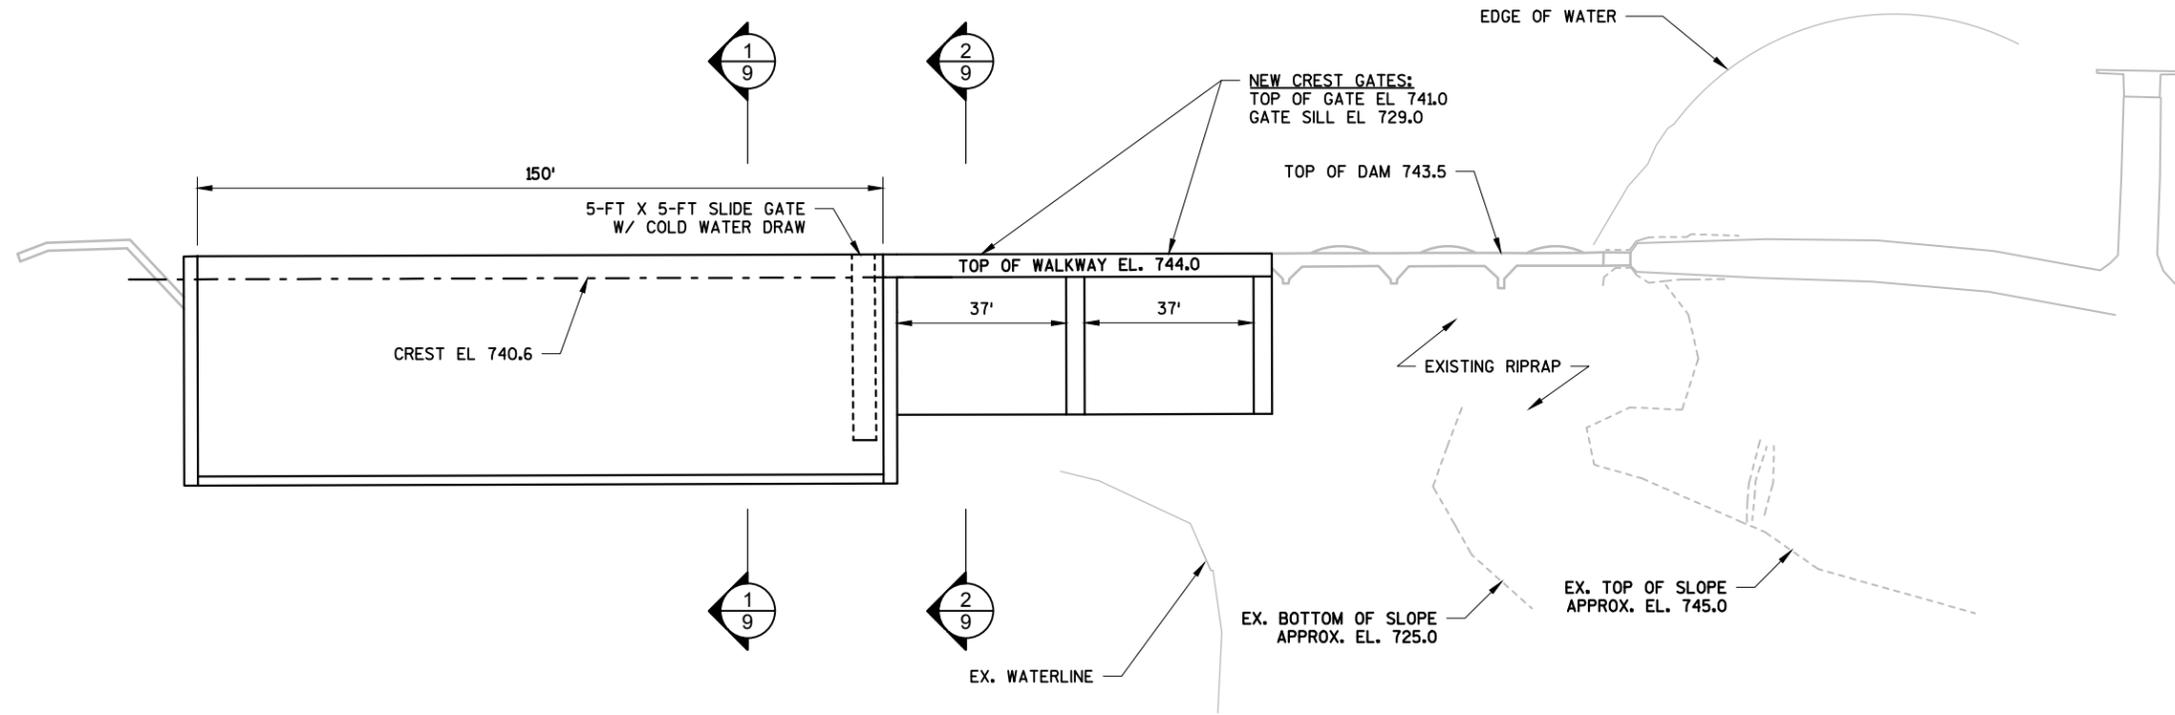
ALTERNATIVE #4 - PLAN VIEW

- REPLACE THE OVERFLOW SPILLWAY, GATES 2-4, POWERHOUSE, GATE 1, AND A PORTION OF THE ARCH BUTTRESS SECTION WITH 150-FT OVERFLOW SPILLWAY AND 2 CREST GATES.
- CREST GATES ARE 37-FT WIDE X 12-FT TALL.
- INSTALL 5'x5' LOW LEVEL OUTLET GATE WITH COLD WATER DRAW AT LEFT ABUTMENT OF OVERFLOW SECTION.

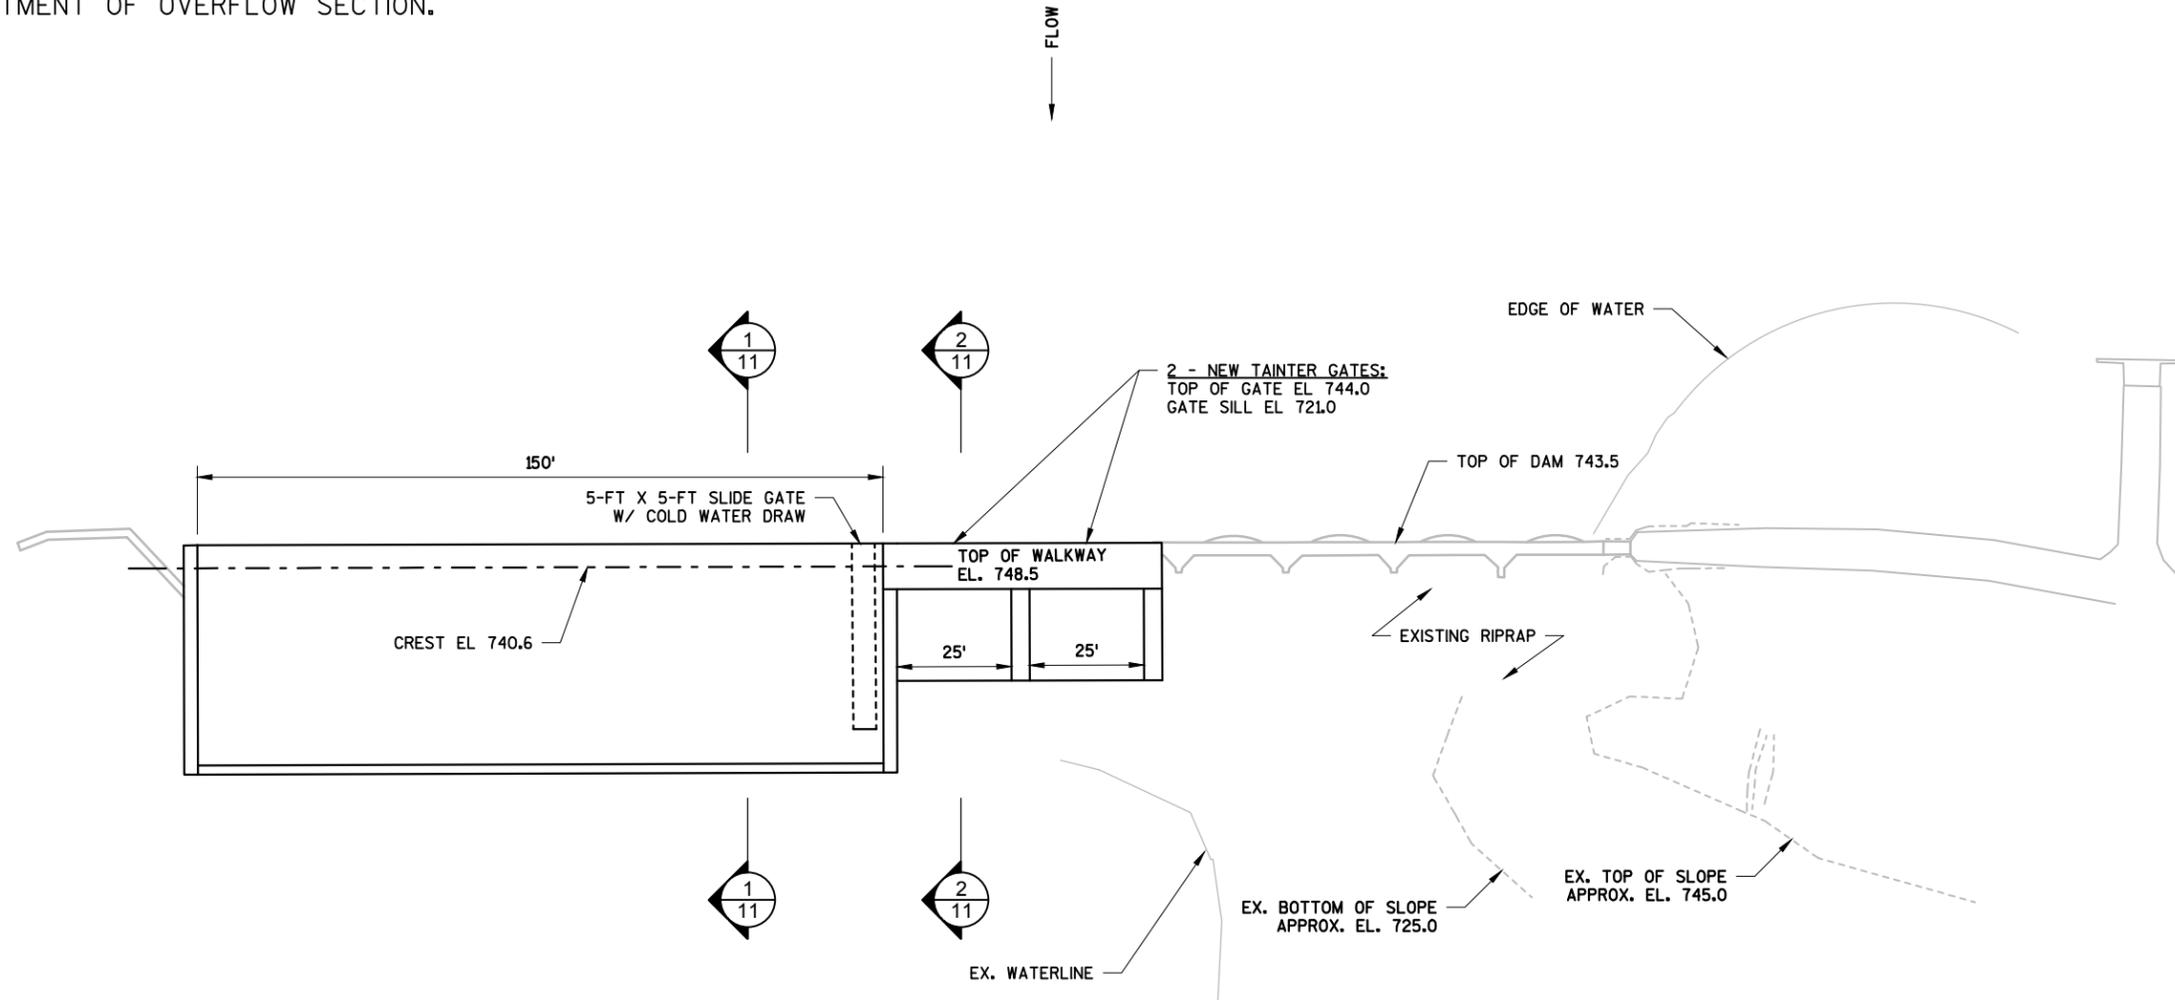
ALTERNATIVE #5 - PLAN VIEW

- REPLACE OVERFLOW SPILLWAY, GATES 2-4, POWERHOUSE, GATE 1, AND A PORTION OF THE ARCH BUTTRESS SECTION WITH 150-FT OVERFLOW SPILLWAY AND 2 TANTER GATES.
- TANTER GATES ARE 25-FT WIDE X 25-FT TALL.
- INSTALL 5'x5' LOW LEVEL OUTLET GATE WITH COLD WATER DRAW AT LEFT ABUTMENT OF OVERFLOW SECTION.

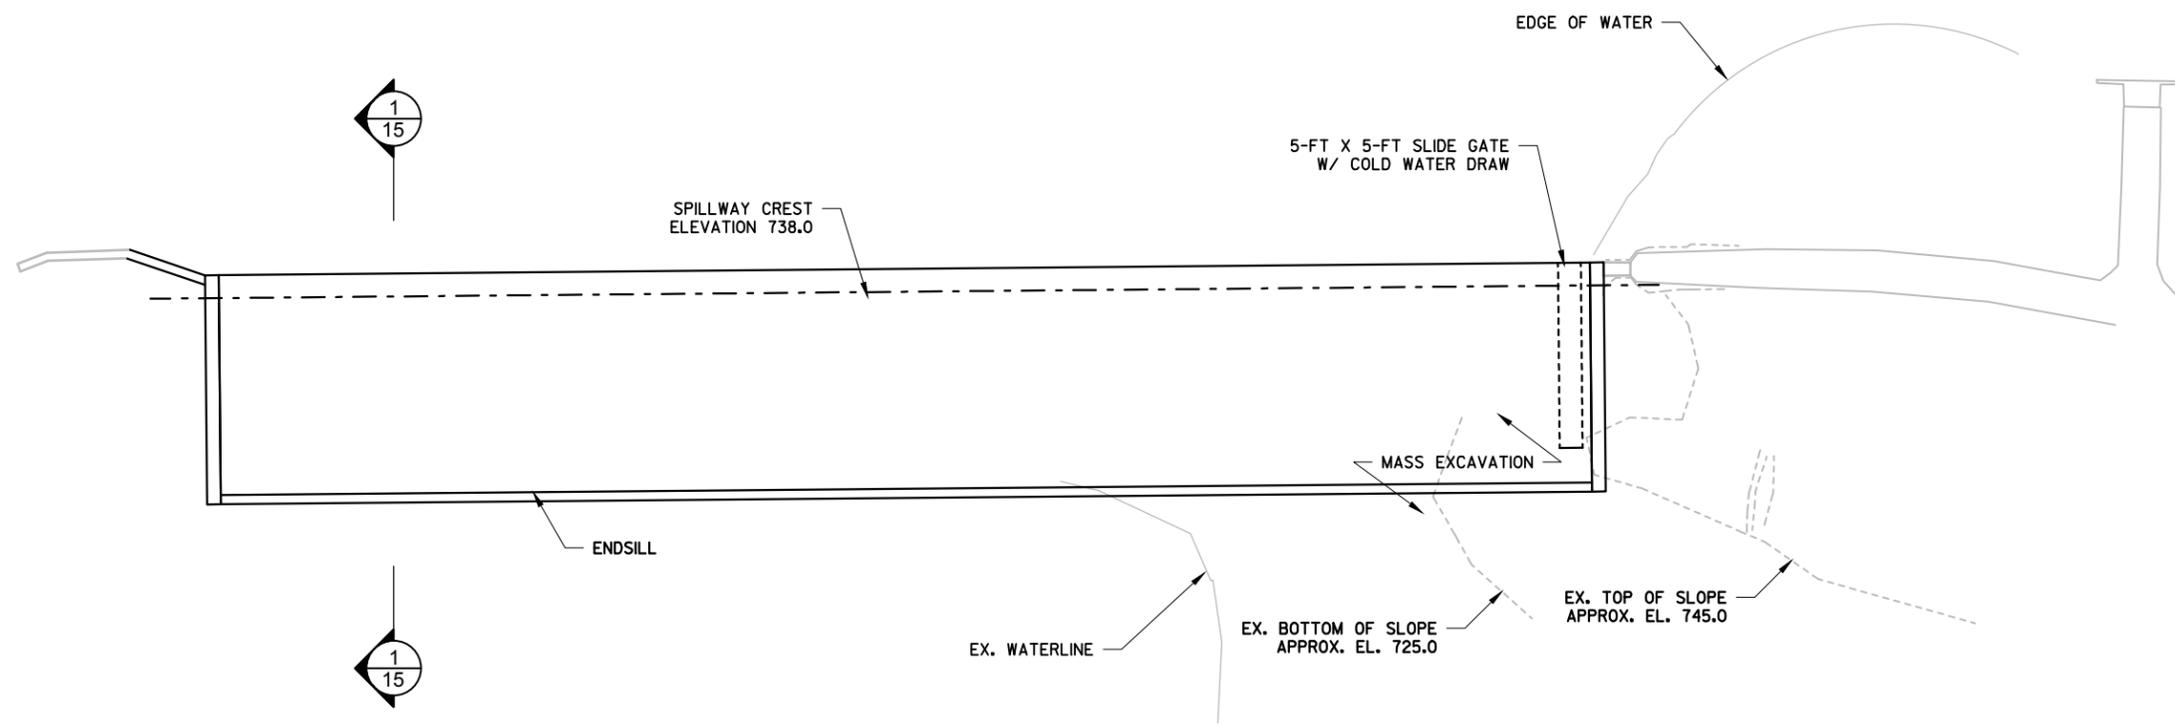
ALTERNATIVE #7 - PLAN VIEW

- REPLACE EXISTING DAM WITH 300-FT LONG FIXED CREST SPILLWAY AT ELEVATION 738.0.
- INSTALL 5'x5' LOW LEVEL OUTLET GATE WITH COLD WATER DRAW AT LEFT ABUTMENT.

g. Alternative #7 – Replace the existing dam with a lower fixed crest ogee spillway 2.5 feet below the normal pool elevation.

The total flow through the Little Falls Dam if this alternative were to be selected would be 17,058 cfs. The hydraulic calculations for this alternative can be found in Appendix D. The opinion of estimated cost for this alternative is \$6,500,000.

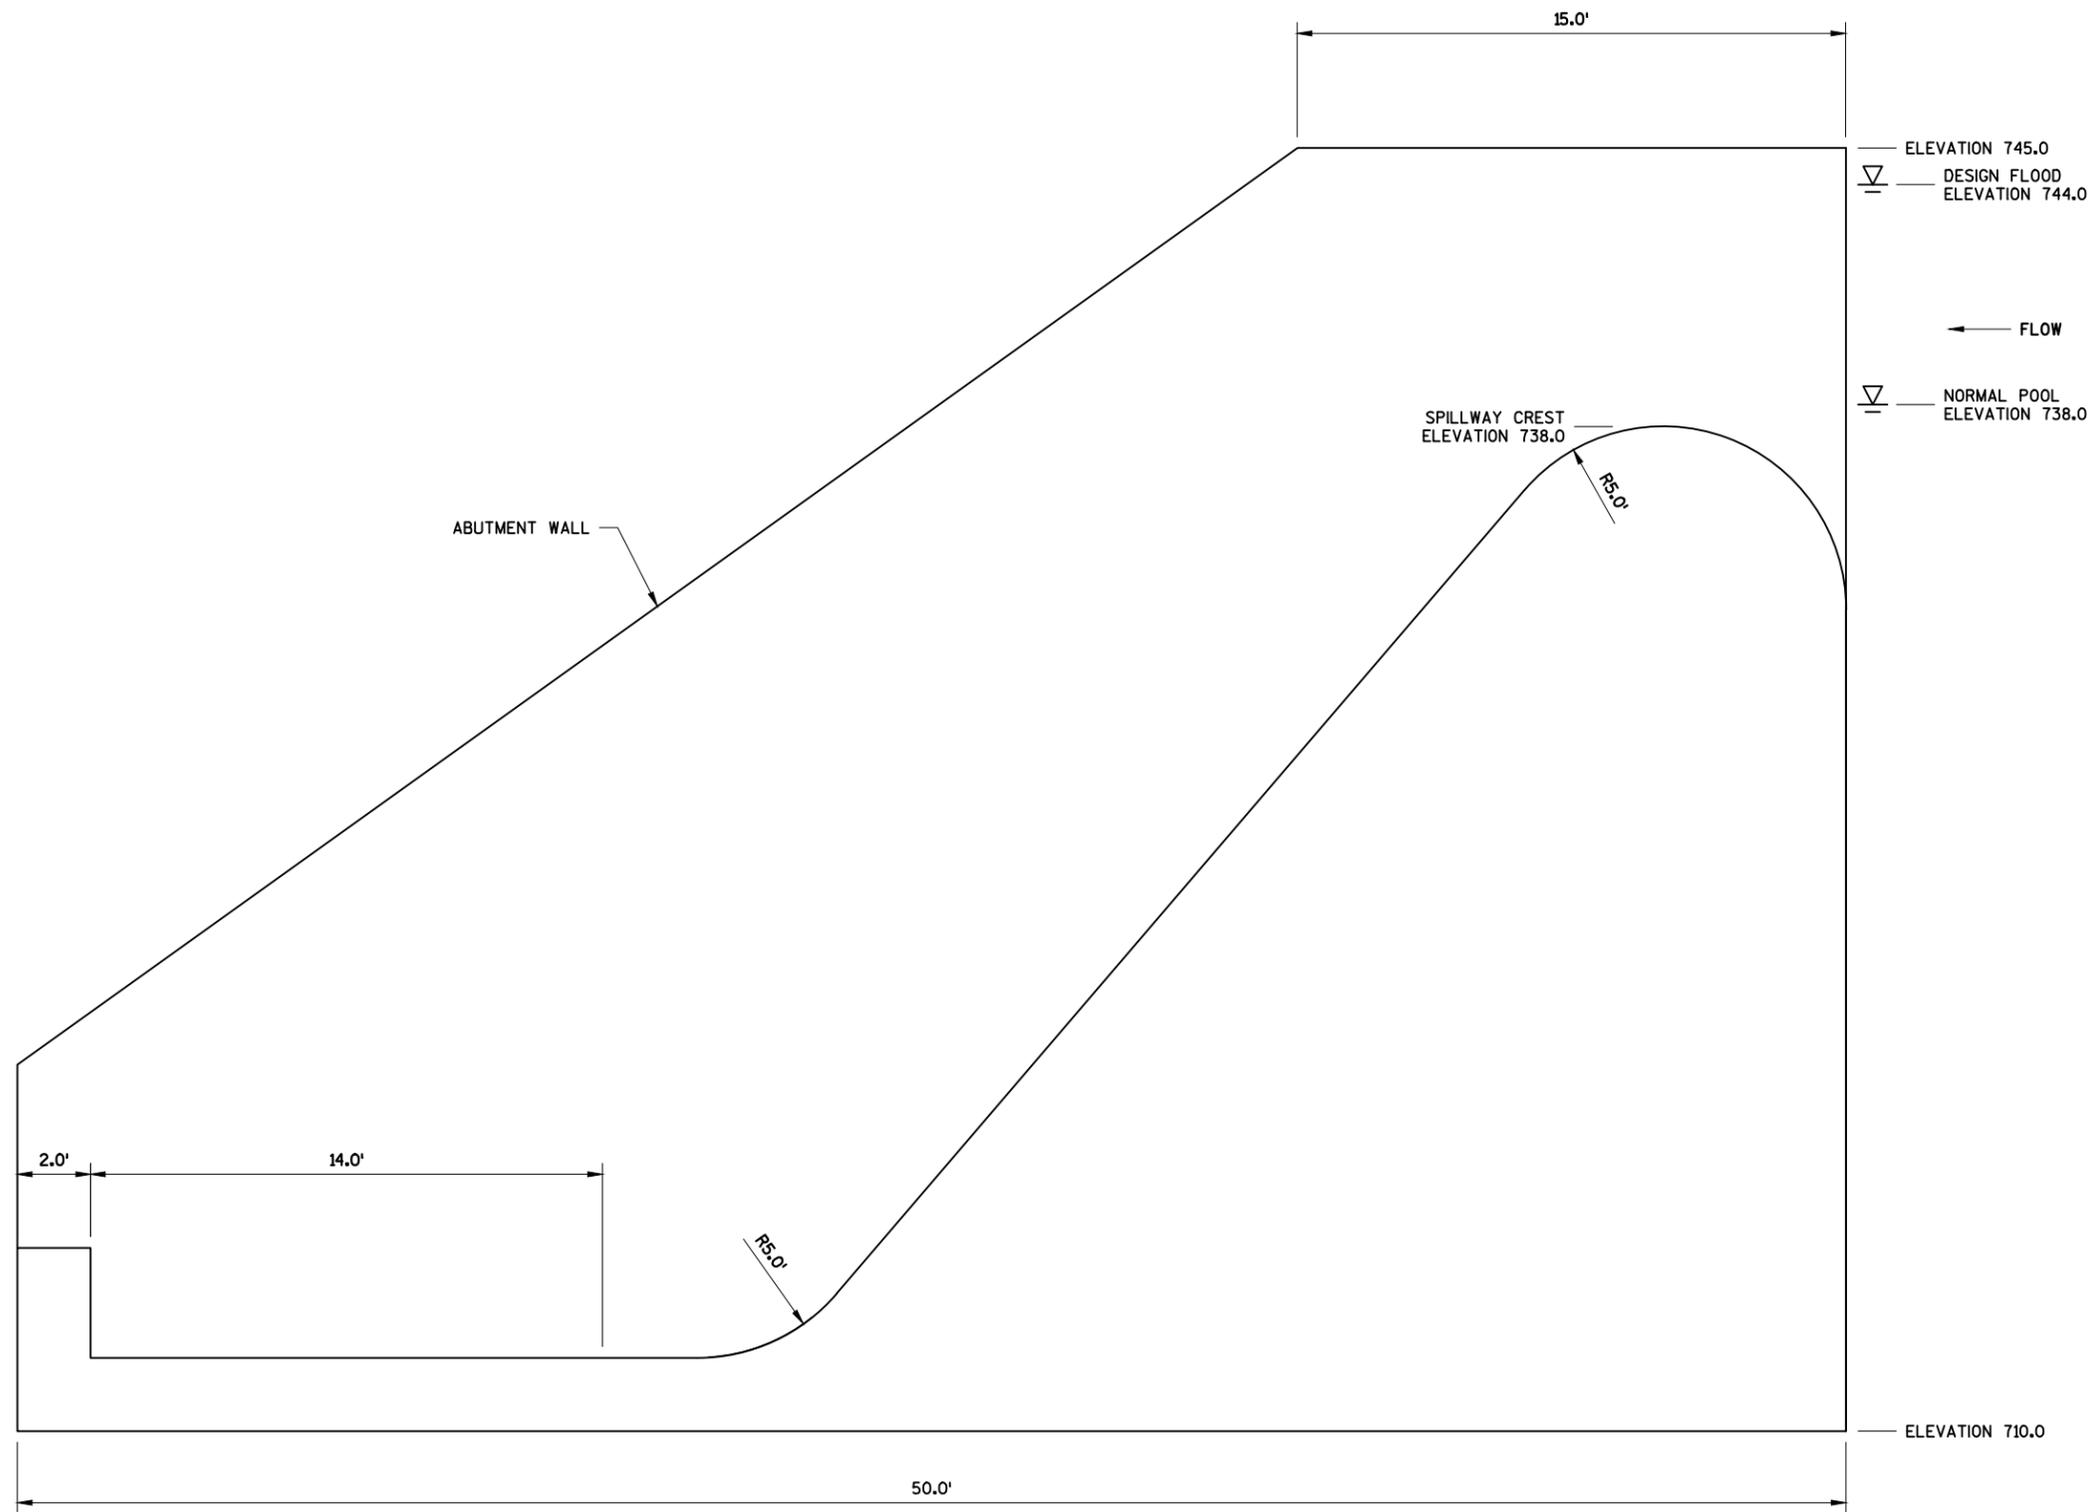
— ELEVATION 745.0
 ▽ — DESIGN FLOOD ELEVATION 744.0
 ← FLOW
 ▽ — NORMAL POOL ELEVATION 738.0

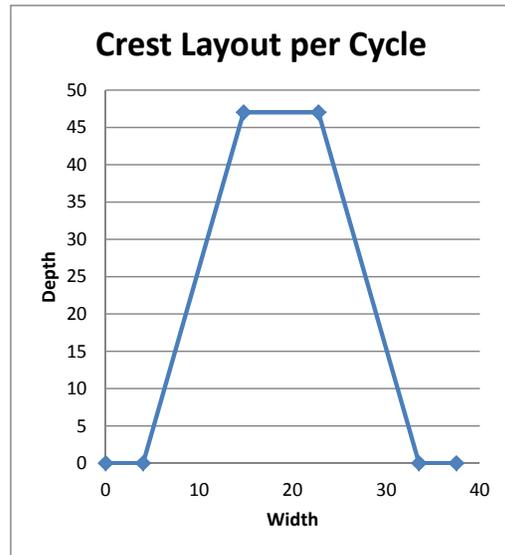
L_d/B must be ≤ 0.35
 H_o/P must be ≤ 0.9
 α must be $\geq 6^\circ$

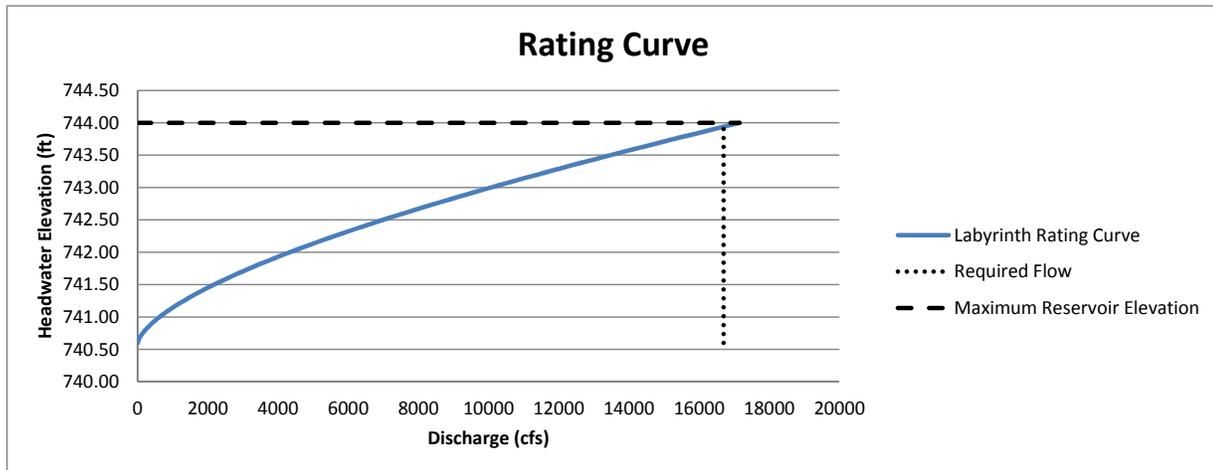
Maximum Labyrinth Flow = 17158 cfs OK

Flow	Reservoir Elevation
FIS 10-Year Flood =	8,319 cfs	742.6 ft
FIS 50-Year Flood =	12,366 cfs	743.3 ft
FIS 100-Year Flood =	13,099 cfs	743.4 ft
FIS 500-Year Flood =	15,876 cfs	743.8 ft
FIS 1000-Year Flood =	16,700 cfs	744.0 ft

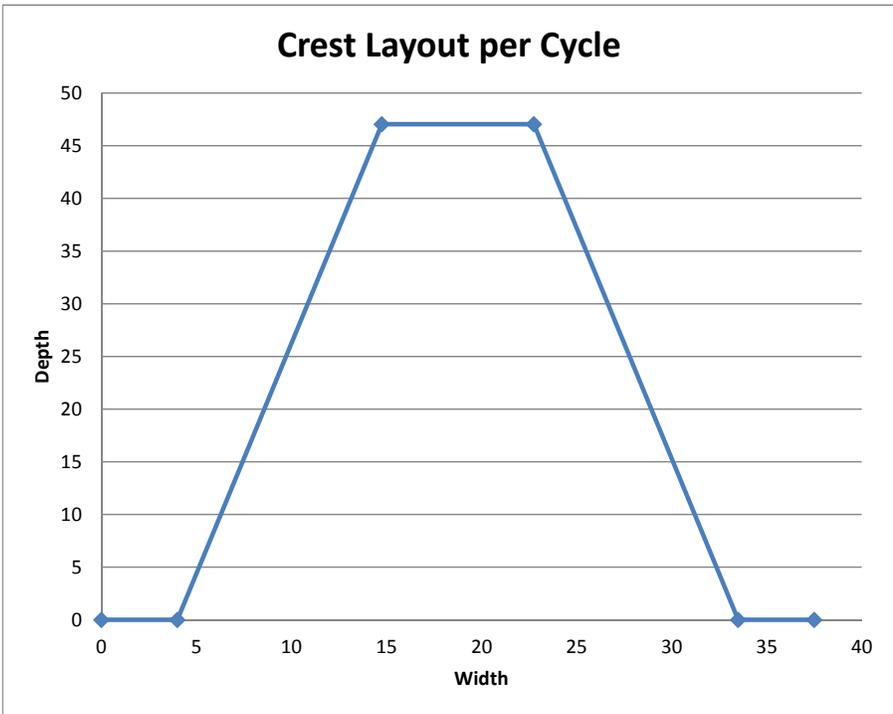
Labyrinth Dimensions			Crest Layout (One Cycle)	
Wall Height	P	20.6 ft		
Width	W	37.5 ft	X	Y
Length	L	112.5 ft	0	0
Wall Length	B	48.25 ft	4	0
Depth	D	47.04 ft	14.75	47.04
Maximum Head	H	3.4 ft	22.75	47.04
Wall Angle	α	12.87 deg	33.5	0
Length of Intereference	L_b	10.6	37.5	0
