A greater clarity

UNPRECEDENTED CITIZEN ACTIONS LED TO A CLEANER, CLEARER DEER LAKE.

Cheryl Clemens and Jim Miller / Photos by Deer Lake Conservancy

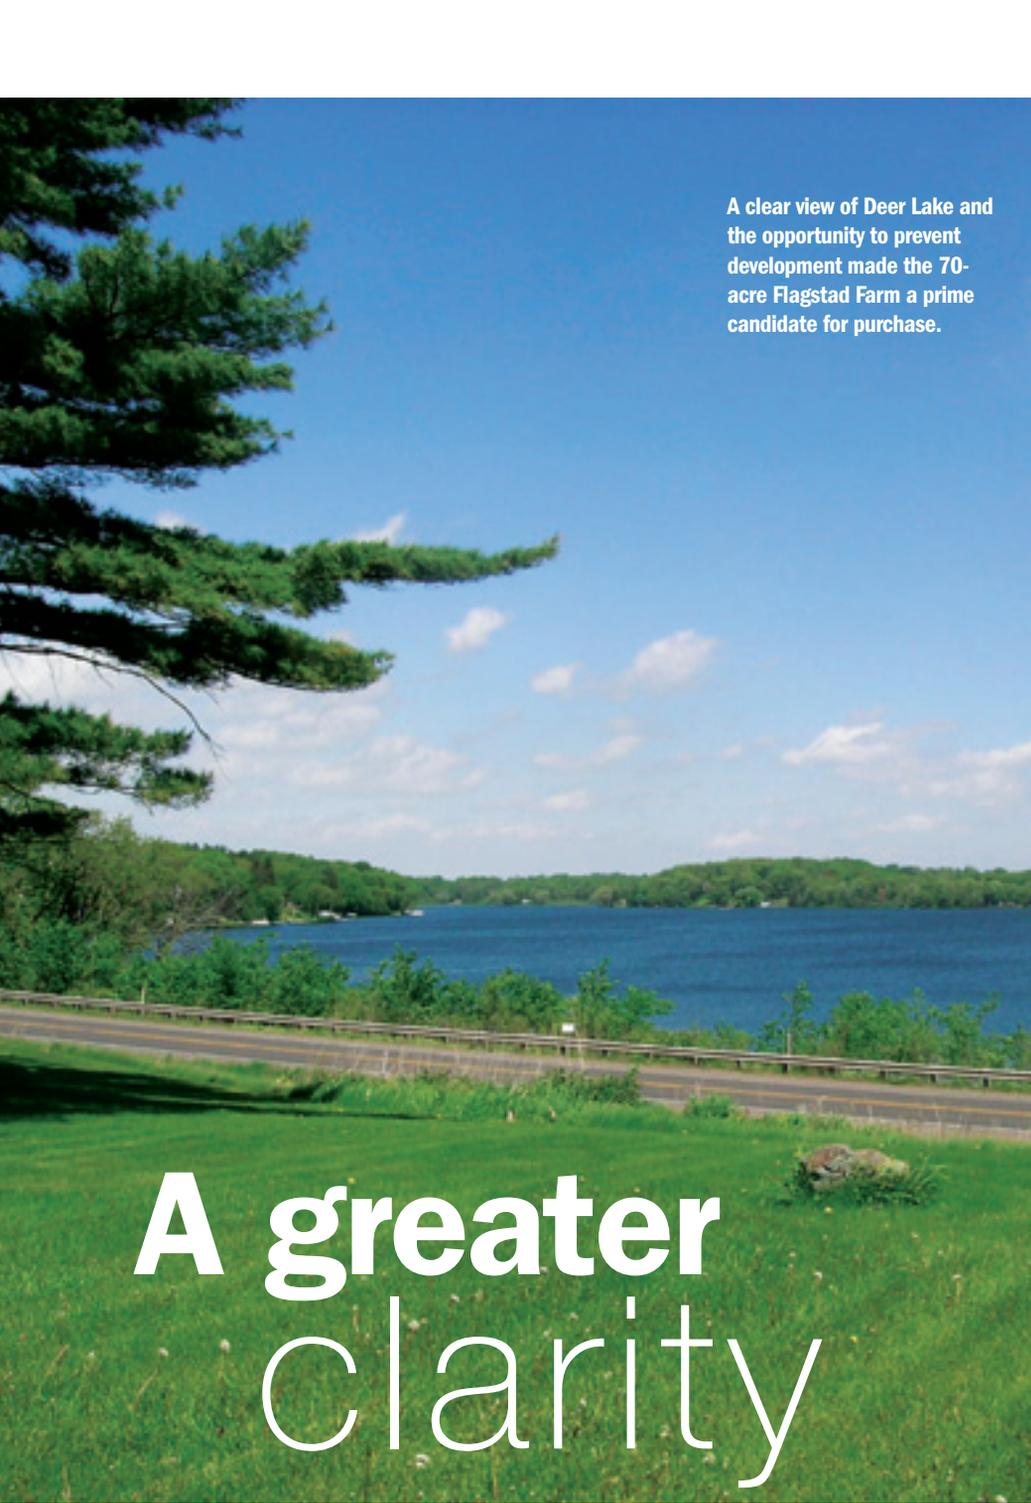
A clear view of Deer Lake and the opportunity to prevent development made the 70-acre Flagstad Farm a prime candidate for purchase.

The conservancy focused efforts on areas north and south of the lake. Initially they focused on reducing phosphorus entering the lake from agricultural watersheds to the north along Dry Creek. These projects helped to capture and infiltrate stormwater runoff where intermittent streams carry runoff to the lake. Latest efforts have shifted to the south, with acquisition and restoration of the Flagstad Farm Preserve.

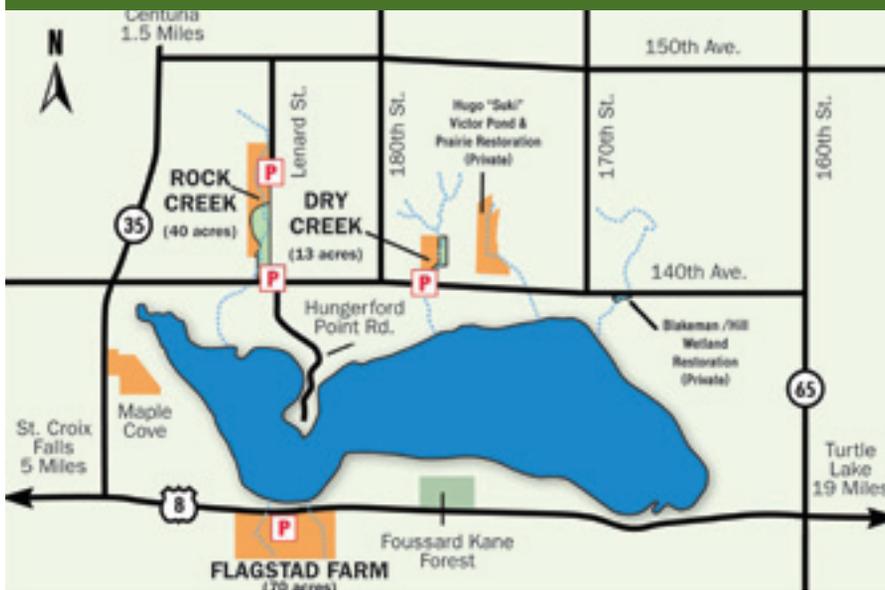
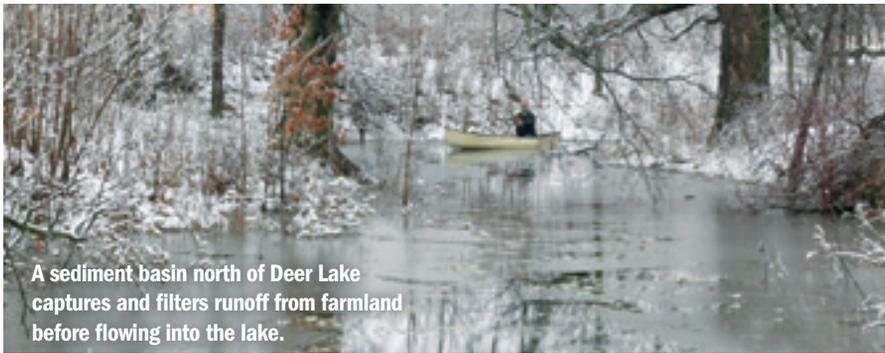
A sediment basin north of Deer Lake captures and filters runoff from farmland before flowing into the lake.

Sediment basins – Earthen berms were constructed to capture runoff water from agricultural land. Ponds that form behind the berms allow dirty water to settle and release clean water slowly. By reducing the rate of flow, downstream erosion is also decreased. The pond created by the earthen berm near the trail reaches the base of the trees more than 100 feet north of the dam during periods of peak flow. A second pond with a permanent pool of over an acre is located on private property to the north.

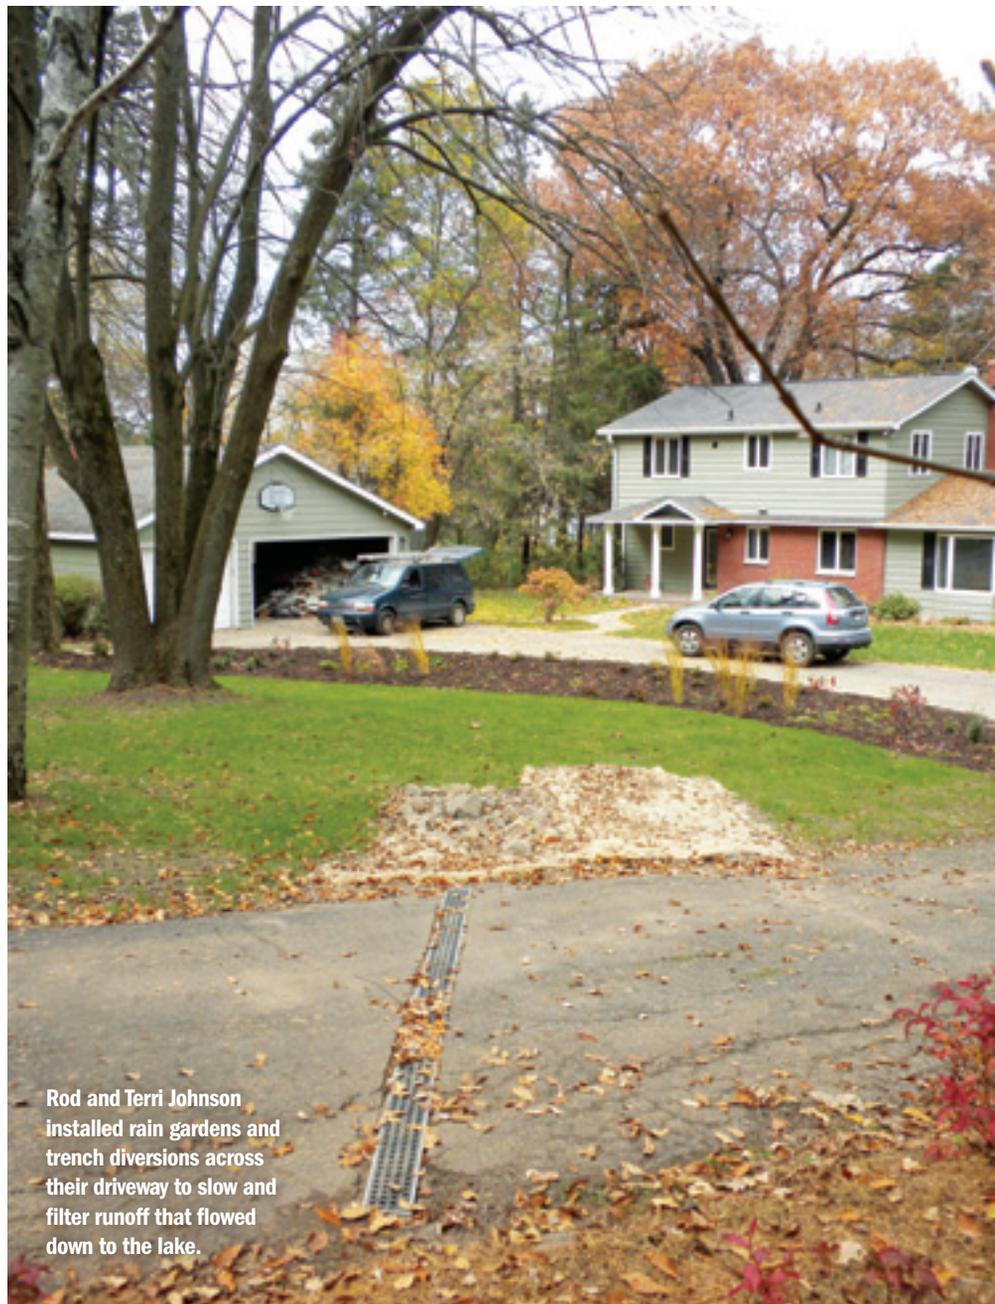
Rod and Terri Johnson installed rain gardens and trench diversions across their driveway to slow and filter runoff that flowed down to the lake.

Rod and Terri Johnson installed a series of rain gardens on their property. Rain gardens are depressions that allow the water to soak into the ground. Runoff flowed from Pinewood Road right down their driveway to the lake, causing considerable erosion along the way. Along with the rain gardens, they installed trench diversions across the driveway.

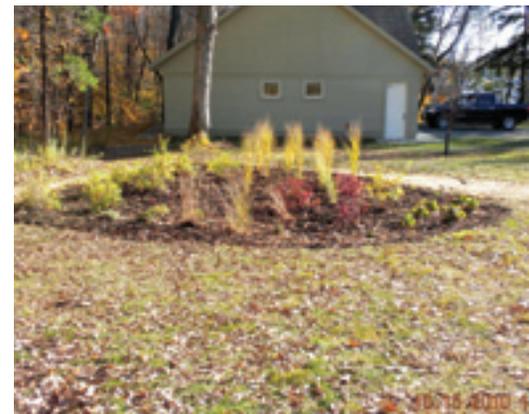
Besides filtering pollutants, rain gardens add beauty to yards and neighborhoods and provide habitat for birds, butterflies and insects.

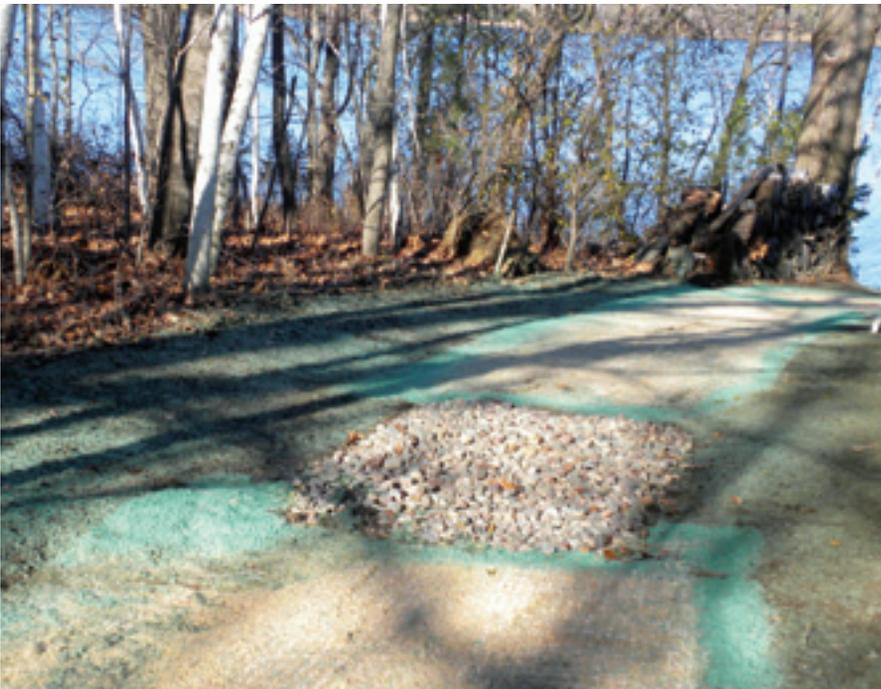
Dick and Susan Ward installed an underground infiltration device below their garage to infiltrate water from the downspout through buried plastic cells lined with filter fabric. This provides temporary storage for water until it can soak into the ground.

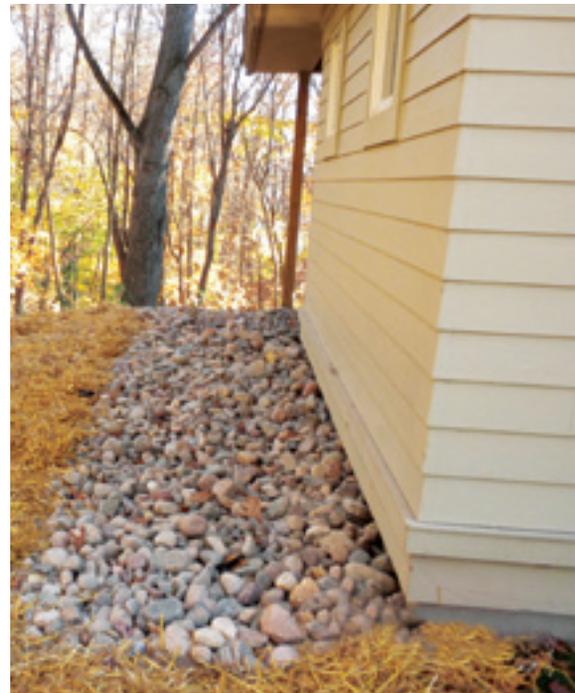
Nancy Deschane and Dean Sather's gutterless garage was causing erosion, so they installed a rock trench to catch and infiltrate water.

driveway. They explain that shortly after completion of their building project in 2008 on Deer Lake, it became evident runoff from and around the new buildings had to be addressed. The property is situated on the precipice of a steep ravine that flows directly into the lake. The area around the garage was especially prone to erosion due to the sandy soil composition and the heavy amount of runoff from the gutterless roof. A rock trench below the roofline of the garage now captures additional water that had been causing erosion to a stream that flows to the lake.

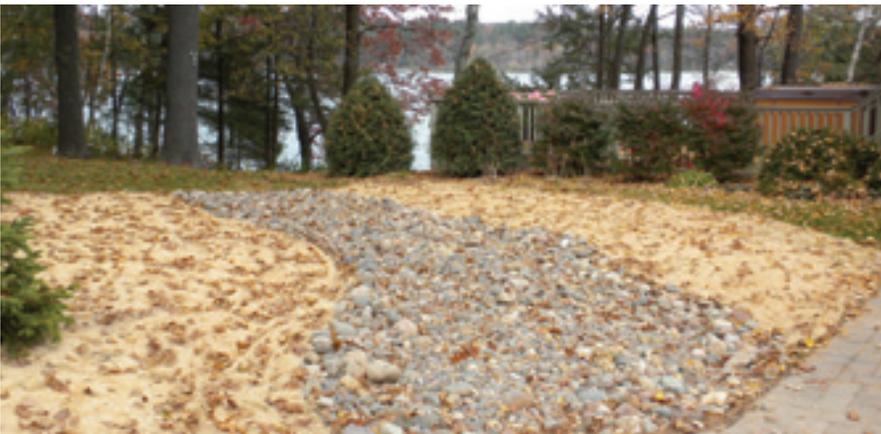
Areas filled with rock are another option for creating water storage to alleviate erosion by filtering water runoff from roads and driveways.

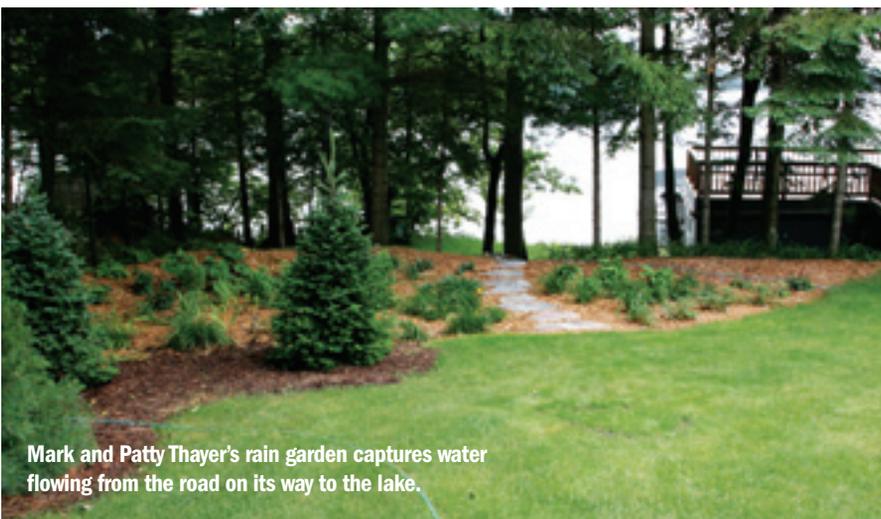
Mark and Patty Thayer's rain garden captures water flowing from the road on its way to the lake.
